# Recall Campaign Bulletin

Campaign No. 2024120001, December 2024

SUBJECT: **Model C-Class, CLK, E-Class, and CLS (203, 209, 211, and 219 platform)  
Model Year 2001 – 2011**

## **Check Sliding Roof Bonding**

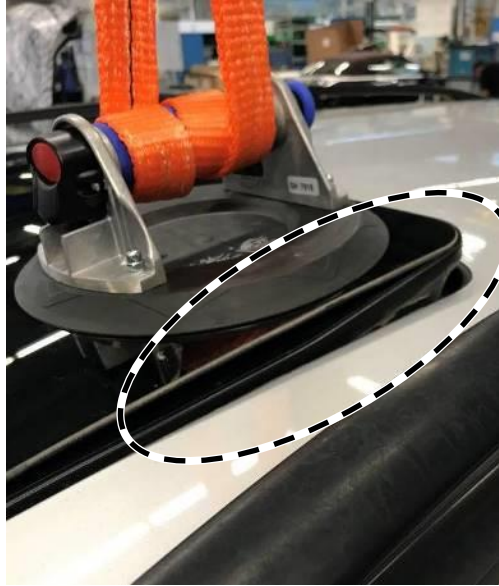
**Figure 6** (*not* OK)

**i** If the sliding sunroof panel detaches from the padding of the tilting/sliding sunroof frame at one of the test positions (see example Figure 6), the sliding sunroof panel must be replaced.

- a. If the sliding roof panel detaches from the padding: Carry out **Work Procedure**.
- b. If the sliding roof panel does **not** detach from the padding: **End measure**.
