December 20, 2024

Version 2

## Safety Recall: 2023–25 Pilot, 2023–24 Passport Fuel Tank Fill Pipe Inspection and Repair

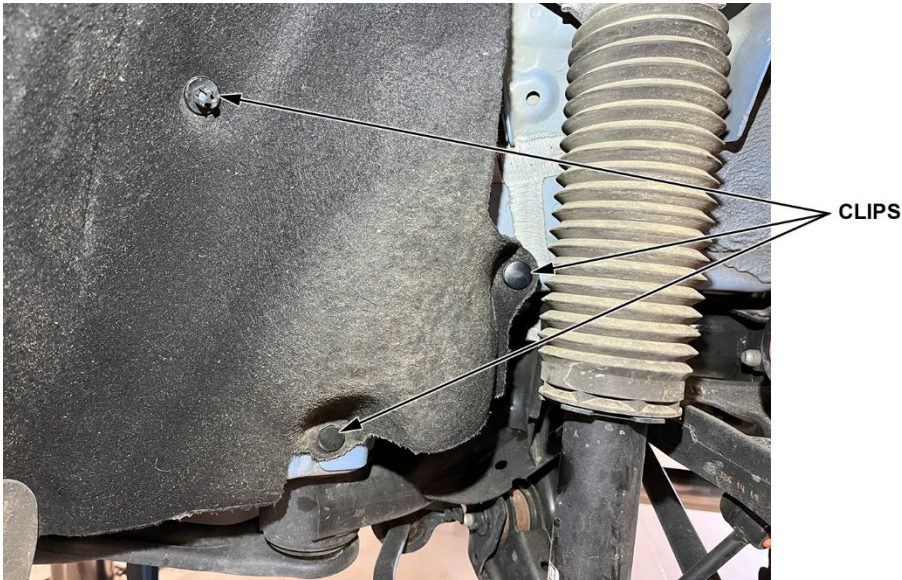
#### PILOT

- Remove the left rear wheel.
- Partially disconnect the [Left Rear Inner Fender](#).
- Remove the clips of the inner fender liner, carefully pull the liner back to access the fuel tank fill pipe.

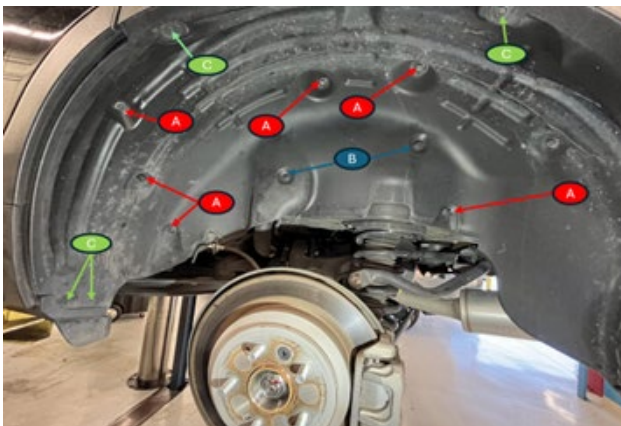
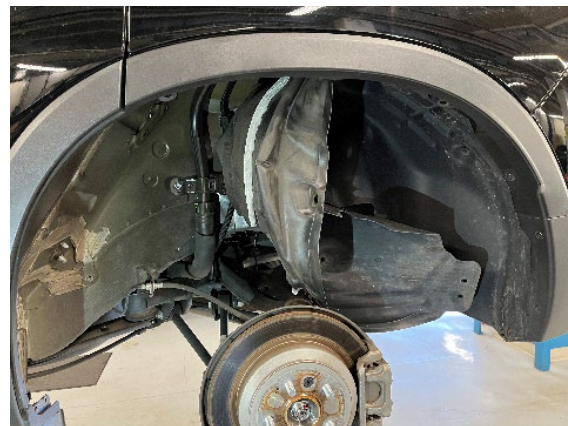
#### PASSPORT

- Remove the left rear wheel.
- Partially disconnect the left rear inner fender by removing the 6 bolts, 2 clips and 4 screws.
- Carefully pull the liner back to access the fuel tank fill pipe.

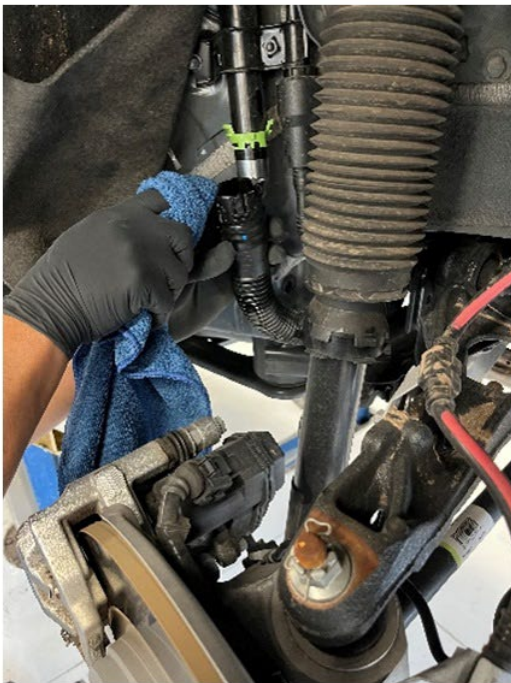
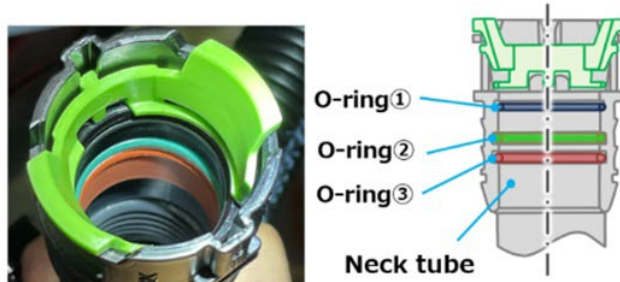
Make sure the O-rings are clean and intact before reinstalling the fuel tank fill pipe.
