TECHNICAL INSTRUCTIONS

SAFETY RECALL

24LA08

POTENTIAL LOSS OF BRAKING PERFORMANCE OR WHEEL SEPARATION

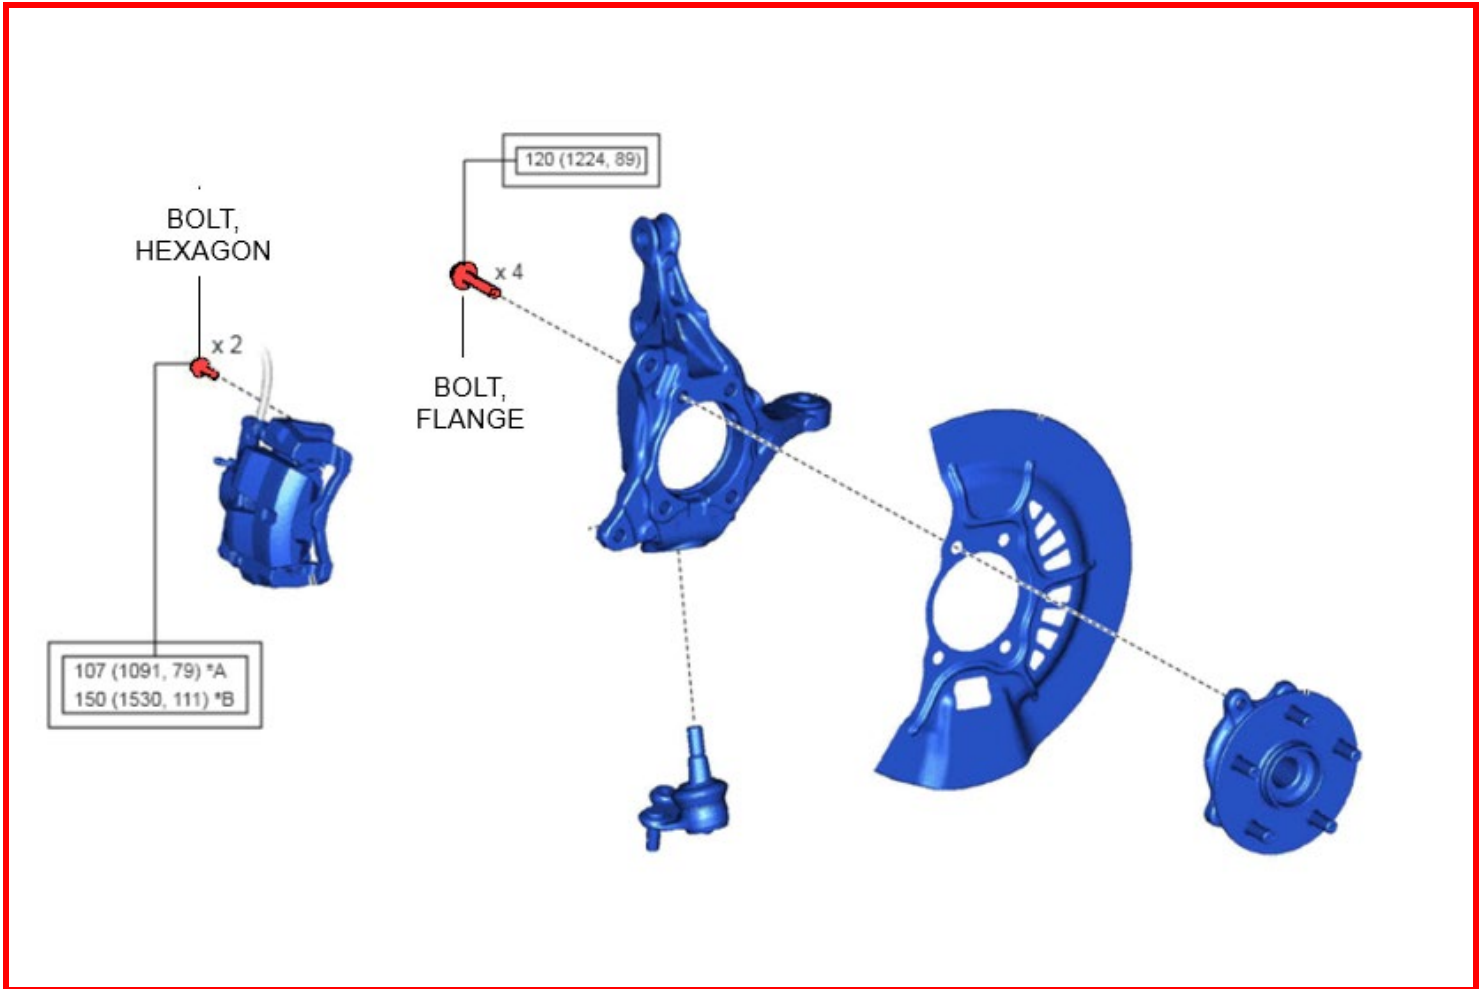
Certain bolts may not have been properly tightened during manufacturing and can loosen over time, potentially causing the front brake calipers or front wheels to detach. If this occurs, there can be an increase in stopping distance or a loss of vehicle control, increasing the risk of crash.

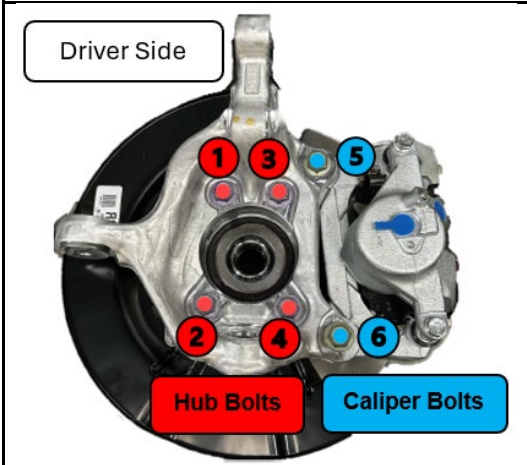
- b. Review the driver side hub and caliper bolt locations.

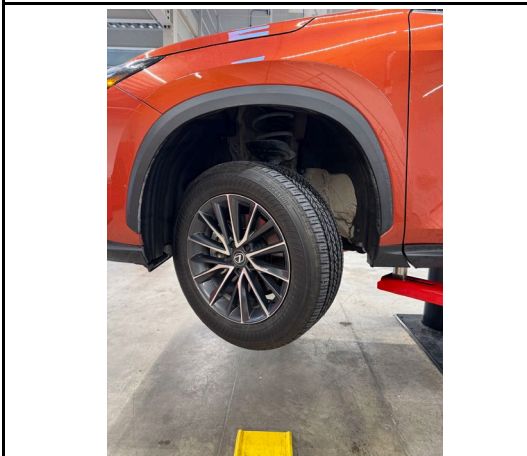
- c. Turn the driver front wheel full mast to the right (towards passenger side).

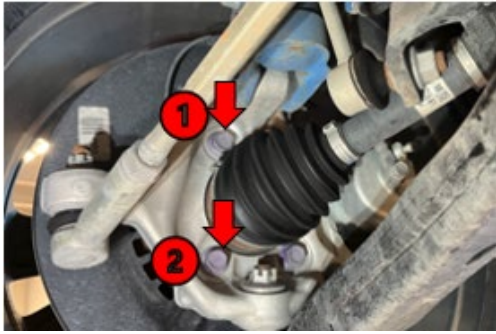
- d. Inspect the driver side (1) and (2) hub bolts for missing or not fully seated (loose).
- e. If any loose bolts found, remove bolt and inspect for damage.

- Check any bolt that is loose for damaged threads.
- Document any missing bolts.

NOTE: If any loose bolts are discovered and the threads are ok, temporarily reinstall bolt.

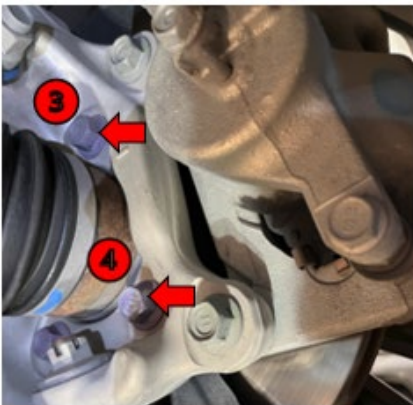
- g. Inspect the driver side hub bolts (3) and (4) for missing or not fully seated (loose).
- h. If any loose bolts found, remove and inspect for damage.

- Check any bolt that is loose for damaged threads.
- Document any missing bolts.

NOTE: If any loose bolts are discovered and threads are ok, temporarily reinstall bolt.

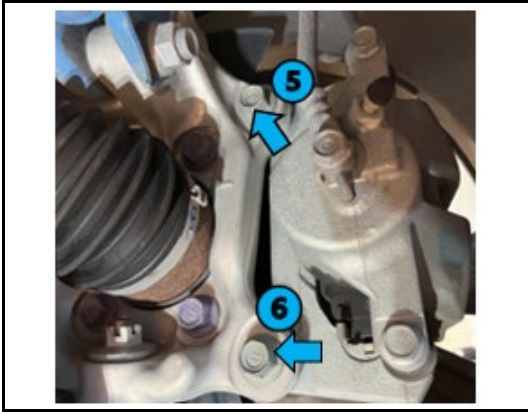
- i. Inspect the driver side caliper bolts (5) and (6) for missing or not fully seated (loose).
- j. If any loose bolts found, remove and inspect for damage.

- Check any bolt that is loose for damaged threads.
- Document any missing bolts.

NOTE: If any loose bolts are discovered and threads are ok, temporarily reinstall bolt.

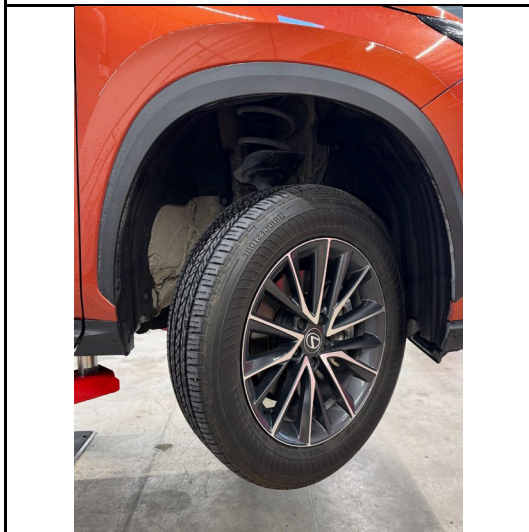
b. Turn the passenger front wheel full mast to the left (towards drivers side).

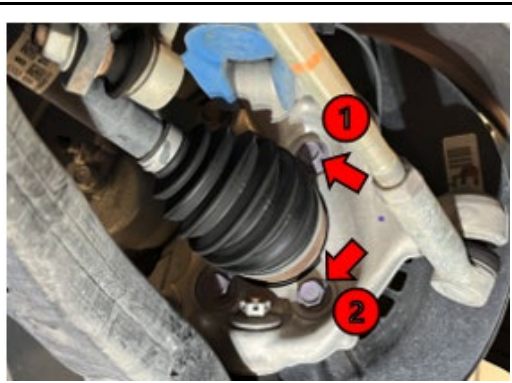
- c. Inspect the passenger side (1) and (2) hub bolts for missing or not fully seated (loose).
- d. If any loose bolts found, remove and inspect for damage.

- Check any bolt that is loose for damaged threads.
- Document any missing bolts.

NOTE: If any loose bolts are discovered and the threads are ok, temporarily reinstall bolt.

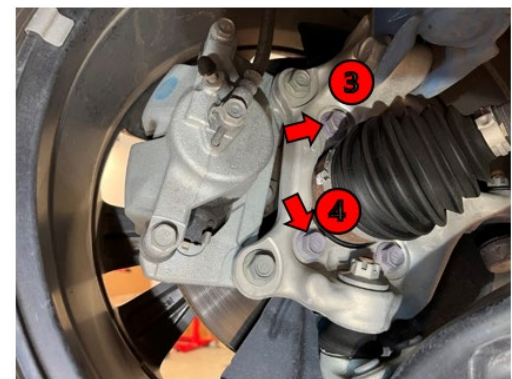
- f. Inspect the passenger side hub bolts (3) and (4) for missing or not fully seated (loose).
- g. If any loose bolts found, remove and inspect for damage.

- Check any bolt that is loose for damaged threads.
- Document any missing bolts.

NOTE: If any loose bolts are discovered and threads are ok, temporarily reinstall bolt.

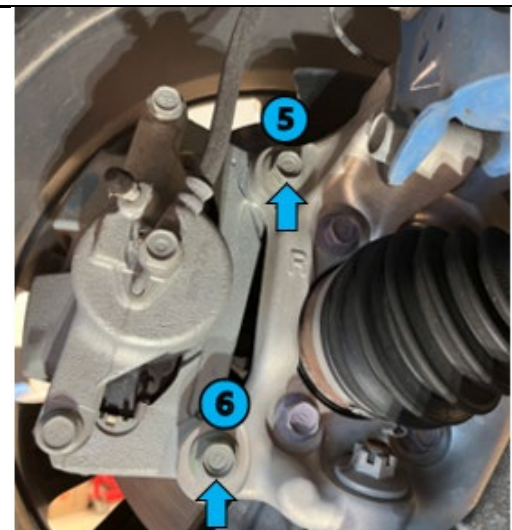
- h. Inspect the passenger side caliper bolts (5) and (6) for missing or not fully seated (loose).
- i. If any loose bolts found, remove and inspect for damage.

- Check any bolt that is loose for damaged threads.
- Document any missing bolts.

NOTE: If any loose bolts are discovered and threads are ok, temporarily reinstall bolt.

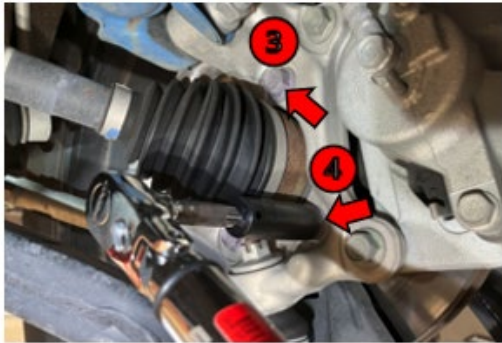
e. Loosen then torque the driver side hub bolts (3) and (4) to specification.

Torque:
120 N·m {89 ft·lbf}

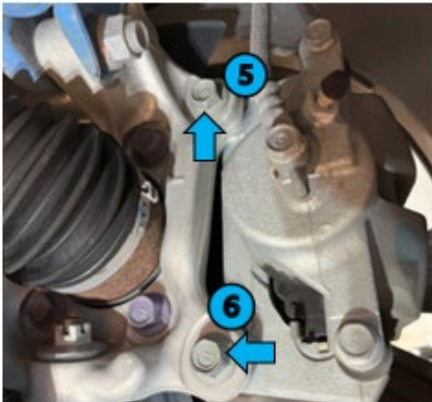
f. Loosen then torque the driver side caliper bolts (5) and (6) to specification.

Torque:
for Steel Steering Knuckle :
107 N·m {79 ft·lbf}

for Aluminum Steering Knuckle :
150 N·m {111 ft·lbf}

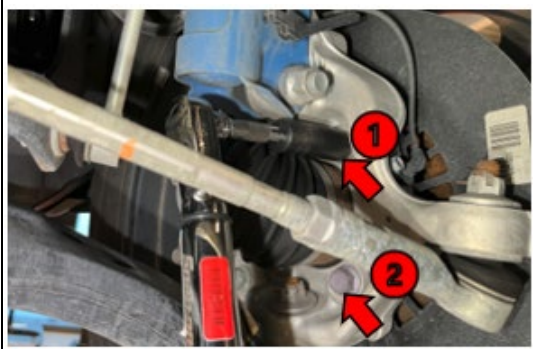
- c. Loosen then torque the passenger side hub bolts (1) and (2) to specification.

Torque:
120 N·m {89 ft·lbf}

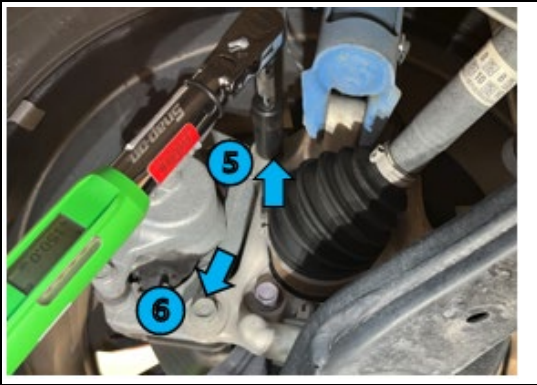
f. Loosen then torque the passenger side caliper bolts (5) and (6) to specification.

Torque:

for Steel Steering Knuckle :
107 N·m {79 ft·lbf}

for Aluminum Steering Knuckle :
150 N·m {111 ft·lbf}
