SAFETY RECALL
 NORTH AMERICA
Rear Bumper Lamps

Reference: D7B / NHTSA 24V-918

FCA US LLC

Remedy available for
 2021 - 2023 (BV) Jeep® Renegade

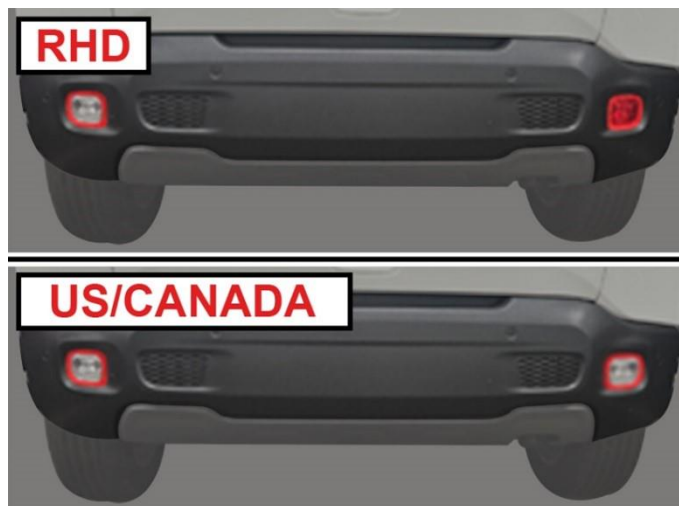
Figure 1 – Lamp Configuration Inspection

1. Depending on the configuration and market, check the layout of the rear lamps as shown (Figure 1).

NOTE: US/Canada vehicles should have mostly clear lens with a red border on both sides of the vehicle. RHD vehicles should have a mostly clear lens with red border on left side and full red lens on right side.

- If the rear lamps layout is different from those shown in (Figure 1), the vehicle is NOT Compliant. Proceed to **Section B. Lamp Replacement**.
- If the rear lamps layout is the same of those shown in (Figure 1), the vehicle is Compliant. Return vehicle to customer or inventory.

**NOTE: Lamp configurations shown are correct/compliant.
Any lamp configuration other than shown is NOT compliant.**

IMPORTANT: Replace one or both rear bumper lamps as needed for regulatory compliance (Figure 1).

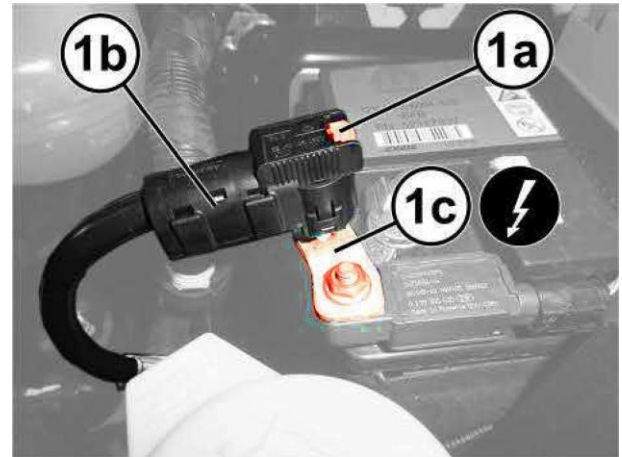
Figure 2 – Battery Negative Terminal

1. Ensure the ignition is in the OFF position and vehicle lamps are turned OFF.
2. Open the lift gate.
3. Open the engine compartment hood.
4. Disconnect and isolate the battery negative terminal. Press the retainer (1a) and disconnect the battery negative cable terminal (1b) from the negative terminal post (1c) (Figure 2).
5. Remove the left-side and right-side tail lamp access covers (1a) by releasing the internal retainers (1b) (Figure 3).

39. Position the left-side and right-side tail lamp access covers (1a) and engage the internal retainers (1b) (Figure 3).
40. Connect the battery negative cable terminal (1b) to the negative terminal post (1c) (Figure 2).

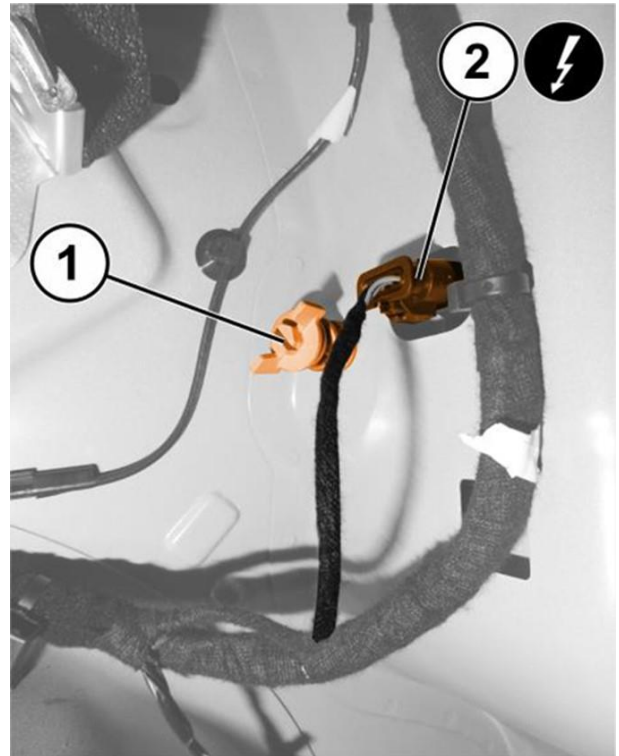
Figure 4 – Tail Lamp

6. Disconnect the wire harness connector (2) from both tail lamp assemblies (Figure 4).
7. Unscrew and remove the fastener (1) securing both tail lamp assemblies (Figure 4).

37. Secure both tail lamp assemblies by installing the fastener (1) (Figure 4).
38. Connect the wire harness connector (2) on both tail lamps (Figure 4).

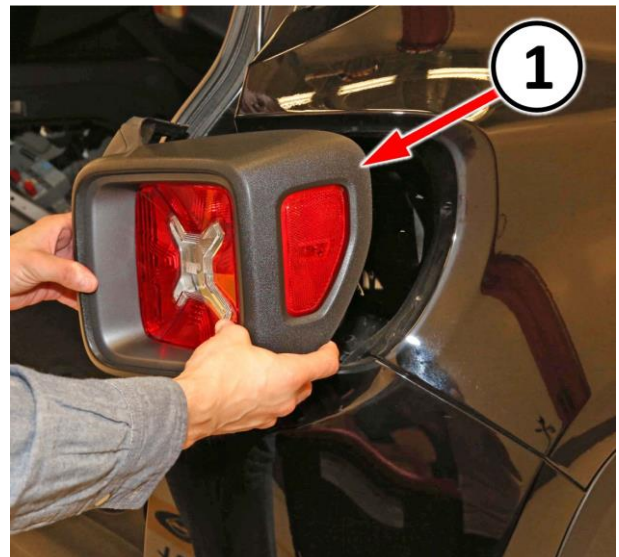
Figure 5 – Tail Lamp

8. Remove both tail lamps (1) from the vehicle (Figure 5).

34. Install the screws (1) at the bottom of the rear fascia and tighten securely (Figure 6).
35. Lower the vehicle.
36. Position both tail lamp assemblies (1) to the vehicle for installation (Figure 5).

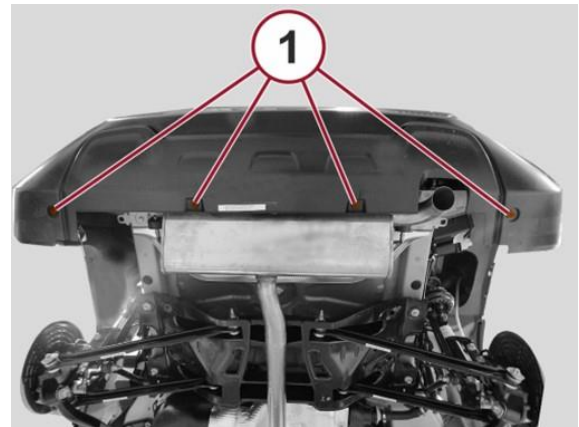
Figure 6 – Rear Fascia

10. Remove the four screws (1) at the bottom of the rear fascia (Figure 6).

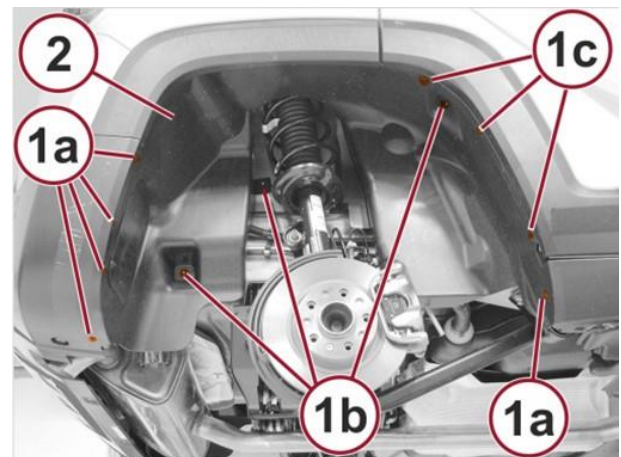
Figure 7 – Wheelhouse Liner

11. Remove the four screws (1a) securing the rear half of the rear wheelhouse liner (2) to the rear fascia on both sides of the vehicle (Figure 7).
12. Remove the two screws (1b) securing the rear half of the rear wheelhouse liner (2) on both sides of the vehicle (Figure 7).

32. Install the screws (1b) securing the rear wheelhouse liner (2) on both sides of the vehicle (Figure 7).
33. Install the screws (1a) securing the rear wheelhouse liner (2) to the rear fascia on both sides of the vehicle (Figure 7).

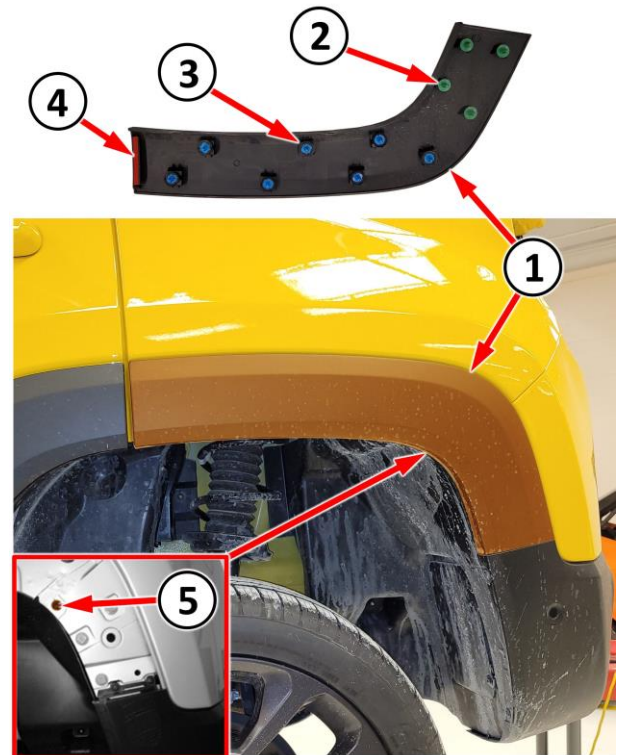
Figure 8 – Wheel Flare

13. Carefully pull back the wheelhouse liner only enough to gain access to the wheel flare (1) lower attaching clips (2, 3) (Figure 8).
14. Release the lower portion of the wheel flare (1) by using a socket of an appropriate size small enough to depress the retaining tabs of the attaching clips (2, 3). Use the socket to push the retaining tabs from the back side (Figure 8).
15. Using a trim stick or equivalent, carefully release the remaining upper portion of the wheel flare attaching clips (2, 3) to remove the wheel flare (1) (Figure 8).

NOTE: The wheel flare (1) is secured to the vehicle by the following (Figure 8):

- Trim adhesive tape (4).
- Four green clips (2).
- Seven blue clips (3).

If any attaching clips require replacement, the part number is listed in the Parts Information table on Page 2 of this recall document. To replace the trim tape (4), use 3M Exterior Attachment Tape 38583 or equivalent.

16. Remove the screws (5) from both sides of the rear fascia (Figure 8).
17. Disconnect the wire harness connector from the rear bumper lamps on both sides of the vehicle (Figure 9).

30. Install the screws (5) on both sides of the rear fascia (Figure 8).
31. Position the rear wheel flare molding (1) and hand tap to engage the retaining clips (2, 3) on both sides of the vehicle (Figure 8).

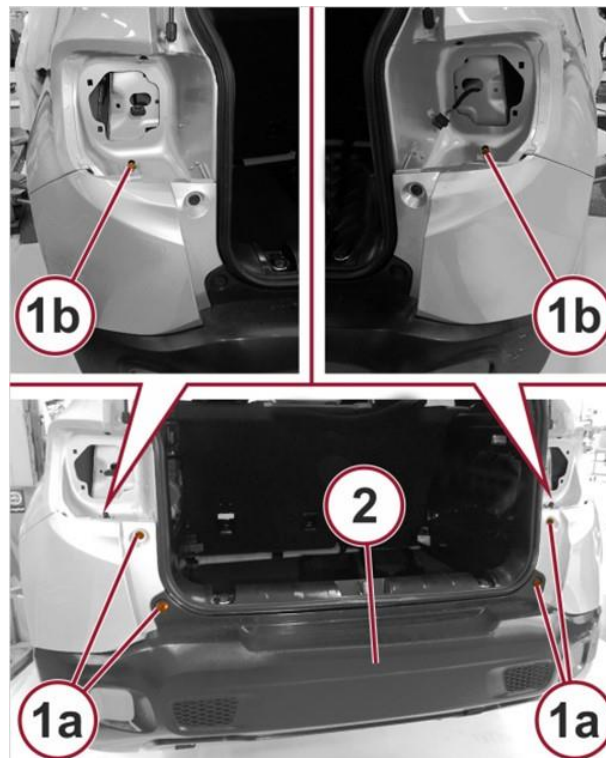
Figure 10 – Rear Fascia

- 18. Remove the screws (1a and 1b) (Figure 10).
- 19. Partly remove the rear fascia (2) (Figure 10).

25. Install and securely tighten the bumper lamp fasteners (1a) (Figure 12).
26. Connect the wire harness connectors to the rear fascia (Figure 11).
27. Position the rear fascia (2) and install the screws (1a and 1b). Tighten the screws securely (Figure 10).

28. Install the screws (2a and 2b) on both sides of the rear fascia. Tighten the screws securely (Figure 10).
29. Connect the wire harness connector to the rear bumper lamps on both sides of the vehicle (Figure 9).

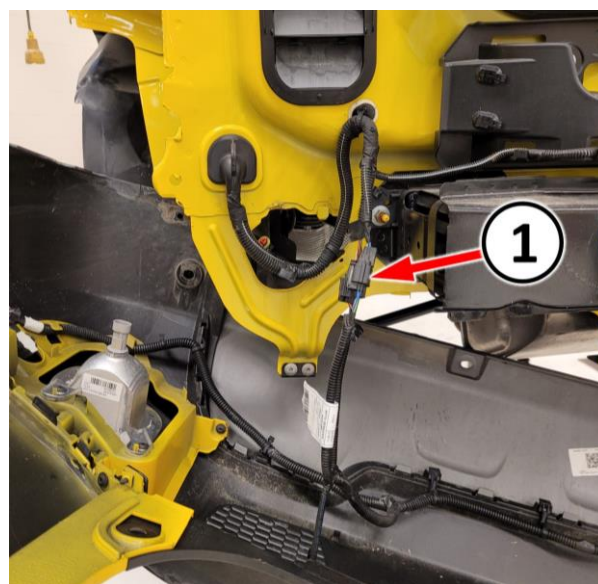
Figure 11 – Fascia Electrical Connector

- 20. Disconnect the wire harness connectors from the rear fascia (Figure 11).
- 21. Fully remove the rear fascia and place on a suitable work surface to prevent any paint damage.

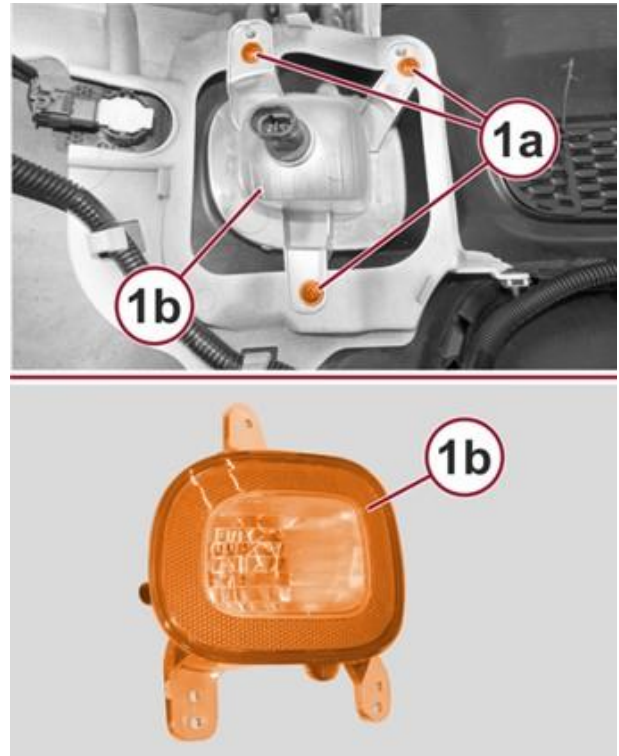
Figure 12 – Bumper Lamp

22. Remove the bumper lamp fasteners (1a) (Figure 12).
23. Remove and **DISCARD** the bumper lamp (1b) (Figure 12).
24. Position the **NEW** bumper lamp (1b) to the rear fascia (Figure 12).
