GROUP	MODEL
Safety Recall Campaign	2025MY
	Sorento PHEV (MQ4 PHEV) w/R-MDPS
NUMBER	DATE
SC328	December 2024

FUEL LINE PROTECTIVE COVER

KIT INSTALLATION (SC328)

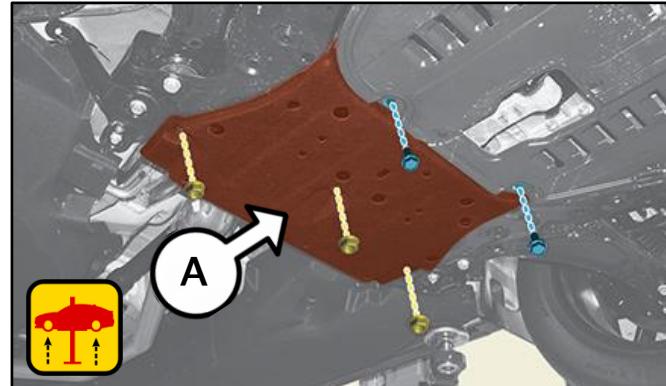
1. Remove the subframe under cover (A).

Tightening torque for bolts:
5.8 - 8.7 lb.ft (7.8 - 11.8 N.m)

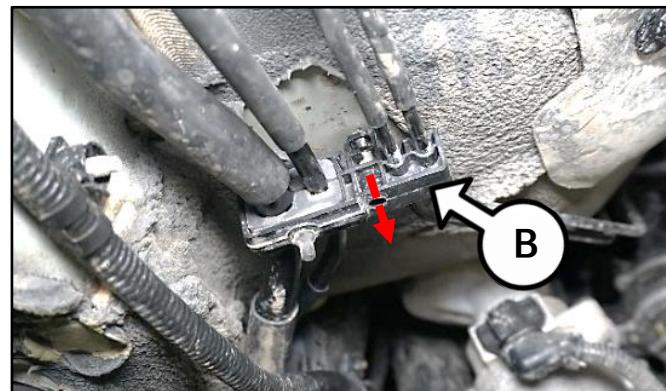
2. Using a clip removal tool, carefully detach the fuel/brake line holder retaining clamp (B) from the vehicle chassis.
3. Unlock the clamp/clip to detach the fuel tube holder and detach the fuel and brake lines.

CAUTION
Be careful not to puncture the fuel line during disassembly.

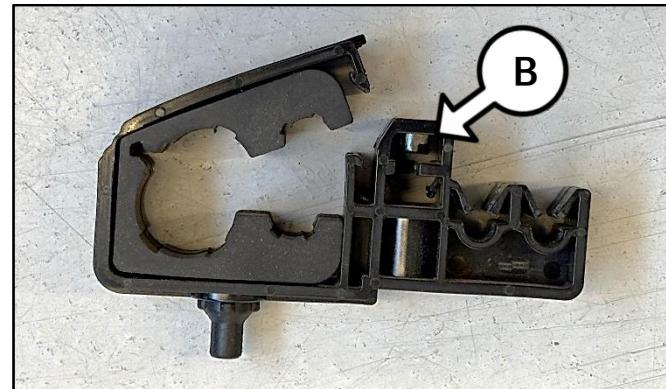
NOTE: Discard the removed plastic fuel tube holder, DO NOT reuse. Also, note the upward position of the holder clamp.

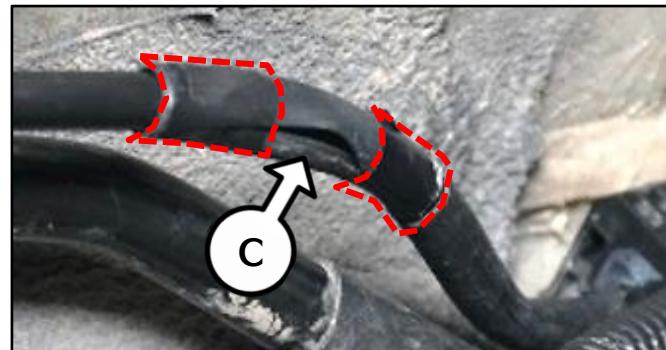
5. Install the protective cover (C) over the fuel line and tape both opposite ends as shown.

Note: Be sure to install the cover along the full length touching the existing line cover.

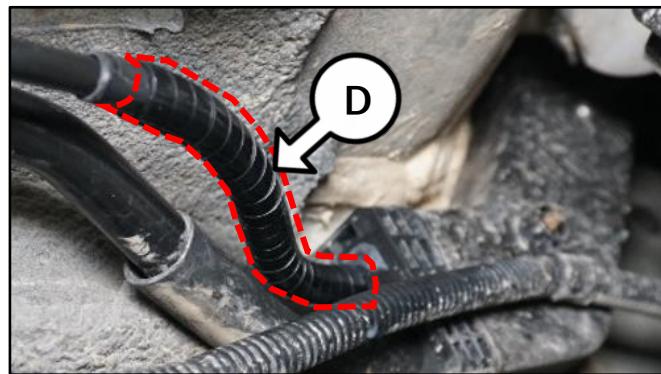
6. Install the spiral armor sleeve (D) over the previously installed line cover and tape both opposite ends as shown.

TECH TIP

Start the left end and then spin the spiral cover (E) around the fuel line until the complete line is covered.

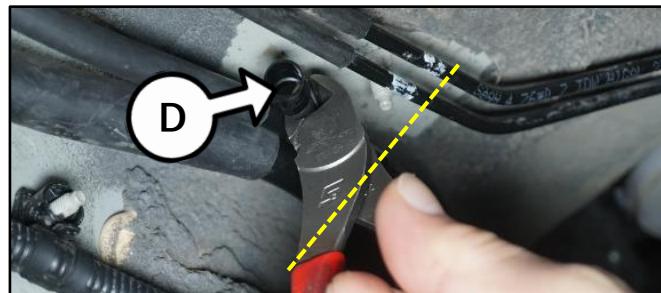
7. Cut-off any excess plastic spiral (D) covering by referencing the white marking on the brake lines.

NOTICE

Do not overlap the fuel line area where the holder clamp is placed.

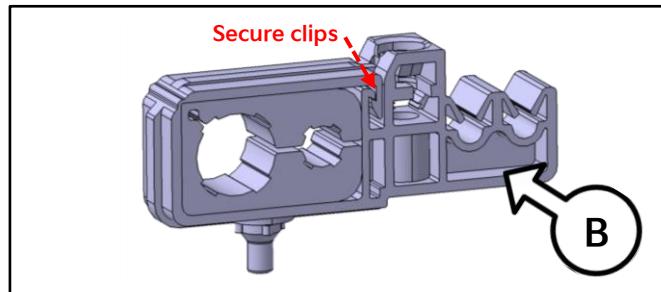
8. Attach the fuel/brake line holder clamp (B) in the reverse order of removal.

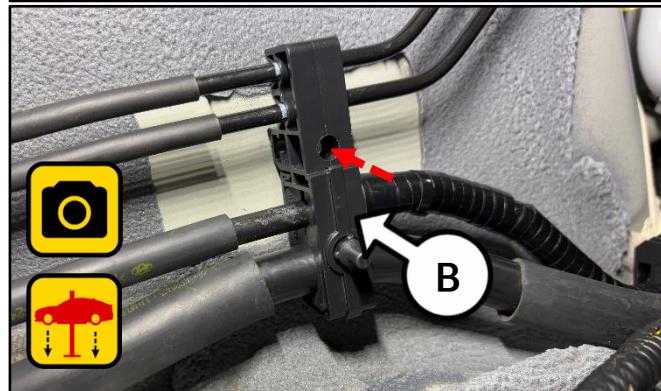
10. Insert and secure the assembled fuel/brake line holder clamp (B) onto the chassis bolt and lock/secure the clips.

11. Take a photo of the completed installation using the KDS Warranty Attachment function.

12. Reinstall the subframe under cover in the reverse order of removal.
