SAFETY RECALL CAMPAIGN 3A05 **2023 - 2025 Burgman 400 Fuel Hose Parts Replacement**

- Affected Models:** 2023 ~ 2025 Burgman 400 (AN400A M3-M5) scooters
- Affected Departments:** Management, Service, Warranty, Sales, Parts, Accessories
- Attachments:** [Sales Bulletin 24-109](#) (Burgman 400 Stop Sales) & Customer Notification Letter
- Reference:** [Burgman 400 \(AN400A\) Service Manual](#) (99500-34243-03E),

Improper installation of the fuel pump caused bending of the metal pipe portion of the hose assembly, placing the fuel supply hose assembly at risk of potential contact with the fuel vapor hose. In the worst case, the fuel supply hose can be abraded by the fuel vapor hose to a degree that could cause a fuel leak from the hose. This can increase the risk of a fire.

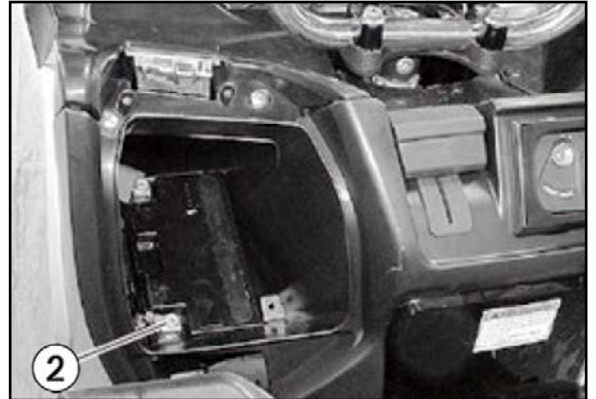
1) Battery Removal:

1. Turn the ignition switch OFF.
2. Remove the battery cover ①.
3. Disconnect the battery (-) lead wire ② and insulate it so it does not touch the battery terminal.

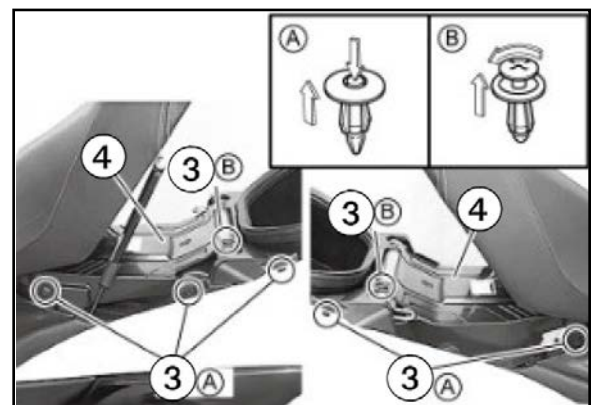
6. Remove the push-pin, plastic fasteners ③.

7. Remove the helmet box front cover ④.

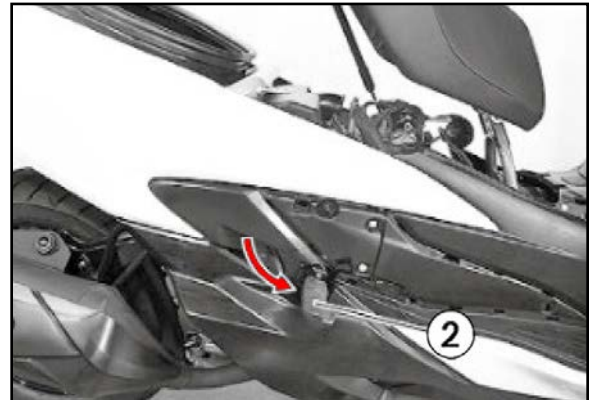
10. Unfold the left and right pillion (passenger) footrests ②.

11. Remove the screws ③, bolts ④, and plastic pin fasteners ⑤ securing both side covers.

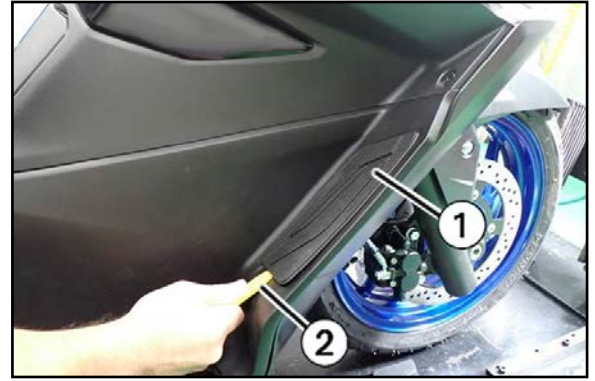
16. Remove the left and right footbords No. 3 ① using the remover tool ②.

17. Remove the left and right lower cowl plastic fasteners ③.

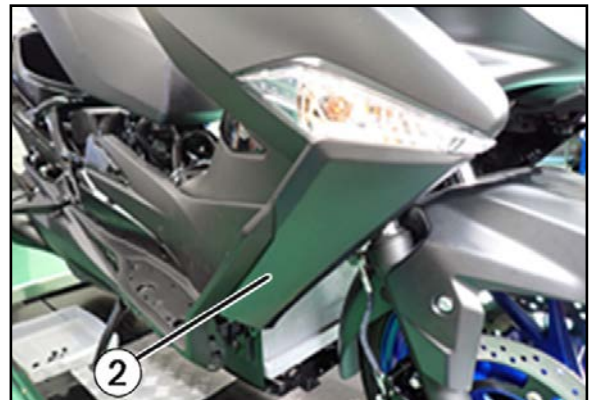
25. Remove the left and right side upper shield ②.

26. Pull the shields forward ③ to disconnect them from the upper cowl.

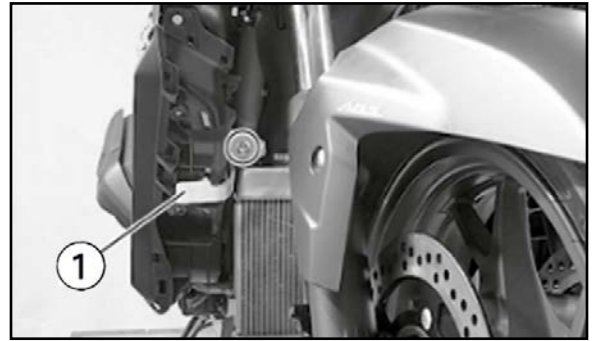
27. Remove the left and right footboard brackets ①.

28. Remove the circled fasteners to remove the left and right footboard sub-assemblies ②.

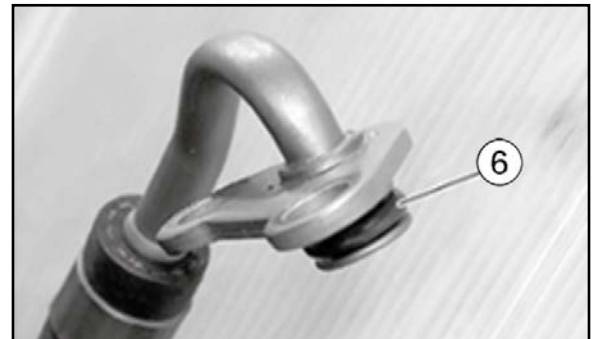
13. Verify that the O-ring ⑥ on the new fuel feed hose is free of foreign materials. Clean the O-ring as necessary, and be sure to apply a think film of clean engine oil to the O-ring.

14. Verify that the hose mounting hole on the fuel pump is free of foreign materials (clean it if necessary). Install the new fuel feed hose and fuel injector assembly to the fuel pump and tighten the fuel feed hose bolts ⑦ to the specified torque [a].

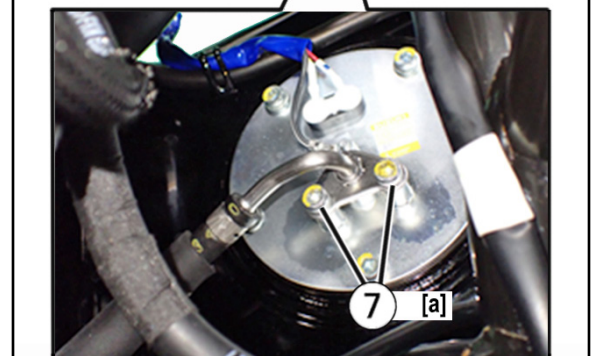
**Tightening torque: Fuel feed hose bolt [a]:**
7.5 lb.-ft (10 N.m, 1.0 kgf-m)

15. Check that the fuel injector mounting hole is free of foreign materials(clean it if necessary). Install the fuel injector side of the fuel feed hose and tighten the feed hose bolt ① to the specified torque [a].

If the fuel feed hose ② is positioned to straddle the throttle body, or the fuel feed hose is pulled and routed as shown in the **NOT GOOD** example image, there is a risk of fuel leakage due to deformation of the fuel feed hose elbow **A**.

Damage can also occur from interference between the fuel feed hose ② and purge hose No. 2 ③.

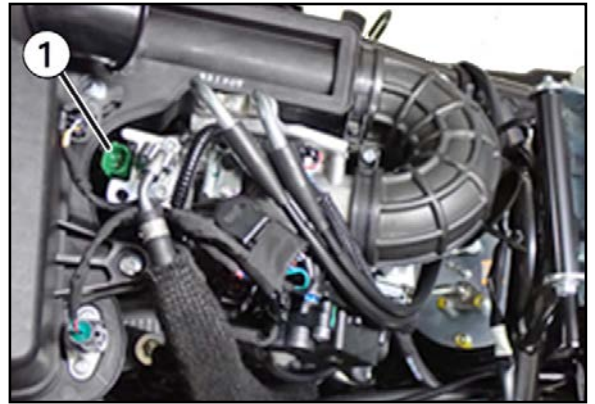
25. Disconnect the fuel injection coupler ①.

26. Install the new clamp ② through the hole ③ of the fuel feed hose bracket.
