**IMPORTANT SAFETY RECALL**  
**NHTSA Number: 24V-543 (School Bus)**

**SUBJECT:** R24DC: FMVSS 221 Noncompliance: Joint Strength – Insufficient Roof Rivet Quantity

# RECALL

## R24DC: FMVSS 221 Noncompliance: Joint Strength – Insufficient Roof Rivet Quantity

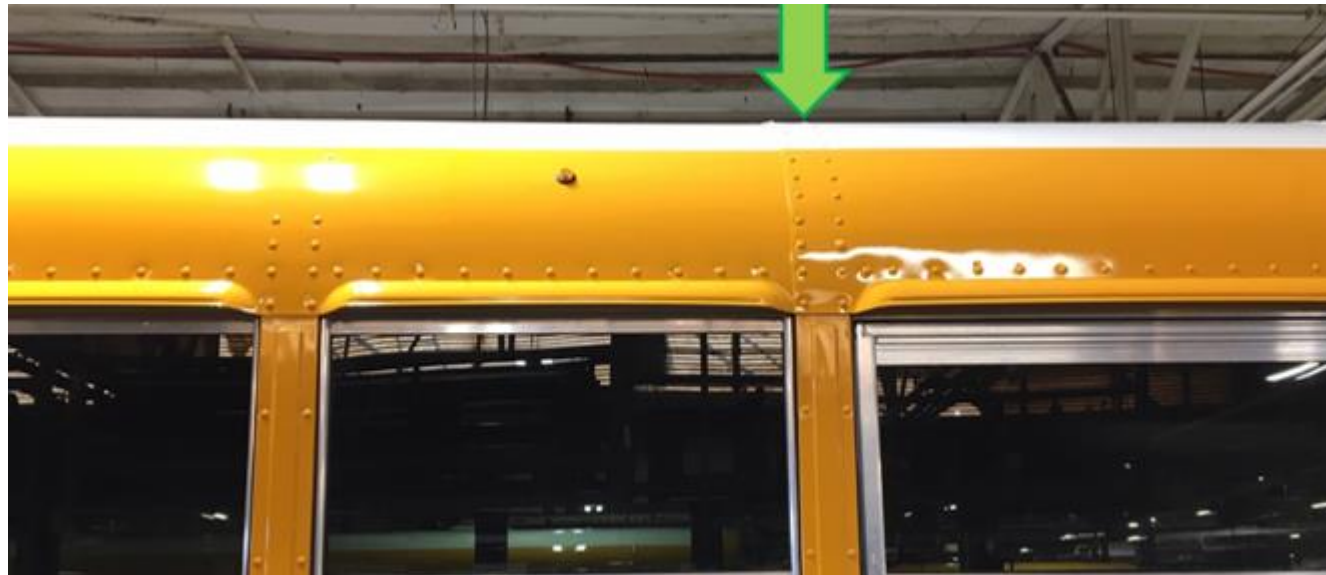
3. Inspect rivet spacing at each roof sheet joint. Roof sheet joints are assembled with two rows of rivets. Joint must have a minimum of six rivets in an eight inch segment. The full length of the roof sheet joint, including the top of the bus, must be inspected and corrected, if needed.

- a. Place the supplied rivet spacing template over the joint and parallel to the edge of the roof sheet, allowing roof rivets to be exposed through the opening in the template, as shown.

- b. Move the template from one side of the roof sheet towards the center of the roof.
  - c. If a segment in the roof joint contains less than six rivets, additional rivets are required. Mark each area that requires additional rivets.

- d. If one rivet is required; add a rivet equally spaced between the two rivets with the largest space in this section.
  - e. If additional rivets are required; add additional rivets between the largest spaces until a minimum of six (6) rivets have been added in the eight (8) inch segment.

4. Using a short 17/64" drill bit, drill a hole through the roof sheet and bow flange only. **Be sure not to drill through the inside headliner.** Drill any required holes on a common centerline with existing rivets.

5. Install rivet (Item 1) in each drilled hole.
6. With the correct color paint, touch up each blind rivet installed.
7. Repeat procedure on the opposite side of the bus.
