SERVICE BULLETIN

FIELD CAMPAIGN SERVICE BULLETIN #: SVC2024-046 Rev. 1 DATE: 27 June 2024

Interim Owner
Notification: Drawbar
Inspection Kit
(SVC2024-046 Rev 1)

**SVC2024-046: BC1800XL DRAWBAR INSPECTION
LOCATION AND CRACK EXAMPLES**

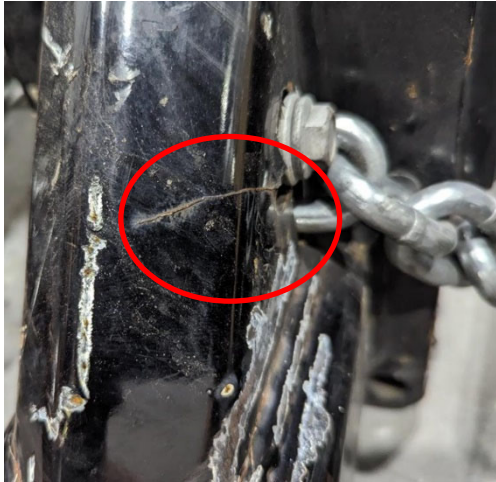
One or more cracks can develop in the surge brake drawbar which can result in severe damage to the brush chipper. If a crack develops and is not identified during the maintenance manual interval inspections, the drawbar can bend and/or break, resulting in loss of stability while towing.

**Photo 2
Example of crack near safety chain location**

Inspect drawbar for cracks every 50 hours or 200 miles, whichever occurs first. Contact your Vermeer dealer if cracks develop. Vermeer Corporation will notify you by letter when the final field remedy kit is available.

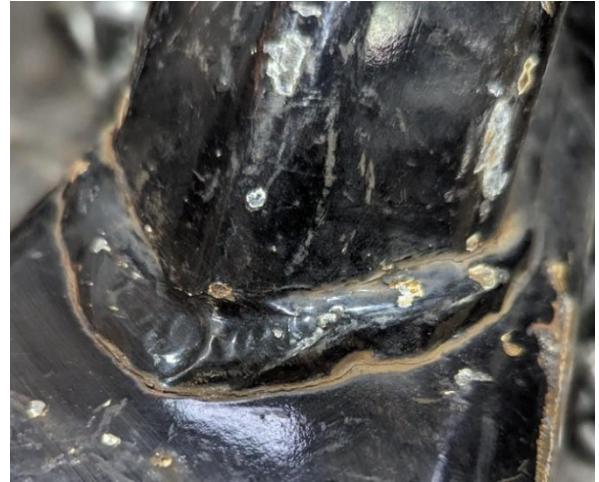
**Photo 3
Example of crack near weld**

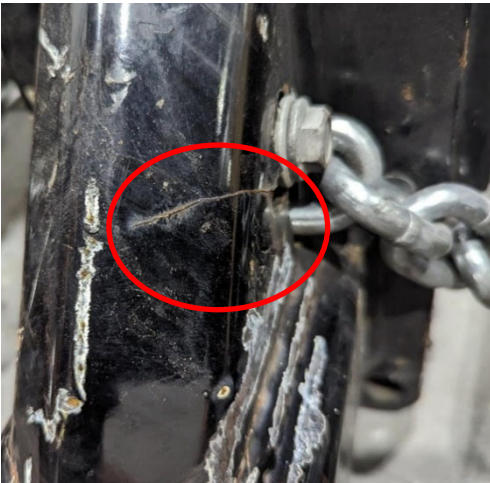
**Photo 2
Example of crack near safety chain location**

Inspect drawbar for cracks every 50 hours or 200 miles, whichever occurs first. Contact your Vermeer dealer if cracks develop. Vermeer Corporation will notify you by letter when the final field remedy kit is available.

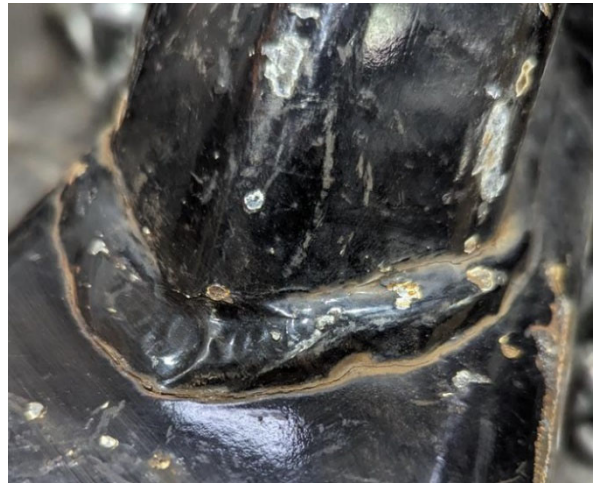
**Photo 3
Example of crack near weld**

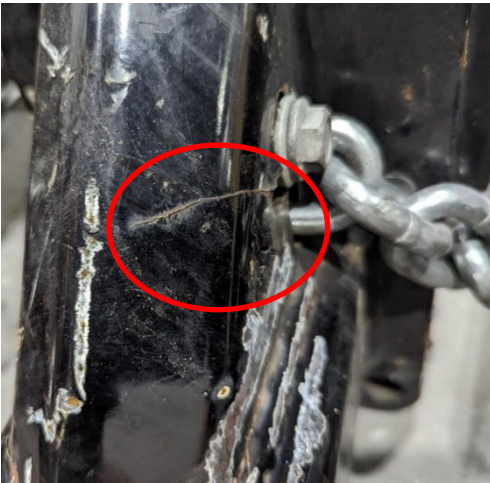
**Photo 2
Example of crack near safety chain location**

Inspect drawbar for cracks every 50 hours or 200 miles, whichever occurs first. Contact your Vermeer dealer if cracks develop. Vermeer Corporation will notify you by letter when the final field remedy kit is available.

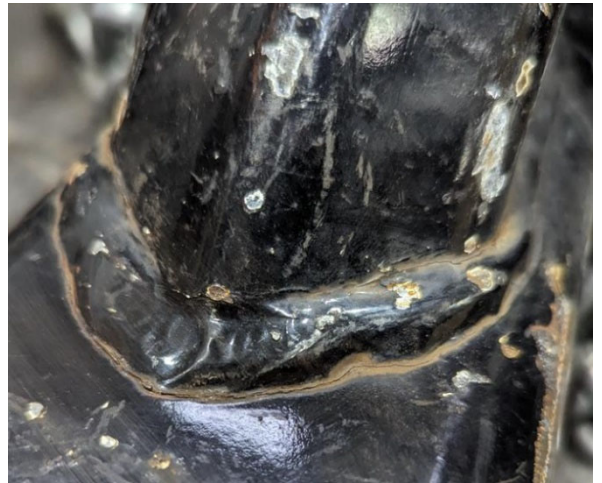
**Photo 3
Example of crack near weld**

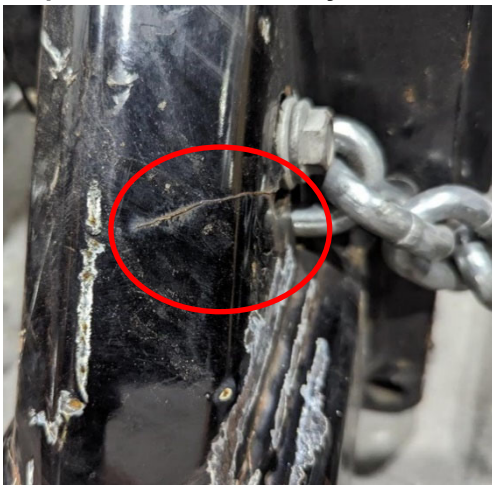
**Photo 2
Example of crack near safety chain location**

Inspect drawbar for cracks every 50 hours or 200 miles, whichever occurs first. Contact your Vermeer dealer if cracks develop. Vermeer Corporation will notify you by letter when the final field remedy kit is available.

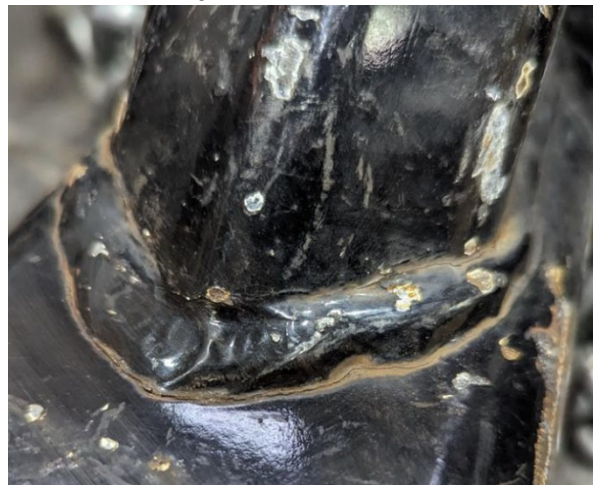
**Photo 3
Example of crack near weld**

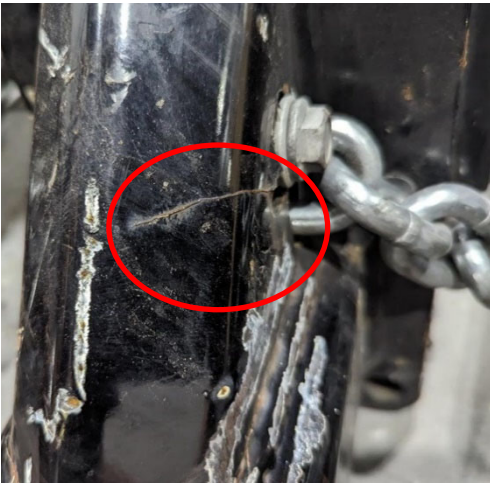
**Photo 2
Example of crack near safety chain location**

Inspect drawbar for cracks every 50 hours or 200 miles, whichever occurs first. Contact your Vermeer dealer if cracks develop. Vermeer Corporation will notify you by letter when the final field remedy kit is available.

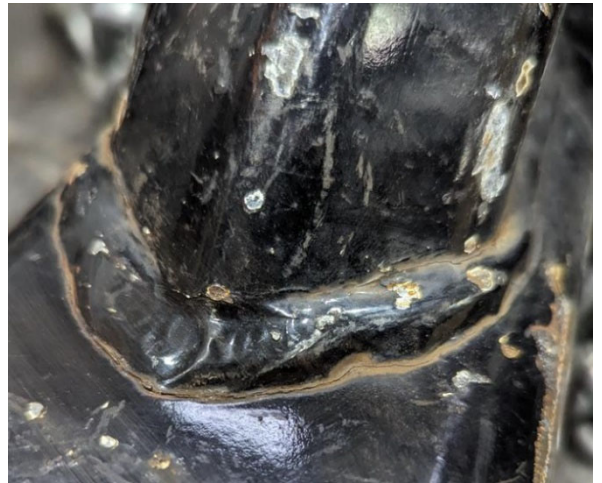
**Photo 3
Example of crack near weld**

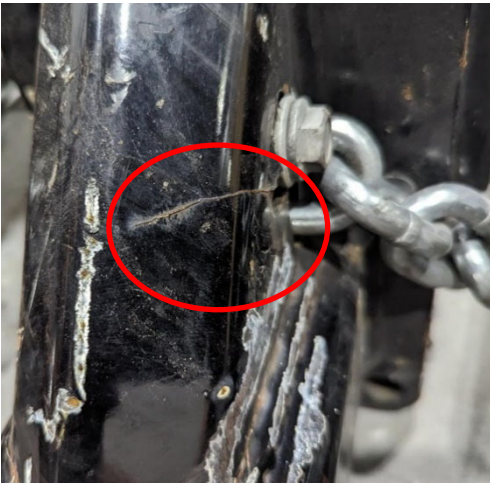
**Photo 2
Example of crack near safety chain location**

Inspect drawbar for cracks every 50 hours or 200 miles, whichever occurs first. Contact your Vermeer dealer if cracks develop. Vermeer Corporation will notify you by letter when the final field remedy kit is available.

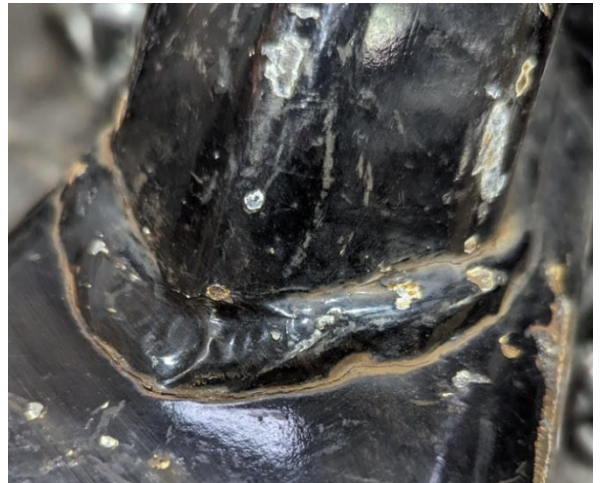
**Photo 3
Example of crack near weld**
