# SERVICE BULLETIN

FIELD CAMPAIGN SERVICE BULLETIN #: SVC2024-068 Rev. 1

**BC900XL Lug Nut  
Torque Instruction  
Correction Kit  
(IK004561 Rev. 1)**

**WHEEL LUG NUTS MAY LOOSEN, LOSS OF WHEEL POSSIBLE**

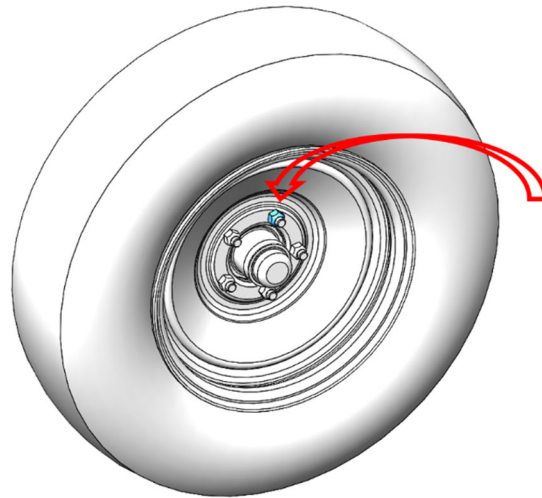
2. Re-install lug nut.

3. Torque to 95 ft-lb (129Nm)
4. Repeat for all lug nuts.
5. If all lug nuts torque to 95 ft-lb (129 Nm), **no further action is needed.**
  - a. Email completed lug nut inspection form to [safetyforms@vermeer.com](mailto:safetyforms@vermeer.com) to receive \$50.00 USD parts credit certificate, and for Vermeer to update records.
6. If any lug nuts are stripped, broken, or unable to maintain 95 ft-lb (129 Nm) torque, **further actions are required.**
  - a. Contact your local Vermeer dealer immediately to make arrangements to get IK034156 installed.
  - b. Email completed lug nut inspection form to [safetyforms@vermeer.com](mailto:safetyforms@vermeer.com) to receive \$50.00 USD parts credit certificate, and for Vermeer to update records
