FIELD CAMPAIGN SERVICE BULLETIN #:SVC2024-068

BC900XL Lug Nut
Torque Instruction
Correction Kit
(IK004561)

Vermeer has decided that a defect that relates to motor vehicle safety exists in certain model year 2015 – 2022 Vermeer BC900XL Brush Chippers.

NHTSA SAFETY RECALL NUMBER 24V357

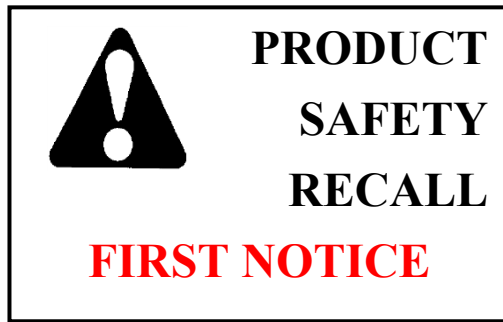
Wheel bearing grease/repack procedure in the Maintenance and Service Manuals included incorrect lug nut torque specification. Incorrectly torqued lug nuts can become loose. Loose lug nuts can cause damage to the wheel rim and result in separation from the brush chipper.

IK004561 has been created to provide the necessary parts and instructions to replace incorrect Maintenance and Service Manuals, inspect existing parts for damage, and replace damaged parts.

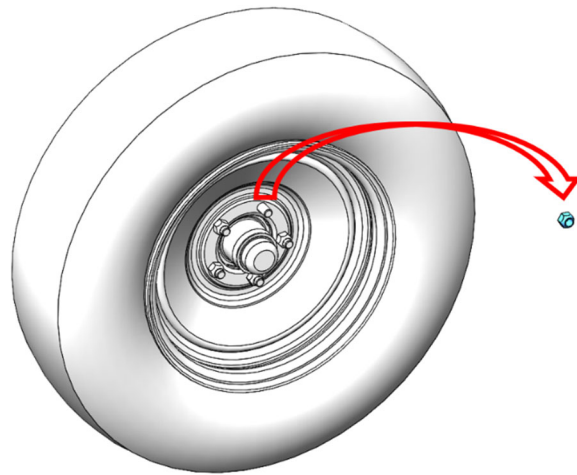
1. Remove lug nut.

3. Torque to 95 ft-lb (129Nm).
4. Repeat for all lug nuts.
5. If all lug nuts torque to 95 ft-lb (129 Nm), **no further action is needed.**
 - a. Email completed lug nut inspection form to safetyforms@vermeer.com to receive \$50.00 USD parts credit certificate, and for Vermeer to update records.
6. If any lug nuts are stripped, broken, or unable to maintain 95 ft-lb (129 Nm) torque, **further actions are required.**
 - a. Contact your local Vermeer dealer immediately to make arrangements to get IK034156 installed.
 - b. Email completed lug nut inspection form to safetyforms@vermeer.com to receive \$50.00 USD parts credit certificate, and for Vermeer to update records.

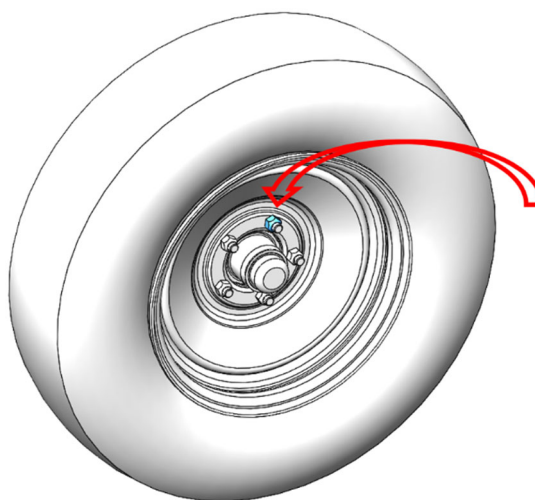
2. Re-install lug nut.

3. Torque to 95 ft-lb (129Nm)
4. Repeat for all lug nuts.
5. If the all lug nuts torque to 95 ft-lb (129 Nm), **no further action is needed.**
 - a. Email completed lug nut inspection form to safetyforms@vermeer.com to receive \$50.00 USD parts credit certificate, and for Vermeer to update records.
6. If any lug nuts are stripped, broken, or unable to maintain 95 ft-lb (129 Nm) torque, **further actions are required.**
 - a. Contact your local Vermeer dealer immediately to make arrangements to get IK034156 installed.
 - b. Email completed lug nut inspection form to safetyforms@vermeer.com to receive \$50.00 USD parts credit certificate, and for Vermeer to update records
