WARRANTY BULLETIN SAFETY CAMPAIGN

Subject: **Engine Output Shaft Can Break and/or
Sprocket Wear - Potential Loss of Drive Power**

No. **2019-13**

**► REVISION 1
April 17, 2025 ◀**

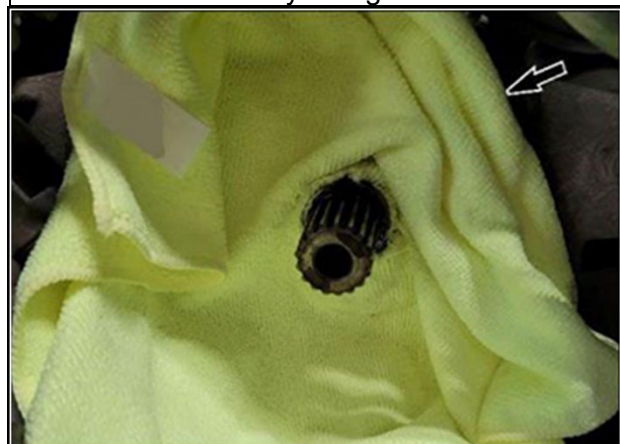
4. Using appropriate cleaner, thoroughly clean the shaft surface. Remove all traces of previous anti-seize grease. Make sure to protect the transmission seal from any harmful product before application.

NOTE: Use a soft brush to clean each spline individually.

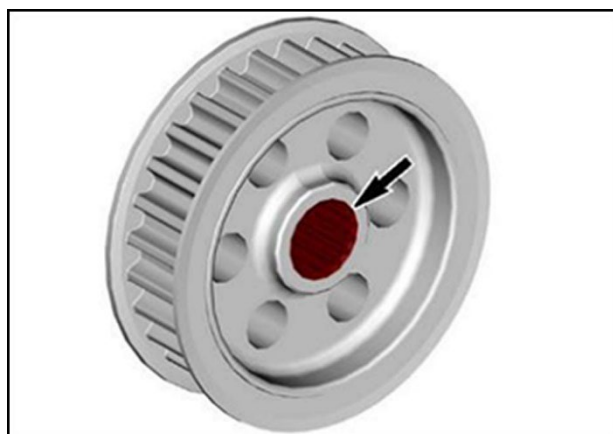
6. Apply retaining compounds sealant in the splines of the new sprocket on the chamfered side. Make sure that there is a uniform layer of sealant in every spline.

SERVICE PRODUCT
Loctite 609 Retaining Compounds or equivalent (603 available worldwide)

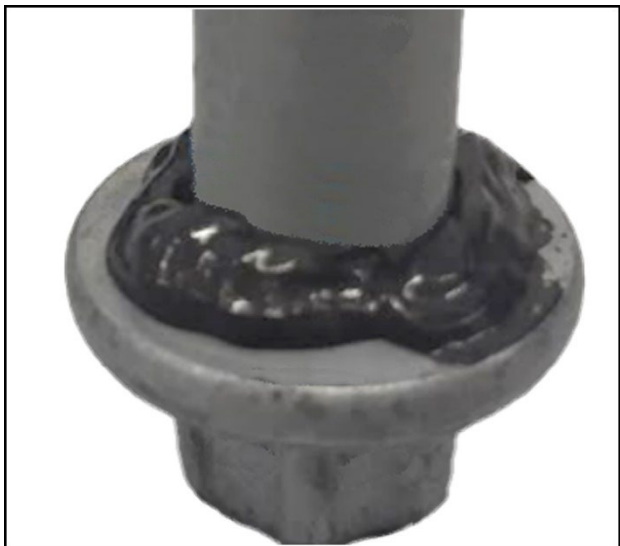
TYPICAL – APPLY LOCTITE 5910 UNDER SCREW HEAD

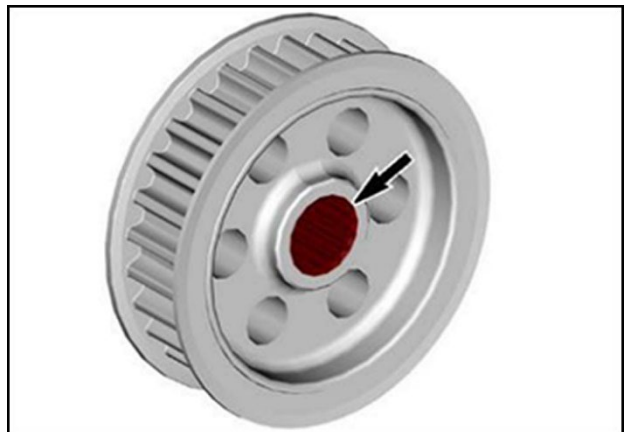
2. Apply retaining compounds sealant in the splines of the new sprocket on the chamfered side. Make sure that there is a uniform layer of sealant in every spline.

SERVICE PRODUCT
Loctite 609 Retaining Compounds or equivalent (603 available worldwide)
