WARRANTY BULLETIN SAFETY CAMPAIGN

Can-Am® On-Road Spyder™

October 8, 2024 Subject: **Engine Output Shaft Can Break - Potential Loss of Drive Power**

No. **2019-12**

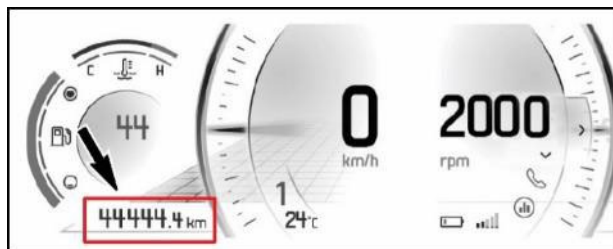
TYPICAL – RT MY18 SHOWN

NOTE: Multifunction gauge display will vary according to vehicle year and model.

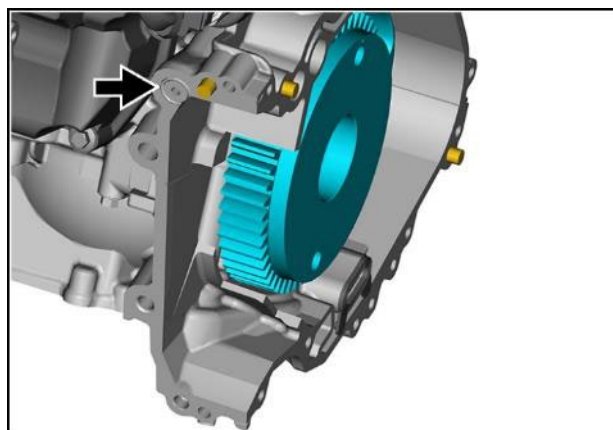
NOTE: Make sure that the hole (oil orifice) on the cylinder block does not get clogged before reinstalling the gearbox.

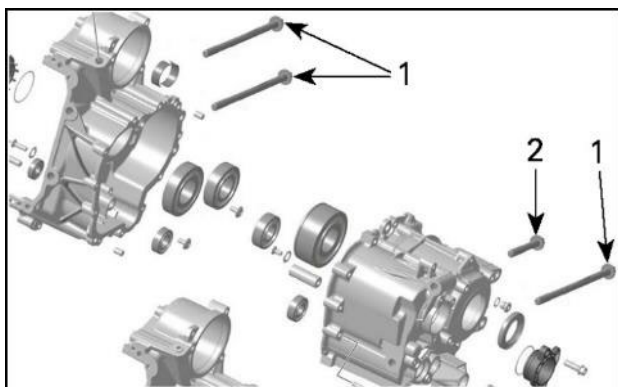
1. Clean, apply Loctite 5910 under head and reuse.
2. Clean and reuse.

Clean previously removed screws using a steel brush then reuse. For the longer ones, apply sealant Loctite 5910 under the screw head surface all around.

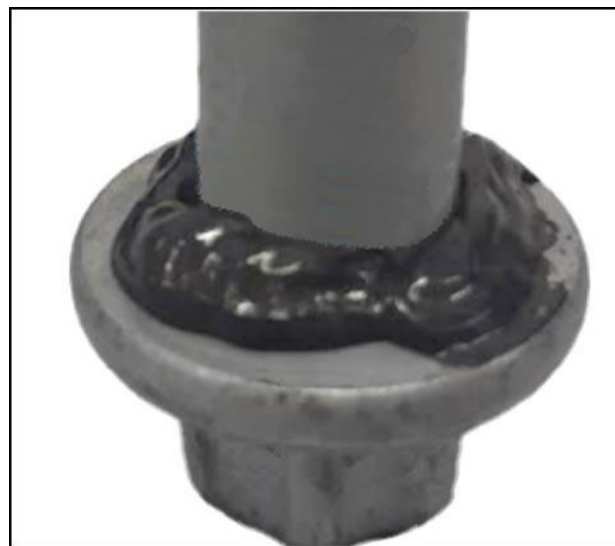
TYPICAL – APPLY LOCTITE 5910 UNDER SCREW HEAD

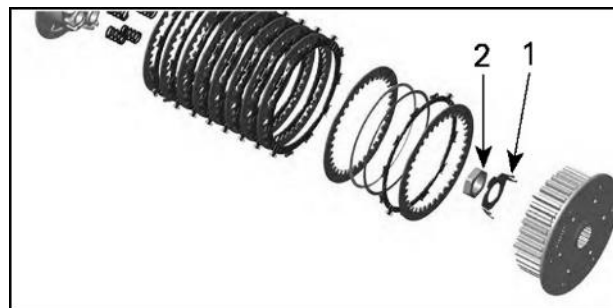
1. Tab washer included in kit
2. Clutch hub retaining nut included in kit

8. Reinstall Clutch. Refer to [CLUTCH \(SE6\)](#) or [CLUTCH \(SM6\)](#) Service Manual subsection. However install tab washer and clutch hub retaining nut included in the kit. Apply threadlocker on threads and tighten clutch hub retaining nut to **new** specification.

TIGHTENING TORQUE	
Clutch hub retaining nut	190 N•m ± 10 N•m (140 lbf•ft ± 7 lbf•ft)

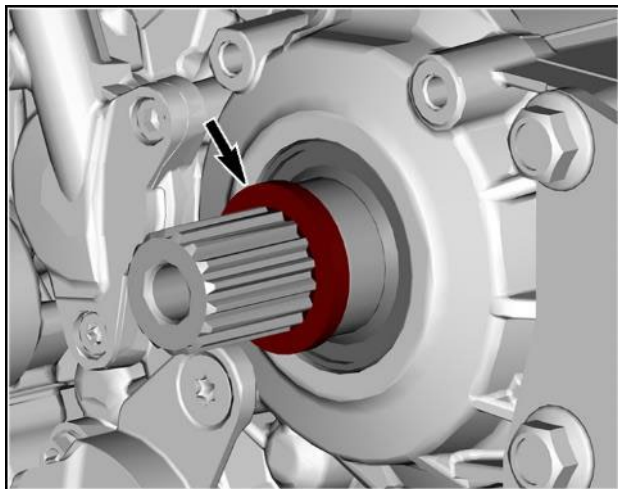
2. Install the washer on the shaft.

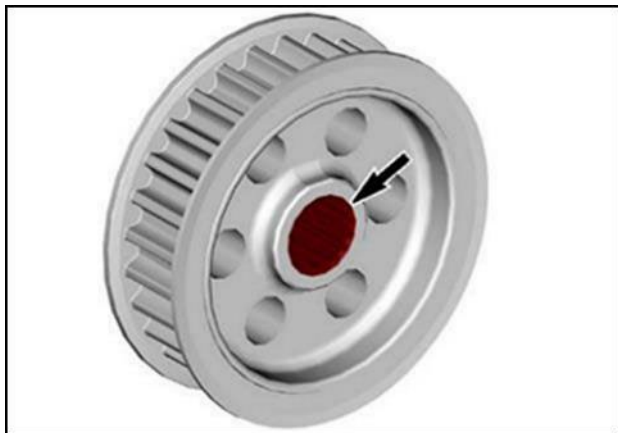
3. Apply retaining compounds sealant in the splines of the sprocket on the chamfered side. Make sure that there is a uniform layer of sealant in every spline.

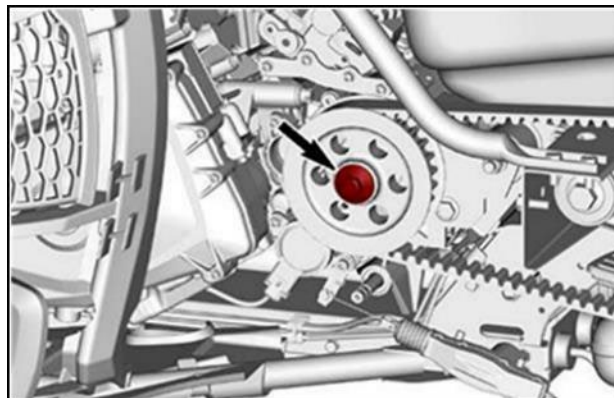
4. Install the sprocket with the chamfered side first until it is in contact with the washer. Install the screw. Tighten to specification.

TIGHTENING TORQUE	
Front sprocket screw	150 N•m ± 5 N•m (111 lbf•ft ± 4 lbf•ft)
