NHTSA SAFETY RECALL NUMBER 24V-098

**IMPORTANT
SAFETY
RECALL**

**Drawbar Inspection
(SVC2024-046)**

**SVC2024-046: BC1800XL DRAWBAR INSPECTION
LOCATION AND CRACK EXAMPLES**

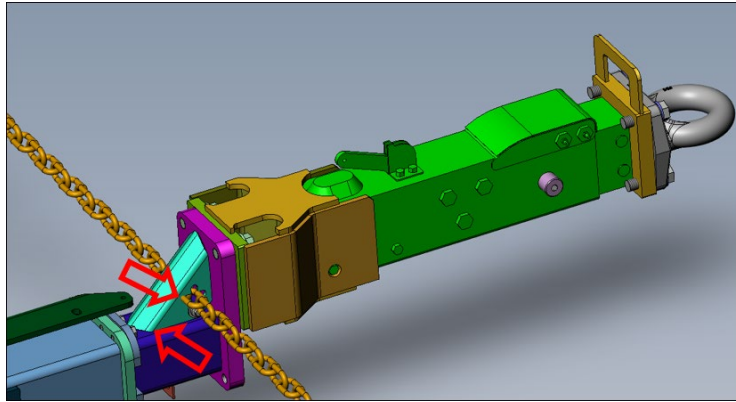
One or more cracks can develop in the surge brake drawbar which can result in severe damage to the brush chipper. If a crack develops and is not identified during the 100-hour maintenance manual interval inspections, the drawbar can bend and/or break resulting in loss of stability while towing.

**Photo 1
Potential crack locations**

Inspect drawbar for cracks every 50 hours or 200 miles, whichever occurs first. Contact your Vermeer dealer if cracks develop. Vermeer Corporation will notify you by letter when the final field remedy kit is available.

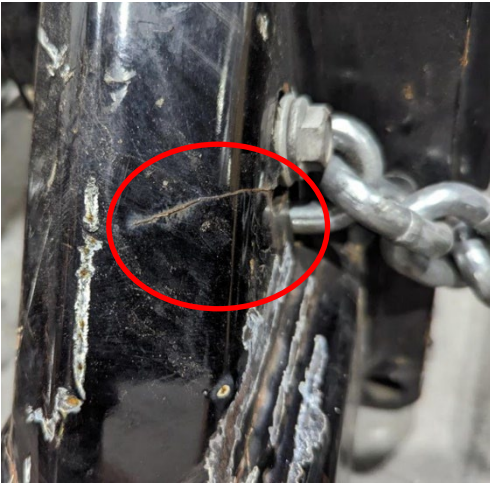
**Photo 2
Example of crack near safety chain location**

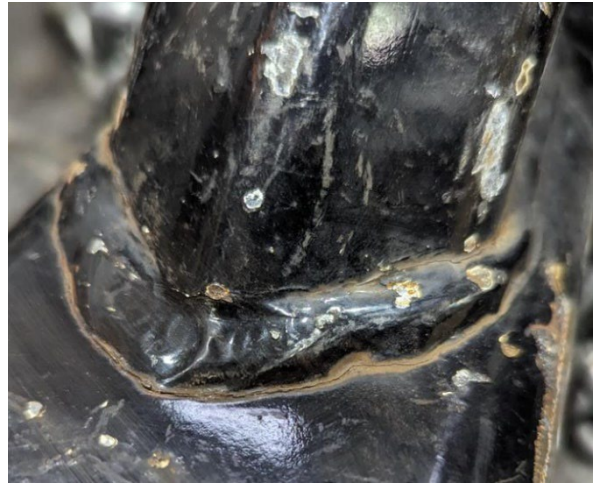
**Photo 3
Example of crack near weld**
