## **IMPORTANT: Safety Recall**

### **SAFETY – RECALL – 24014 (24V-799)**

Spartan Fire, LLC has decided that a defect which relates to motor vehicle safety exists in certain model year 2024-2025 Metro Star and FC-94, and 2025 Gladiator and KME Panther model emergency response chassis cab vehicles.

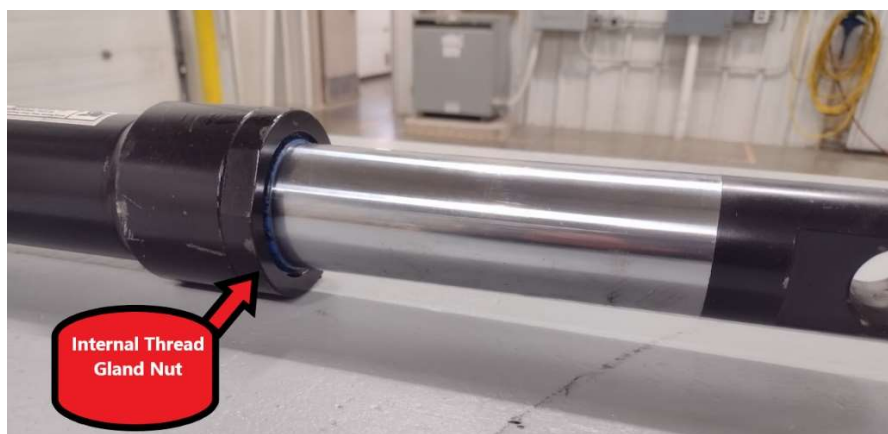
### **Cab Tilt Cylinder Type 1**

Cylinder gland nut has external threads and threads internally into the barrel.

- 1) Ensure cab is in the lowered and in the cradled position with the park brake set.
- 2) Go under the front of the truck and inspect both cab tilt cylinders under the front section of the cab.
- 3) Take clear pictures of each of the cab tilt cylinders showing the following:
  - a. A picture of the upper portion of the cylinder at the gland nut where the piston extends from the cylinder barrel
  - b. A picture showing the part number and serial number that is etched/engraved into the barrel of the cylinder. *(See Figures below for examples)*
- 4) Email last 8 digits of the VIN number along with the photos taken in step 3 to [andy.haigh@spartanmotors.com](mailto:andy.haigh@spartanmotors.com). Further directions will be provided at that time.

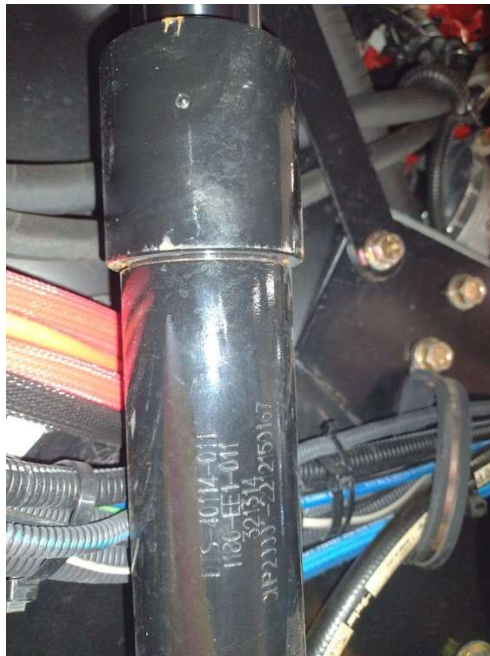
### **Cab Tilt Cylinder Type 2**

Cylinder gland nut threads externally over the cylinder barrel. Part number and serial number are engraved in the cylinder barrel.
