## Recall Information Bulletin

No: C10129 Issued: 2/25/2025

Safety Recall C10129 – Fuse Box Water Invasion

FEC7K (E16L/E16M), FEC9K (E18L/E18M)

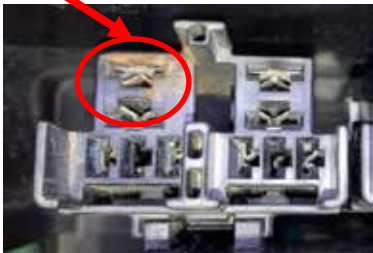
Rust is visible around terminal

If green rust is found on the surface of the fuse terminals, take the following measures

- 1: Remove all fuses
- 2: Clean the fuse terminals with a brush. Do not use a metal brush.
- 3: Insert and remove each fuse five times.
- 4: Apply electronic cleaner to the fuse terminals.
- 5: Apply contact spray to the fuse terminals.
- 6: Insert new fuses into the fuse holder.

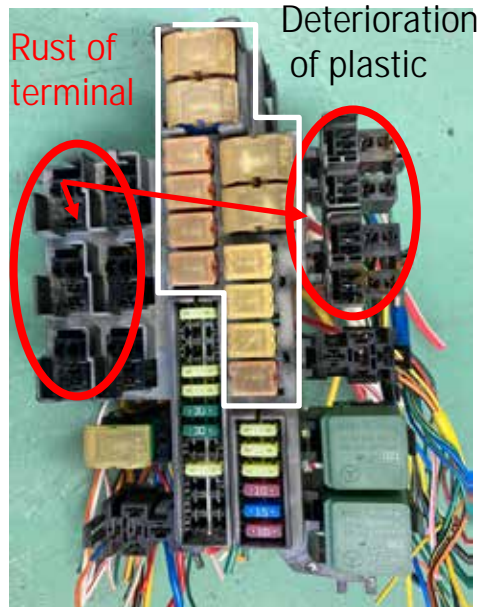
The outside surface of relay terminals have rusted

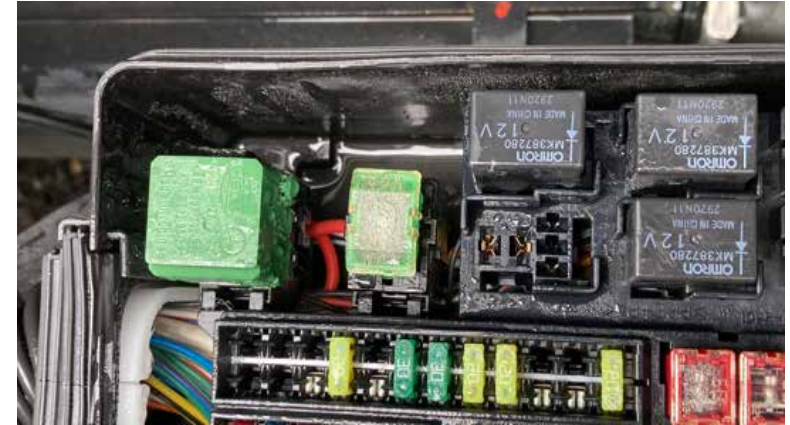
## Exchange criteria of Relay:

Water has reached the bottom of relay.

1. Pull the relays and check for water at the bottom of relay.
2. If a relay has water accumulated at the bottom, replace the affected relay on a case-by-case basis.
3. Replace the relay with the appropriate spare part by referring to the image and table

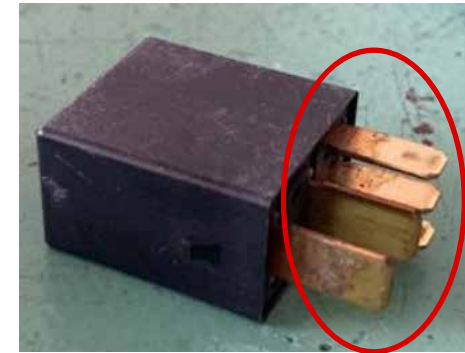
Water noticed at bottom of relay terminals
