Storyteller Overland, LLC
Customer Service Department
428 Industrial Lane
Birmingham, AL 35211

TO: Storyteller Overland, LLC Dealers
Subject: NHTSA Recall: 25V-070

MODE XO Seat Recall

Rev03062025

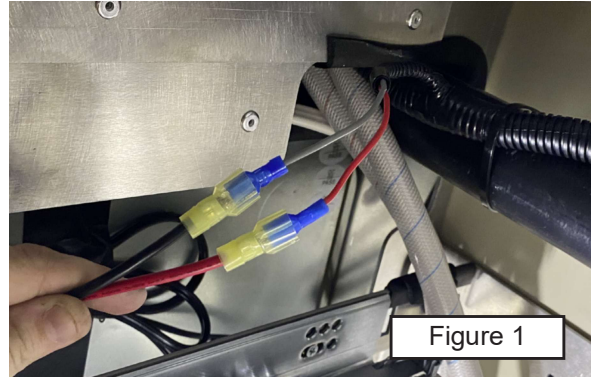
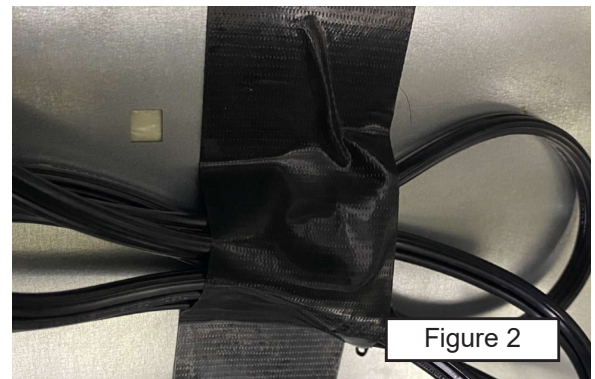
c. Disconnect (2) spade connections on the backside of the fridge. **Note: some models will also have 110 power cable that is taped to the backside of fridge this will need to be disconnected from an internal galley 110 receptacle prior to removing the fridge.** (See Figure 1 and 2)

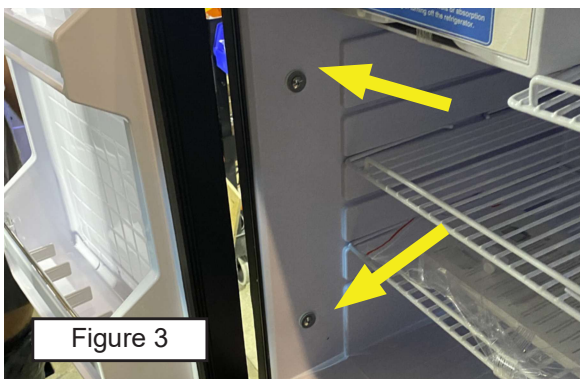
d. Open the fridge door and take a phillips bit screw driver and 1/8" allen key to remove the (4) screws that are securing the fridge to the galley. Retain all hardware once removed. (#10-24 x 1" SS barrel nut, 1/4" PVC washer, #10-24 x 1.25" Flat Head Screw and aluminum counter sunk washer. (See Figure 3)

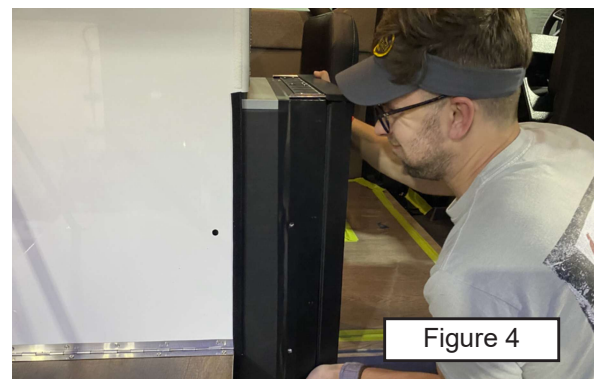
e. Slightly lift up on the fridge then carefully slide the fridge forward, towards the front of the van and remove to set out of the way. (See Figure 4) **Note: be very cautious to not damage the floor trim when removing the fridge.**

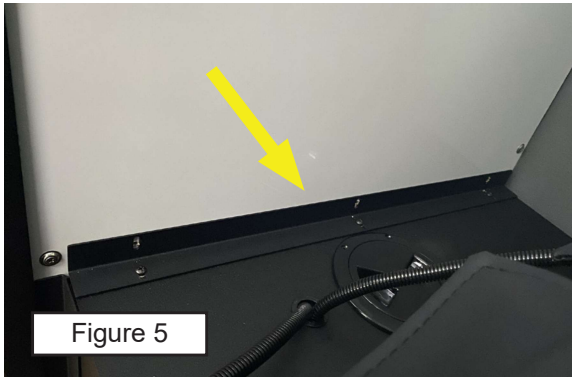
a. Slide the XO seat forward to access the top plate of the seat shroud to remove the (3) wafer head wood screws securing the black angled trim to the front face of the shower wall. Next remove the (3) wafer head self tapping screws that go through the top of the plate and into the bracing below the panel. (See Figure 5)

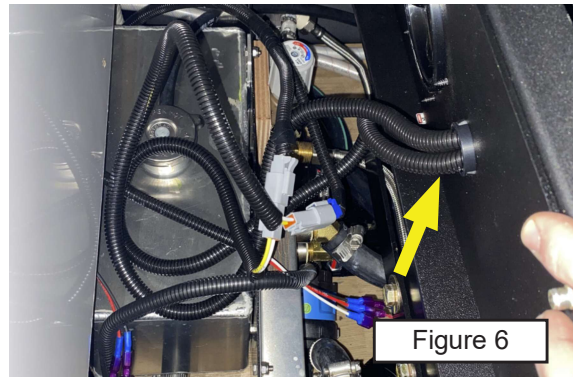
b. With the (3) wafer head screws removed, rotate the top plate up and disconnect the (2) loomed cables, then pass the (2) loomed cables back through the top of the seat shroud. Carefully remove the top plate and set out of the way. (See Figure 6)

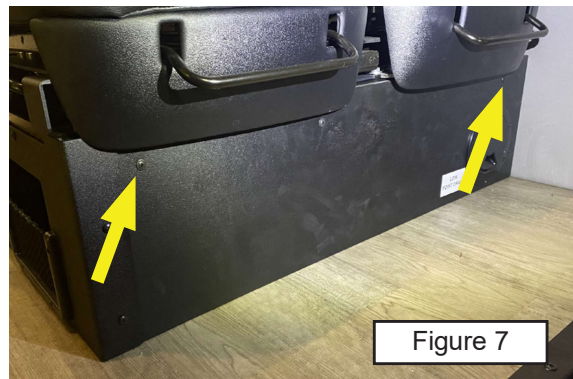
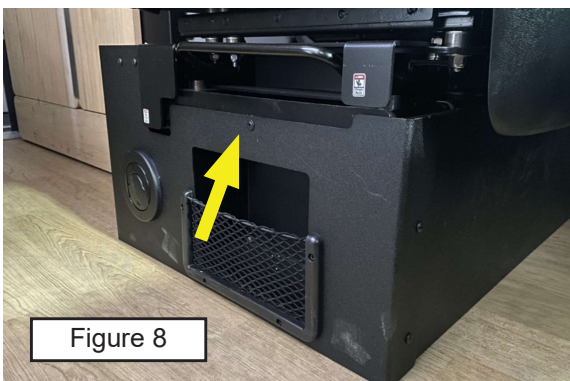
d. Remove the (2) wafer head screws from the front and (1) wafer head screw from the side of the lower seat shroud panels. (See Figure 7 & Figure 8)

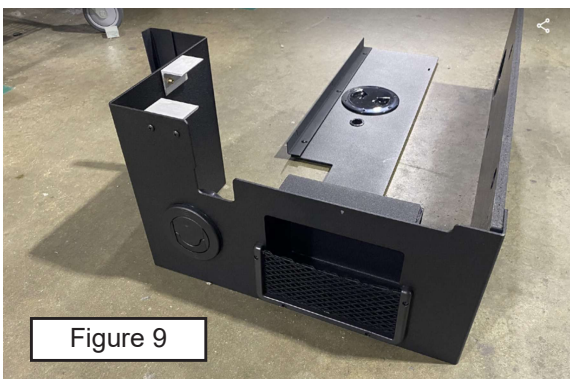
e. Carefully slide the seat shroud assembly away from the seat and set outside the van. (Figure 9)

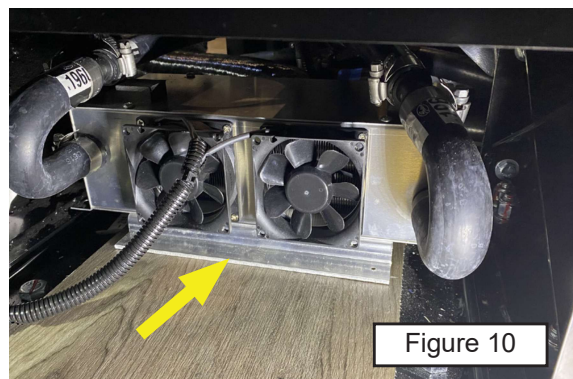
f. Next remove the screws that are securing the air handler to the floor between the seat legs. (Figure 10)

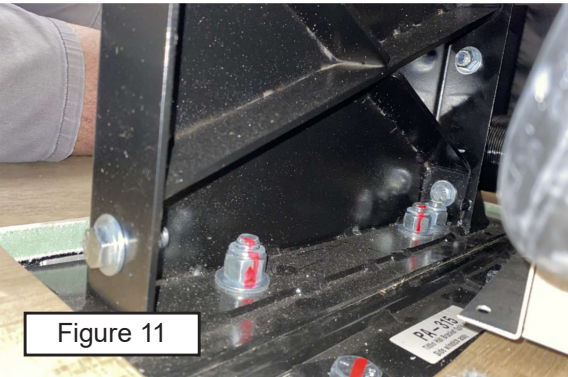
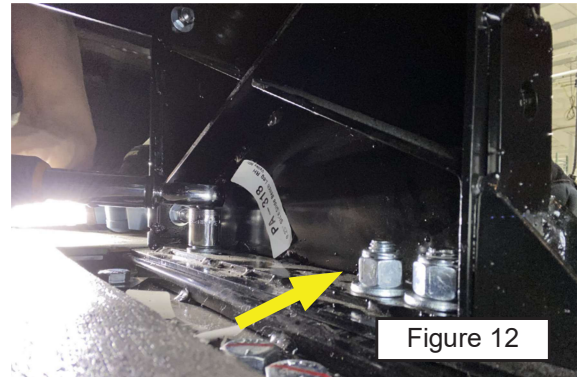
- a. Use a 3/4" socket/wrench to remove the (8) 1/2" nylon lock nuts and (8) 1/2" SAE washers that secure the seat base to the floor brackets. (See Figure 11 and Figure 12) **Note: the nylon lock nuts will need to be replaced with new ones when the seat is reinstalled into the van.**
- b. Once the (8) 1/2" nylon lock nuts are loose, carefully remove the seat from the van making sure not to damage any of the floor or surrounding area.

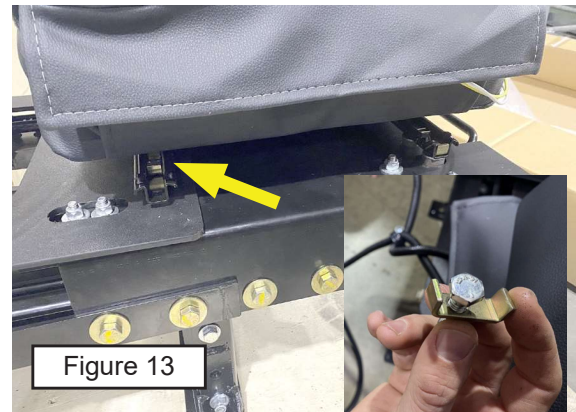
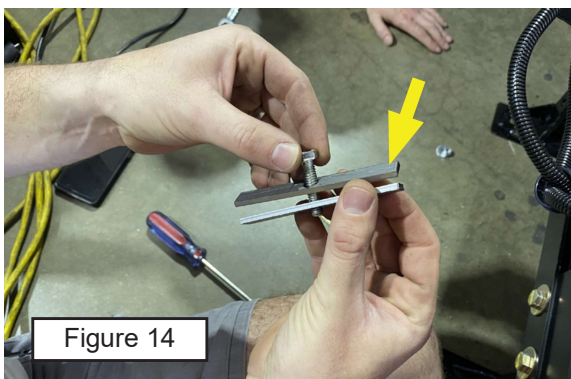
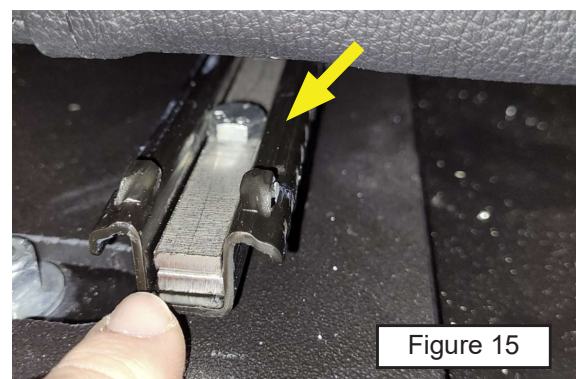
- a. With the seat removed from the van, use a 1/2" combination wrench and flat blade screwdriver to remove the bolt holding a gold U bracket from the inside seat, left rear track. (See Figure 13) **Note: It is easiest to access this bolt with the inside seat slid all the way forward and sideways away from the other seat.**
- b. Once the U bracket is removed replace with (2) flat bar spacers. (See Figure 14) Position the (2) spacer in the track, from the back side of the seat, then reuse the existing nylon lock nut and bolt to secure the (2) flat bars in place. (See figure 15) **Note: the gold U bracket will no longer be used and can be discarded.**

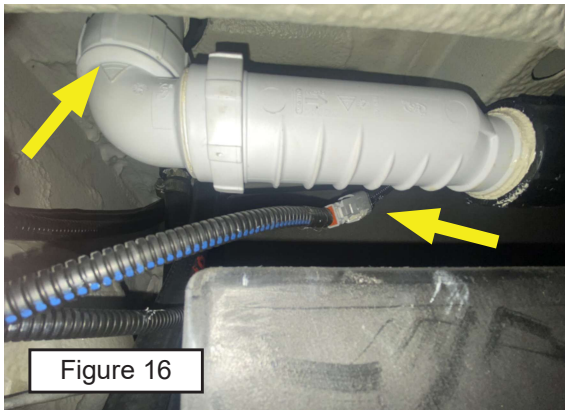
b. On the top inboard side of the grey tank disconnect the fitting for the hepvo valve at the elbow below the shower drain. In the same area on top of the grey tank, disconnect the deutsch connector for the tank sensor. (See Figure 16)

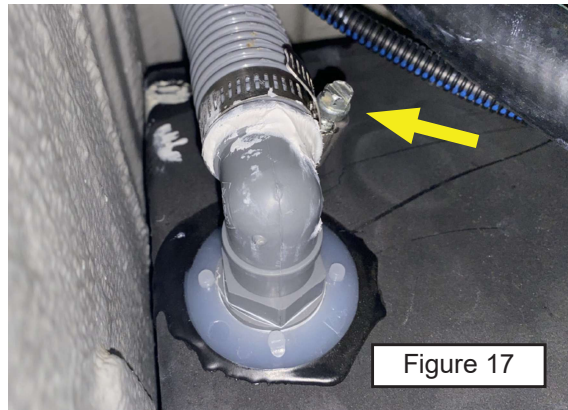
c. Use a 5/16" socket/wrench to loosen the hose clamp on the grey ribbed macerator hose then carefully remove the ribbed hose from the 90° fitting. (See Figure 17) **Note: this connection has silicone to seal the hose to the fitting. The hose will need to be carefully twisted, pulled and/or pried off of the barbed fitting. When prying, make sure to not damage the hose, fitting or tank.**

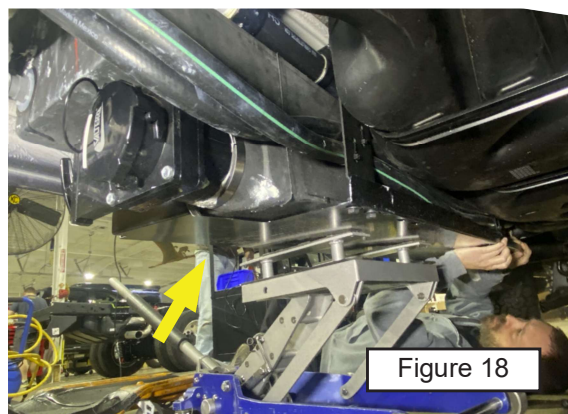
d. Once the tank is supported, use the 9/16" socket to remove the (8) 3/8" x 1/2" hex head bolts and 3/8" flat washers along the bottom, sides of the grey tank bracket. (See Figure 18)

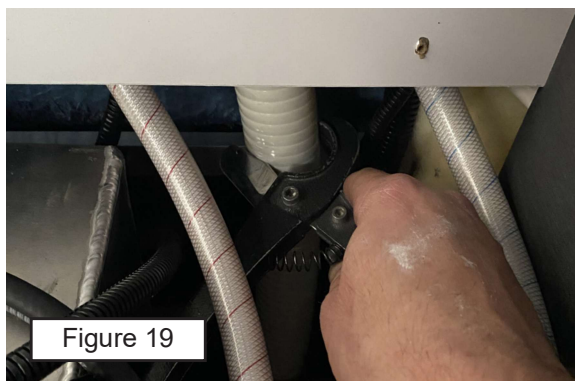
f. On the Inside of the van use a pair of hose cutters to carefully cut the grey tank vent hose at approximately 2-3" below the white shower finish panel as shown. (See Figure 19)

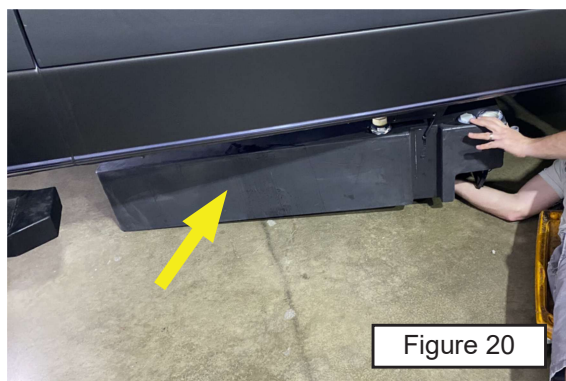
g. Once grey tank vent hose has been cut from the inside of the van, carefully lower the grey tank down and out of the way. (See Figure 20)

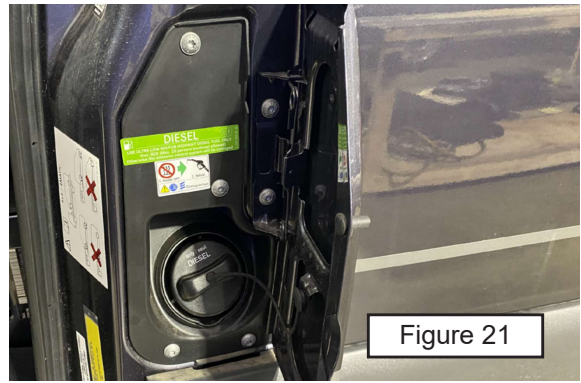
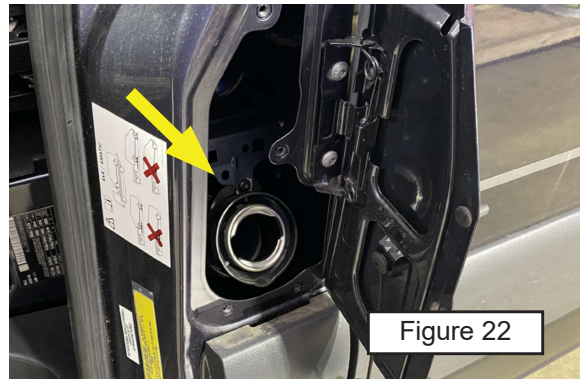
- a. Open the fuel door and use a T-30 torx bit with an extension to remove the (4) bolts securing the fuel filler neck housing. (See Figure 21)
- b. Next loosen the (2) bolts holding the fuel door hinge, to the van, then rotate the fuel door enough to remove the fuel filler neck housing and set the hardware to the side.
- c. Once the shroud has been removed, use the same T-30 torx bit to remove the single screw holding the filler neck in place. (See Figure 22)
- d. Disconnect the fuel cap tether from the fuel door and reinstall the fuel cap back on the filler neck to prevent any fuel being spilled during the repair process.

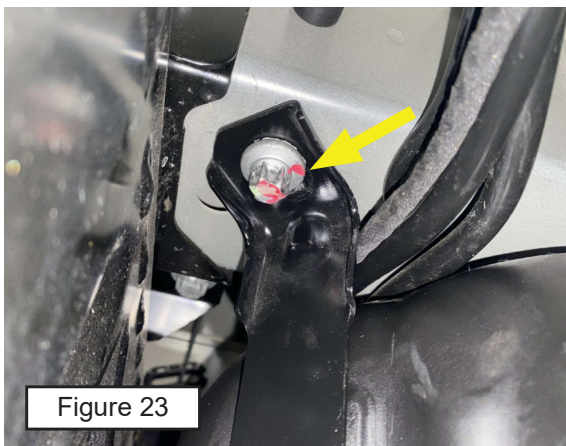
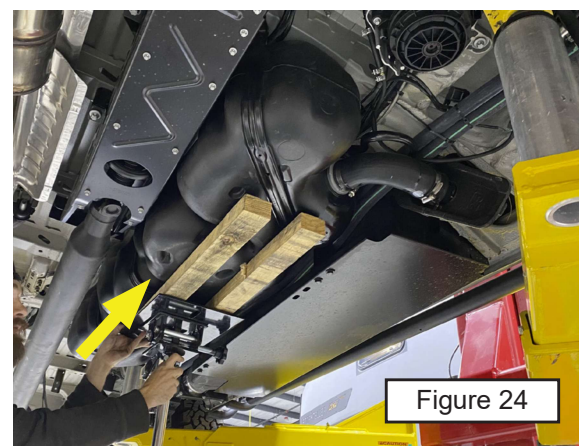
- e. Use the E16 socket to remove the (2) bolts holding the center fuel tank strap. (See Figure 23)
- f. Reposition the jack back under the van and centered under the fuel tank. With the jack in place, remove the (2) bolts holding all (3) the fuel tank straps. (See Figure 24) **Note: retain all hardware and tank strap brackets, these will be needed when reinstalling the fuel tank.**
- g. With the (3) fuel tank straps removed slowly lower the tank down while paying attention to the fuel line mounting points, disconnecting the fuel lines from the chassis mounting points as needed to lower the tank until it is supported by a stand (such as a pallet). **NOTE: The fuel tank needs to remain supported off the floor with a stand to prevent having to disconnect the fuel lines and to prevent damage the lines during the repair process.**

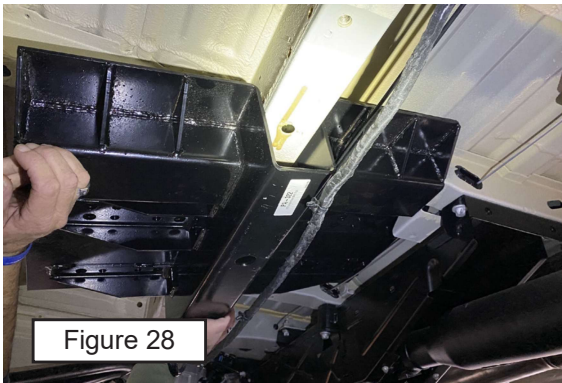
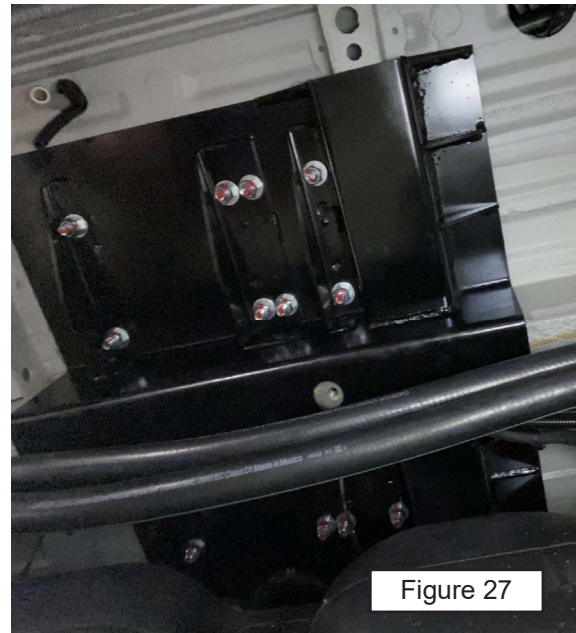
d. Position the coolant lines for the Rixen furnace out of the way then use a 3/4" socket and wrench on the bottom side to remove the (15) under body seat bracket bolts. (See Figure 27) **Note: this step will require (2) people (1) Inside the van to loosen the bolts and (1) on the bottom side to hold the nuts in place with a breaker bar and socket.**

e. Carefully lower the under-body bracket down making sure not to damage any fuel or break lines in the area. (See Figure 28)

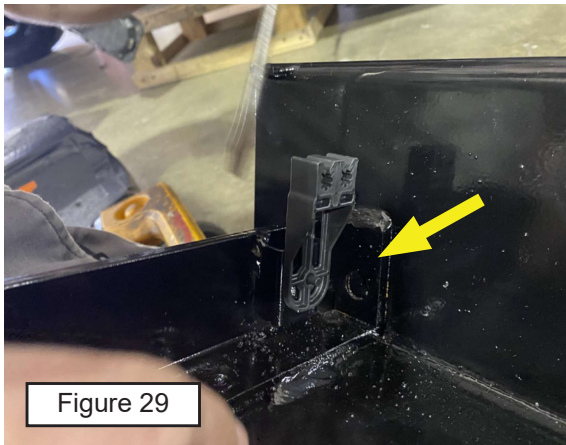
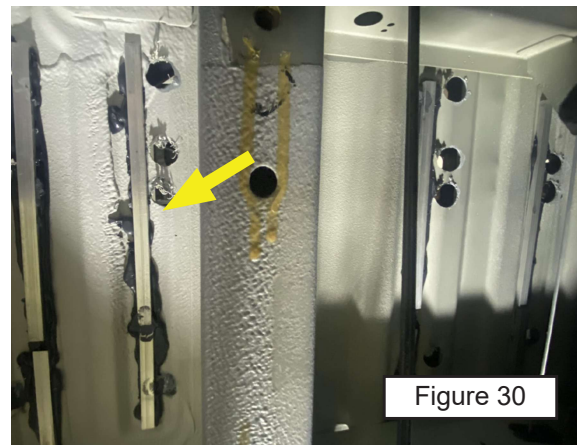
f. Once the under-body bracket is down on the ground, use a flat head screwdriver to press the center pin on the break line clips and remove the (2) clips from the bracket. (See Figure 29) Verify that the aluminum spacers have remained in place on both the top and bottom side of the van. (4) long spacers (4) short spacers as shown. (See Figure 30)

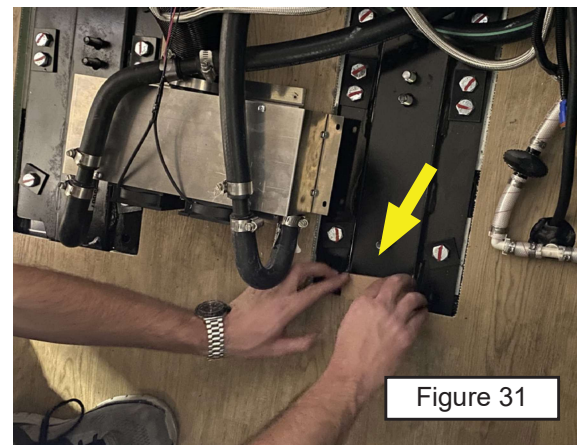
a. Remove upper seat mounting brackets from inside the van, then position the new upper seat mounting bracket back in the original place. (See Figure 31)

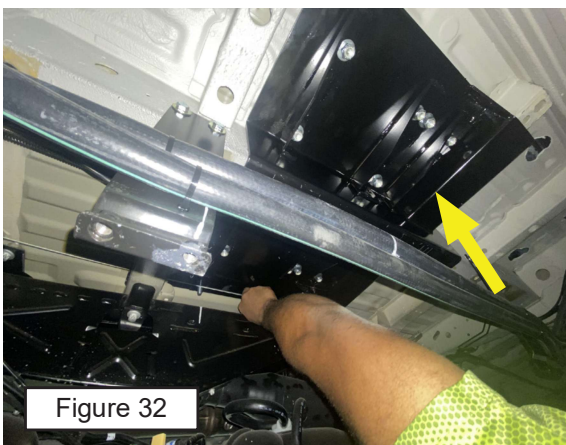
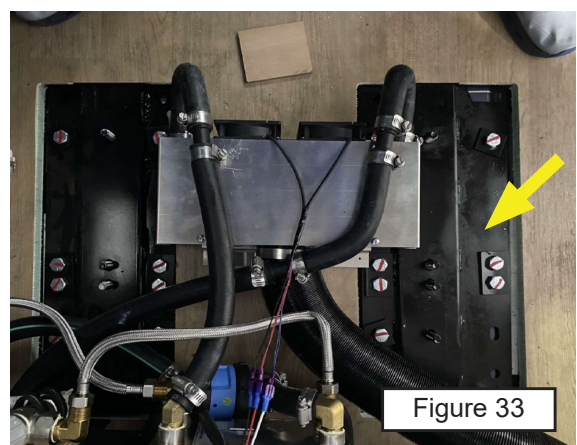
c. Carefully position the lower seat mounting bracket up and over all the coolant lines, fuel lines and brake lines making sure not to damage any of these lines while aligning the new bracket in place over the frame rail. (See Figure 32)

d. With the top and bottom set of brackets positioned in place, feed the bolts back through the bracket from the top side and reuse the single and double hole washer plates in the corresponding locations. Thread on washers and new nylon lock nuts on the bottom side van. (See Figure 33) **Note: the floor brackets will need to be aligned with seat base, before the bolts are tightened and torqued.**

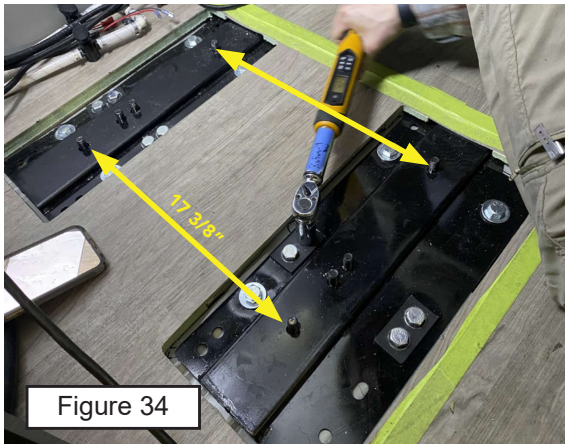
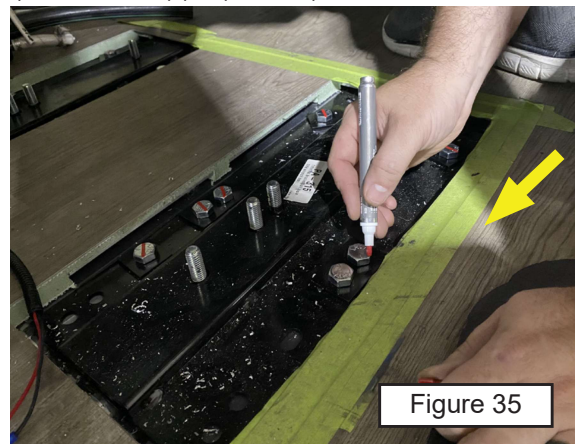
e. Align the studs on the top set of brackets, spaced at 17 3/8" to center of stud, then verify that the seat base matches that same measurement. With the brackets in the correct location then tighten and torque each bolt down. (See Figure 34)

f. Once aligned, use a torque wrench and a 3/4" socket to torque each of the (15) bolts to **102 NM or 75 ft lbs.** **Note: this step will require (2) people (1) Inside the van to torque the bolts and (1) on the bottom side to hold the nut in place.**

g. Once all bolts are secured and properly torqued, use a red paint pen on both the top and bottom side of the van to mark that each of the bolts have been torqued to the appropriate specs. (See Figure 35)

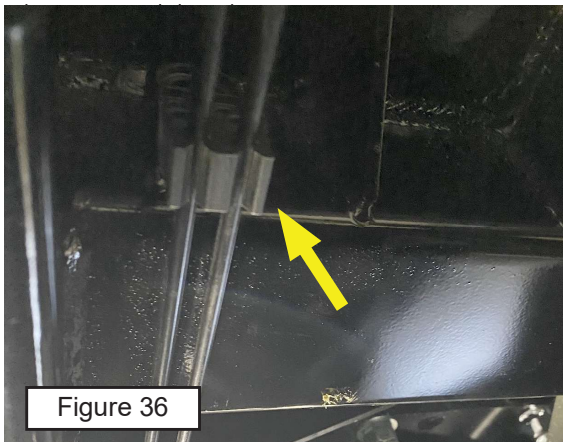
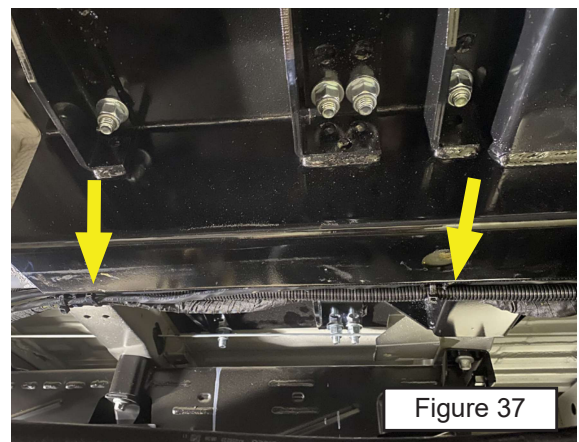
a. Start with re-installing the brake line clips back onto the lower seat bracket on the underside of the van, by positioning the clip into the mounting locations prior depressing the center pin to lock the clip in place. Once in place reposition the brake lines back into all (4) clips making sure not to twist them. (See Figure 36)

b. Next re-install (2) zip ties back through the bracket to secure the harness along the frame rail, (See Figure 37) then install (2) more zip ties back around the coolant lines to secure them through the holes on

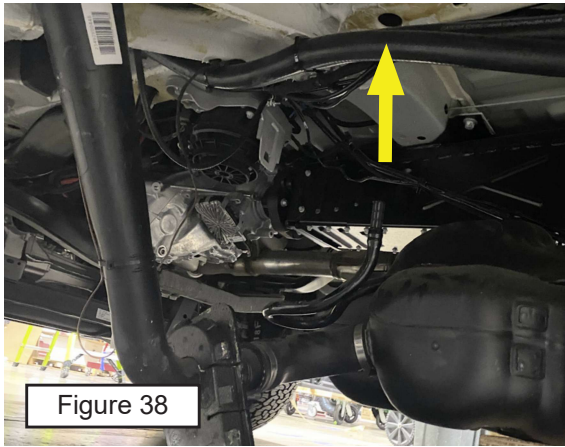
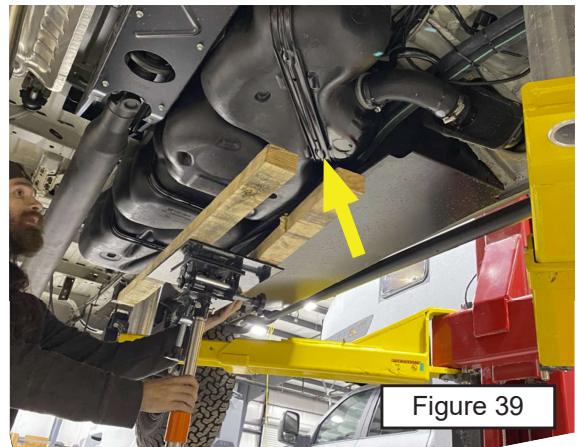
c. Carefully reposition the fuel tank back in place and return the fuel neck back up and through the exterior of the van near the driver's side door. Make sure when lifting the tank back in place to reinstall the breather line back through the opening in the frame rail. (See Figure 38)

d. Next re-secure the (3) tank straps in place around the fuel tank, use the E16 external torx socket to torque all (6) factory bolts back to **56 NM or 41.3 ft-lbs**, then use a paint pen to mark that each bolt has been torqued. (See Figure 39)

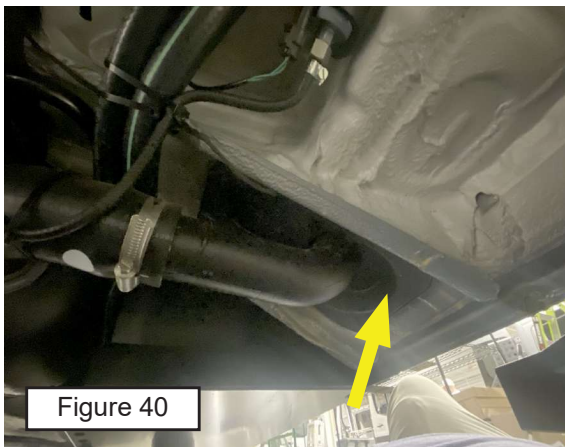
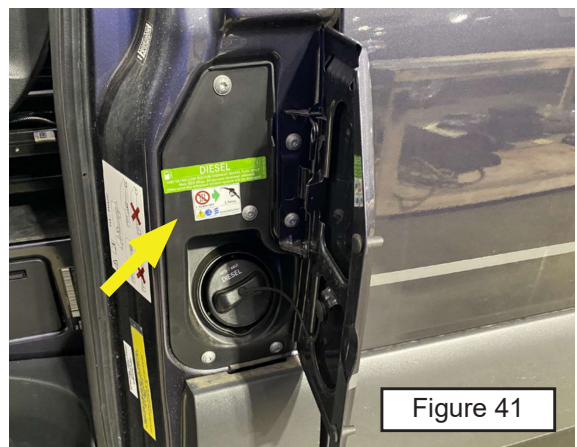
e. Reinstall the lower foam grommet around the fuel filler neck and back in place on the bottom side of the chassis. (See Figure 40)

f. Use a T-30 Torx bit to reinstall the fuel filler neck using the same factory hardware, then install the (4) bolts securing the fuel filler neck housing. Reposition the fuel filler door then secure the (2) bolts holding the fuel door hinge to the van. (See Figure 41) **Note: Verify that the fuel door aligns correctly with the van body and adjust accordingly with the 2 bolts on the hinge.**

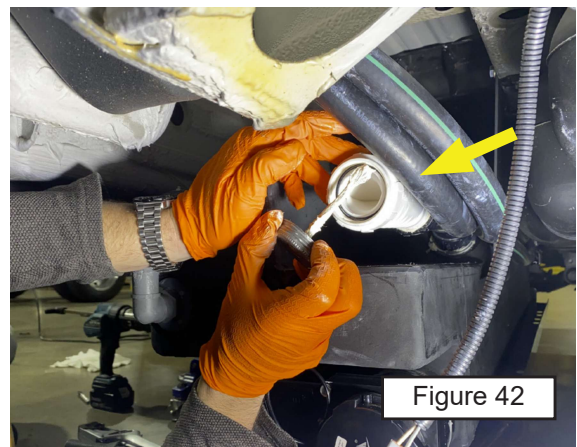
b. Apply quadmax to the 90° elbow macerator fitting at the end of the grey tank and re-apply pipe joint compound to the hepvo valve that is running along the top of the grey tank. (See Figure 42)

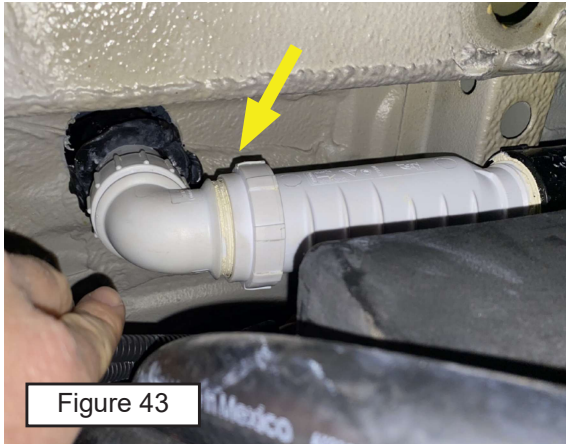
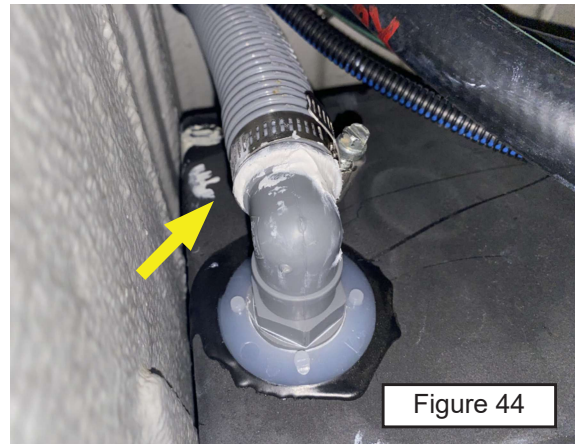
d. With the tank remaining in the up position, secure the hepvo valve once aligned (See Figure 43) and connect the grey macerator line to the 90° elbow at the end of the grey tank. Wipe away any excess quadmax sealant from the fitting and re-secure the hose clamp. (See Figure 44)

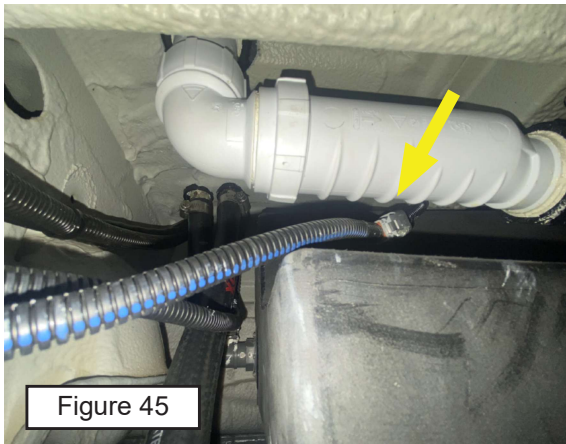
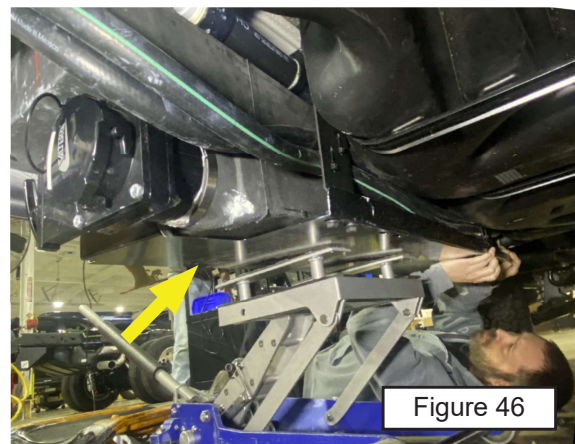
e. Secure the grey tank monitor deutsch connector back to the harness along the topside of the grey tank. (See Figure 45) **Note: the harness zip ties may need to be removed in order to reinstall the connection, if zip ties are removed make sure to replace them with new zip ties in the same area to prevent the harness from hanging below the chassis of the van.**

f. With the hepvo valve reconnected, realign the holes of the grey tank pan with the brackets and reinstall the (8) 3/8" x 1/2" SS black hex head bolts, and (8) 3/8" SS flat washers through the bottom side of the bracket and secure using a 9/16" socket and combination wrench. (See Figure 46)

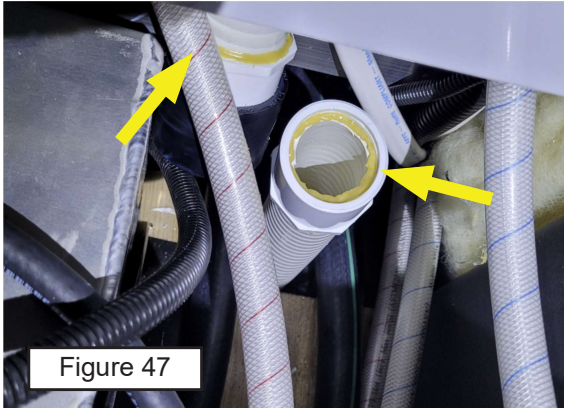
Figure 47

- b. Apply the all purpose plumbers cement to both sides of the grey tank vent hose then install the (2) 1 1/4" x 1 1/2" PVC bushing adapter to each side of the grey tank vent hose. (See Figure 47)
- c. With the (2) PVC bushing in place at the (2) open ends of the grey tank vent lines, next apply the all purpose plumbers cement to the 1 1/2" x 1 1/2" Hub x Hub black ABS coupling, then position the coupling between the (2) bushing adapters. (See Figure 48)
- d. Wipe up any excess plumber's cement, then let the glue set prior to testing.

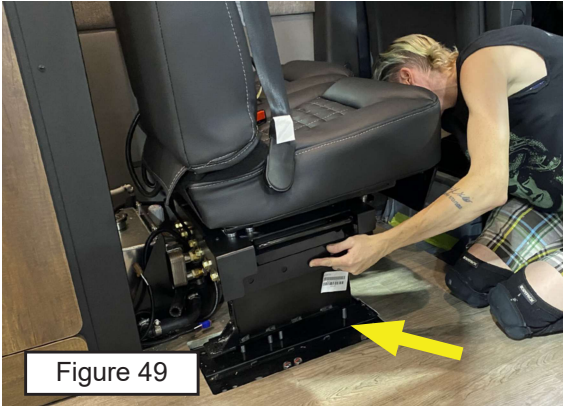
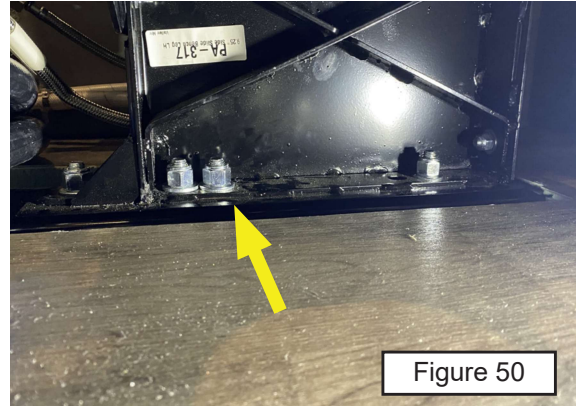
a. Inside the van carefully lift and re-position the seat back in place on the studs, making sure not to damage the studs, wiring or Rixen plumbing as you set the seat down on the studs. (See Figure 49)

b. Once aligned, install the original (8) 1/2" SAE washers and (8) new 1/2"-13 nylon lock nuts to secure the seat base to the floor brackets. Use a torque wrench and a 3/4" socket to torque each of the (8) nuts to **102 NM or 75 ft lbs.** **Note: new 1/2"-13 nylon lock nuts need to be installed once the seat is reinstalled.**

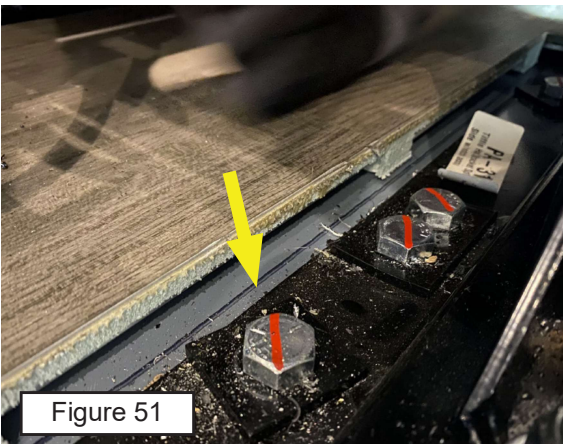
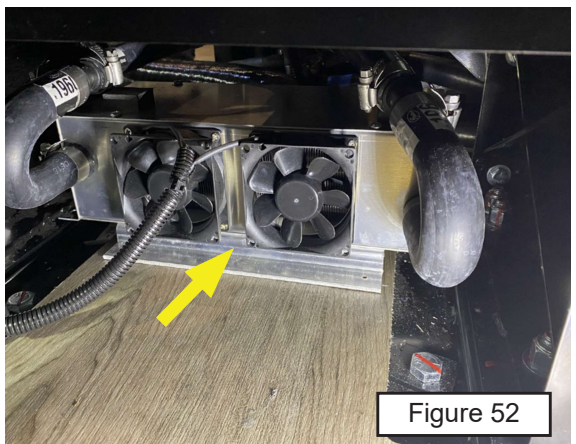
c. Use a paint pen on both the top and bottom side of the van to mark that each of the bolts have been torqued to the appropriate specs. (See Figure 51) Next reposition the air handler back in place and install the wafer head screws along the front and back edge of the air handler. (See Figure 52)

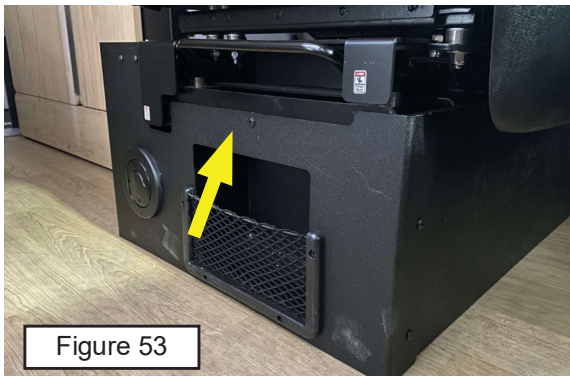
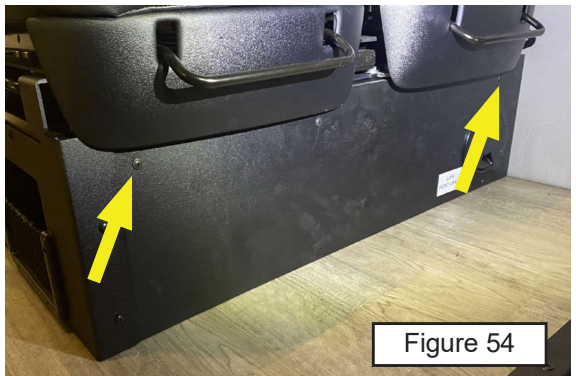
d. Position the seat shroud back in place and install the (2) wafer head screws from the front and (1) wafer head screw from the side of the lower seat shroud panels. (See Figure 53 & Figure 54)

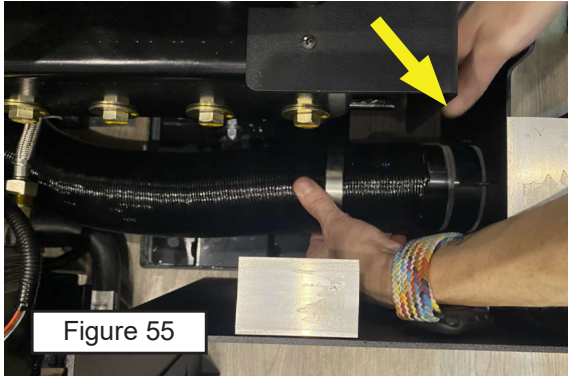
Figure 55

e. Position the air duct back on the side outlet of the seat shroud and use a 5/16" socket to secure the hose clamp inside of the seat shroud. (See Figure 55)

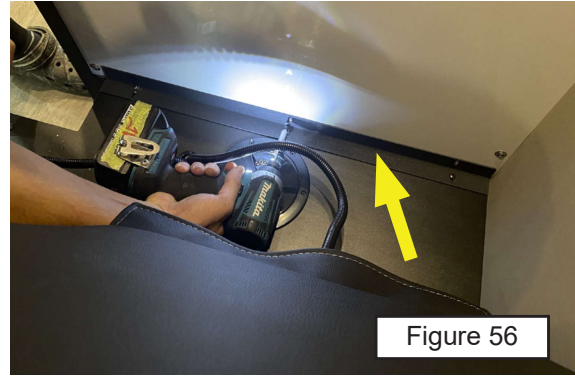
Figure 56

g. Reposition the top plate back in place and install the (3) wafer head self-tapping screws back down through the panel, then re-install the (3) wafer head wood screws along the angled trim to the front face of the shower finish panel. (See Figure 56)

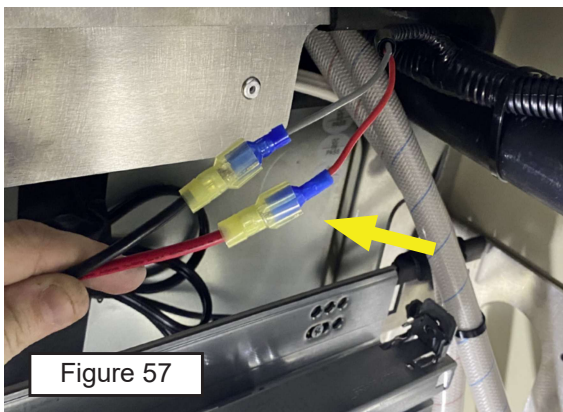
Figure 57

a. Carefully position the fridge inside the van and connect (2) spade connections on the backside of the fridge. **Note: some models will also have 110 power cable that is taped to the backside of fridge this will need to be connected to an Internal 110 receptacle prior to installing the fridge.** (See Figure 57)

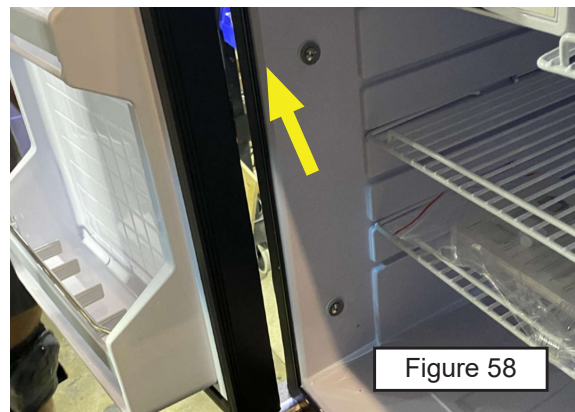
Figure 58

b. Once fridge is aligned, open the fridge door and take the phillips bit and 1/8" allen key to re-install the (4) screws to secure the fridge to the galley. (See Figure 58) (#10-24 x 1" SS barrel nut, 1/4" PVC washer, #10-24 x 1.25" Flat Head Screw and aluminum counter sunk washer) **Note: tighten hardware using a philips head screwdriver from the inside of the fridge, while holding the allen wrench from the outside. Make sure not to overtighten hardware to prevent damaging the fridge or galley.**
