**Update High-Voltage Starter  
Alternator Software – Wave 1****Campaign Details**

# Recall Campaign Bulletin

| SUBJECT | Update High-Voltage Starter-Alternator Software – Wave 1 |
| MODEL(S) | AMG GT Coupe, AMG GT 4-Door Coupe, AMG S-Class, AMG SL,<br>and AMG GLC/Coupe (192, 290, 223, 232 and 254 platform) |

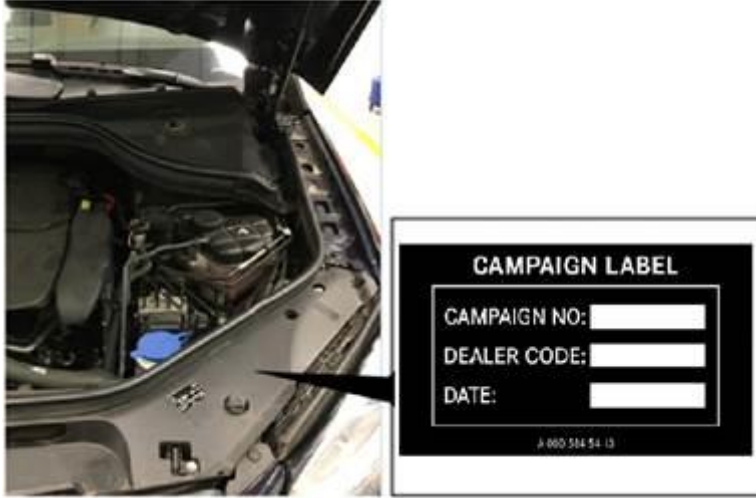
**Figure 1**

Apply Proof of Correction Label (A 000 584 54 13) to area identified in **Figure 1**. Fill in the blank areas of the label. The “**Campaign No.**” for the California Proof of Correction is unique and must be entered as such (25V129), your “**Dealer Code**”, and the “**Date**” of the repair, using a black permanent marker.

**i** Note: Clean bonding surface prior to affixing label.
