Safety Recall 25S30 – Supplement 1

Certain 2024-2025 Model Year F150, 2024-2025 Expedition, and 2024 Navigator Vehicles

3.5L Engine Cup Plug Inspection

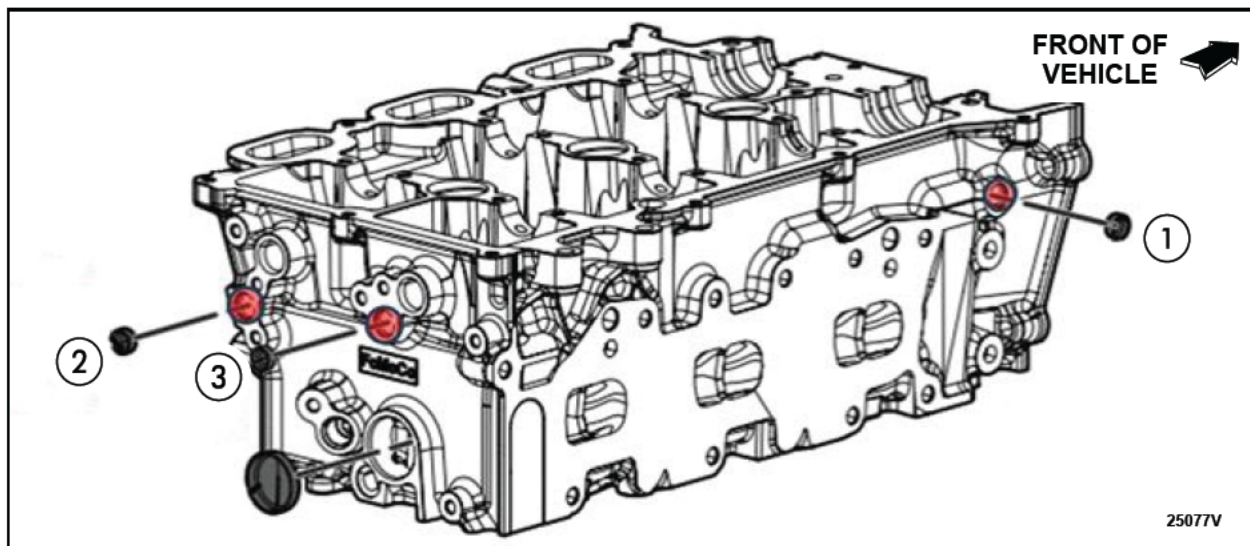
FIGURE 8

* For cup plug locations, See Figure 8 below.

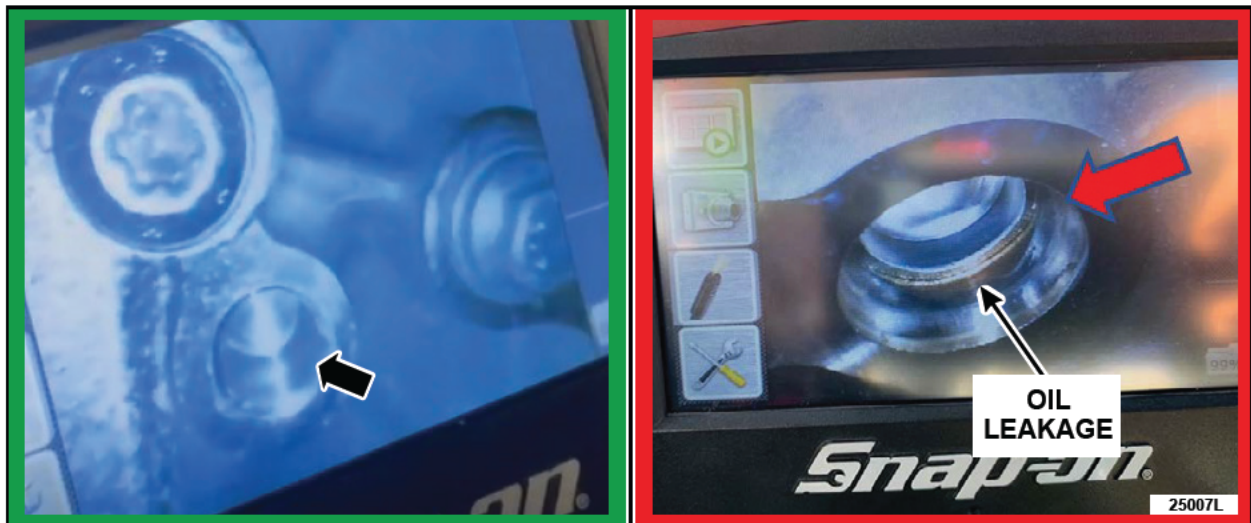
FIGURE 12

4. Using an inspection mirror or bore scope, inspect the cup plugs for any signs of oil leakage. See Figure 12.

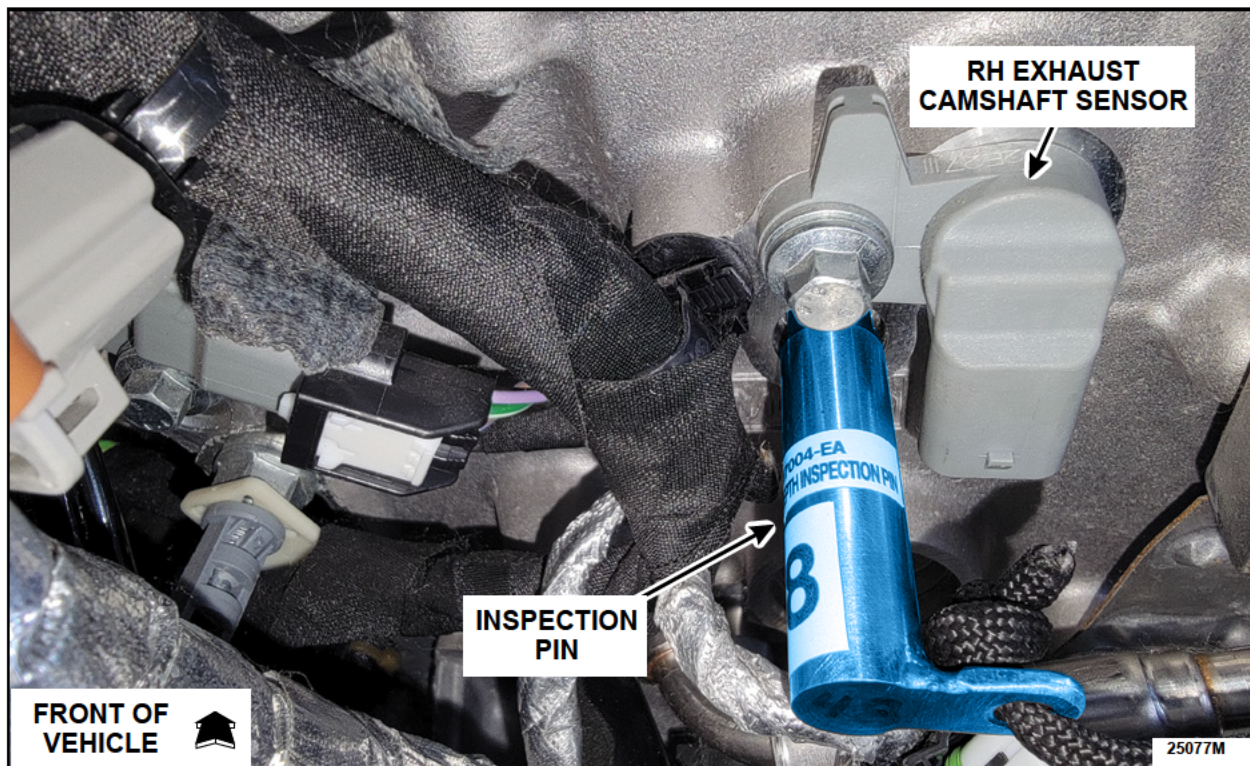
FIGURE 14

NOTE: RH rear outboard cup plug shown, others similar.

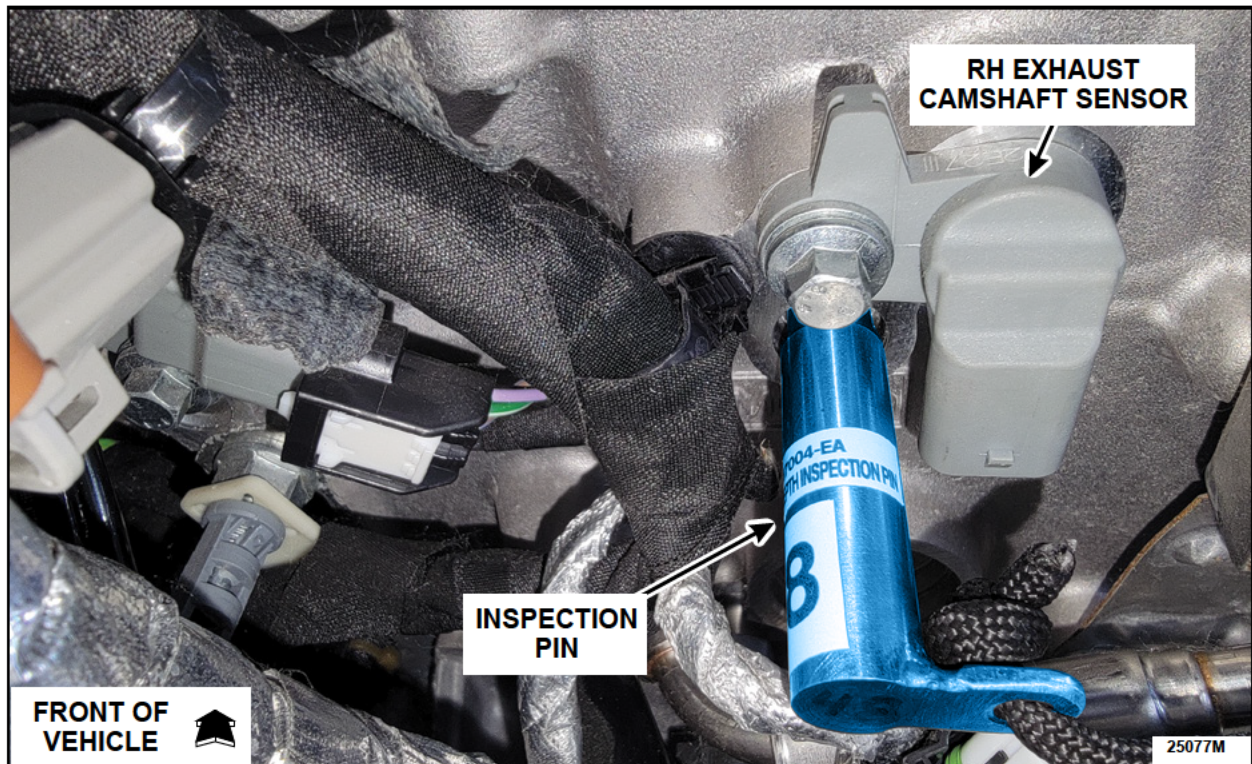
FIGURE 20

NOTE: RH rear outboard cup plug shown, others similar.
