**TO: Storyteller Overland Dealers
Subject: NHTSA Recall: 25V-588**

What is the reason for this recall? Storyteller Overland is recalling certain 2024-2026 Storyteller GXV HILT vehicles. The auxiliary power system wires may have been improperly routed. The wires may be damaged by contact with the intake manifold.

NHSTA Recall 25V-588 Hilt Wiring Recall

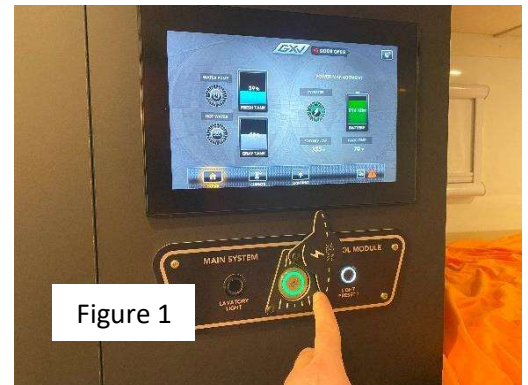
Figure 1

1. Ensure unit is parked with Ignition turned off
2. Turn off the electrical system in the capsule by holding down the illuminated green button until there is an audible "click". (Figure 1)
3. Exit the capsule and lock the entry door. The technician performing the work should have the entry door keys on their person from this point on to prevent others from entering the capsule
4. Pop the hood of the RAM chassis
5. Disconnect the driver's side negative battery terminal and secure with a zip tie (Figure 2)
6. Disconnect the passenger's side negative battery terminal and secure with a zip tie (Figure 3)

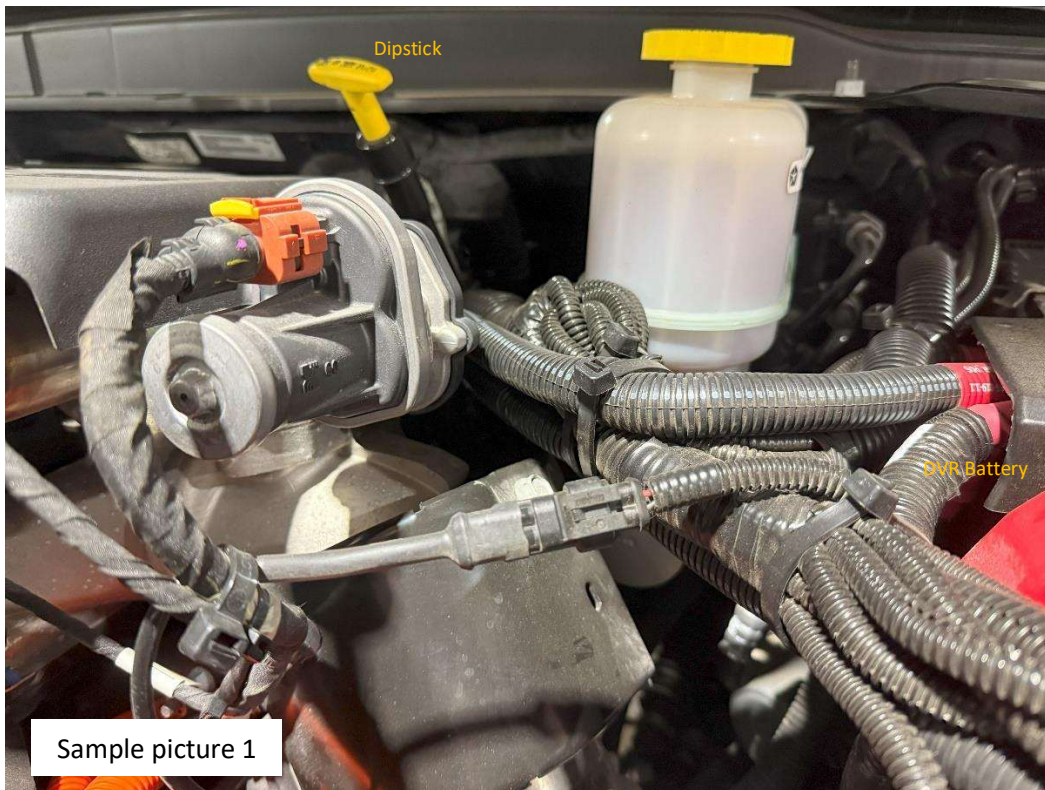
7. Take picture Identical to "sample picture 1"

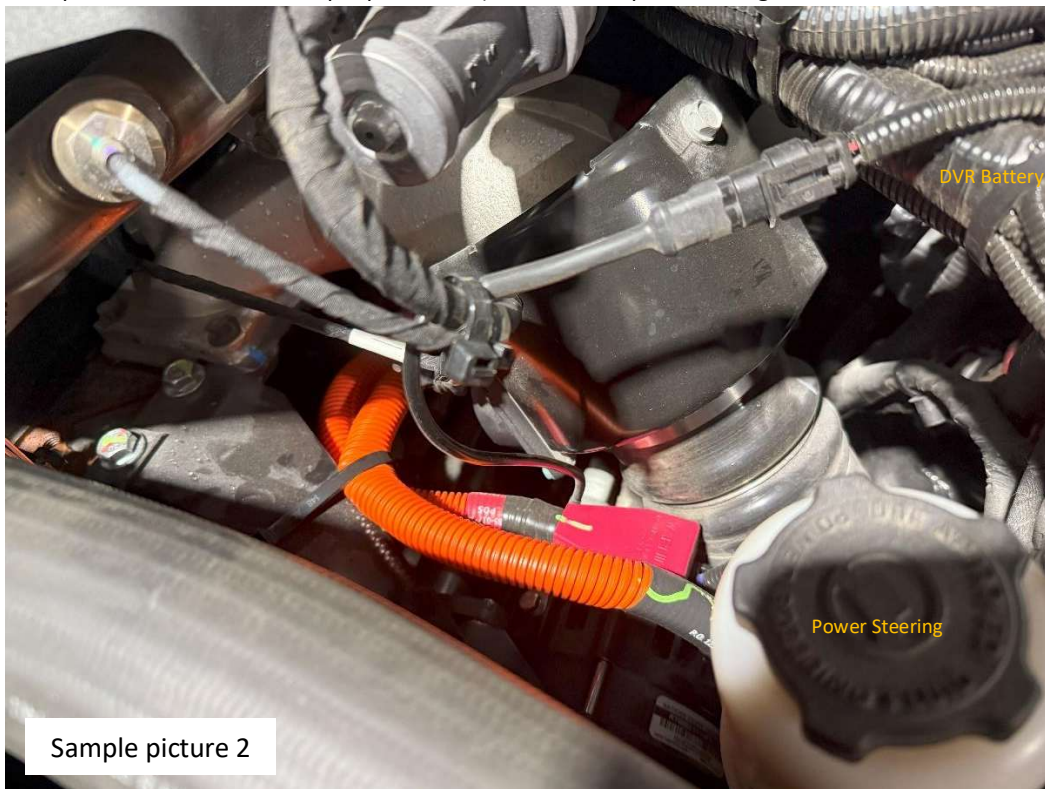
8. Take picture Identical to "sample picture 2" (If there is a ziptie securing to bracket, cut and remove)

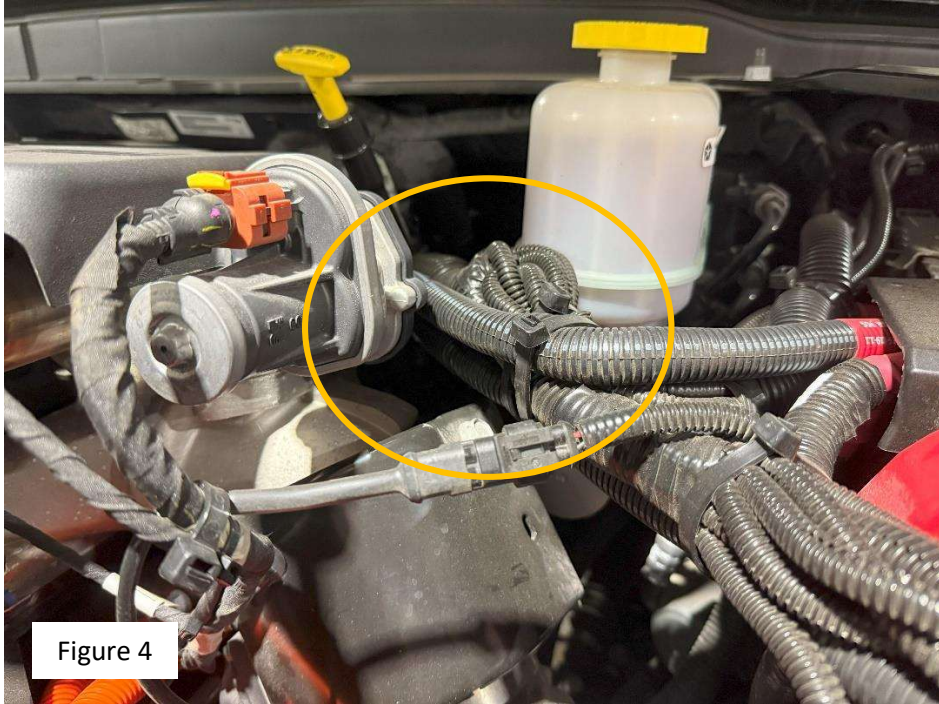
9. Carefully remove bundle of wires shown from sheathing through the split in plastic. Zip ties or electrical tape may have to be removed
10. Inspect for any visible damage of wire Insulation
11. Remainder of photos will be taken In the area shown In Figure 4

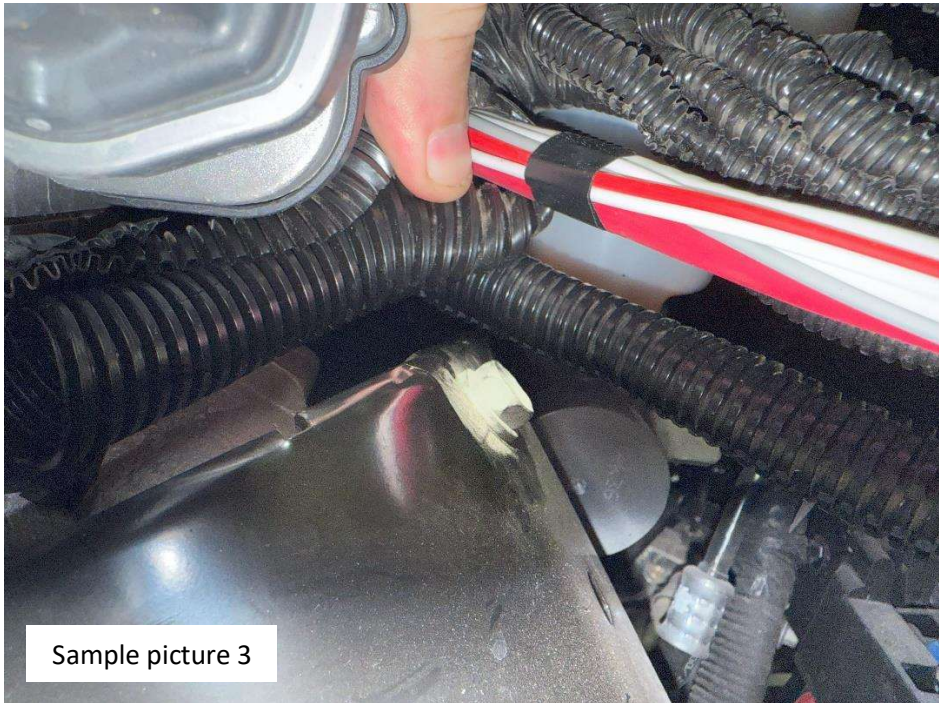
12. Take picture identical to "sample picture 3"

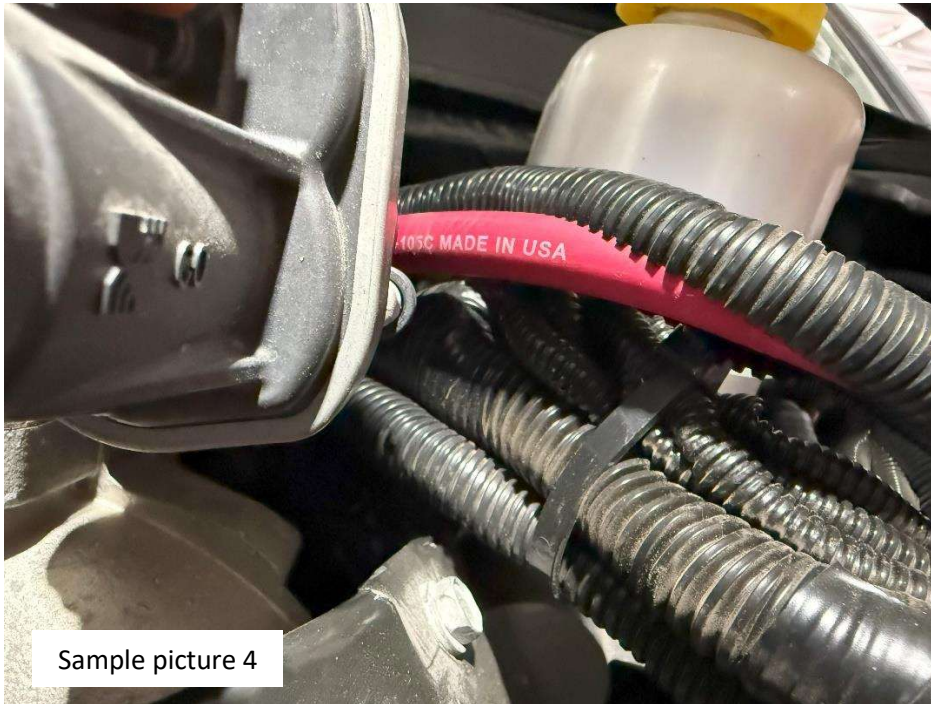
13. Carefully remove the first large wire shown from sheathing through the split in the plastic
14. Inspect for any visible damage of wire Insulation

15. Take picture Identical to "sample picture 4"

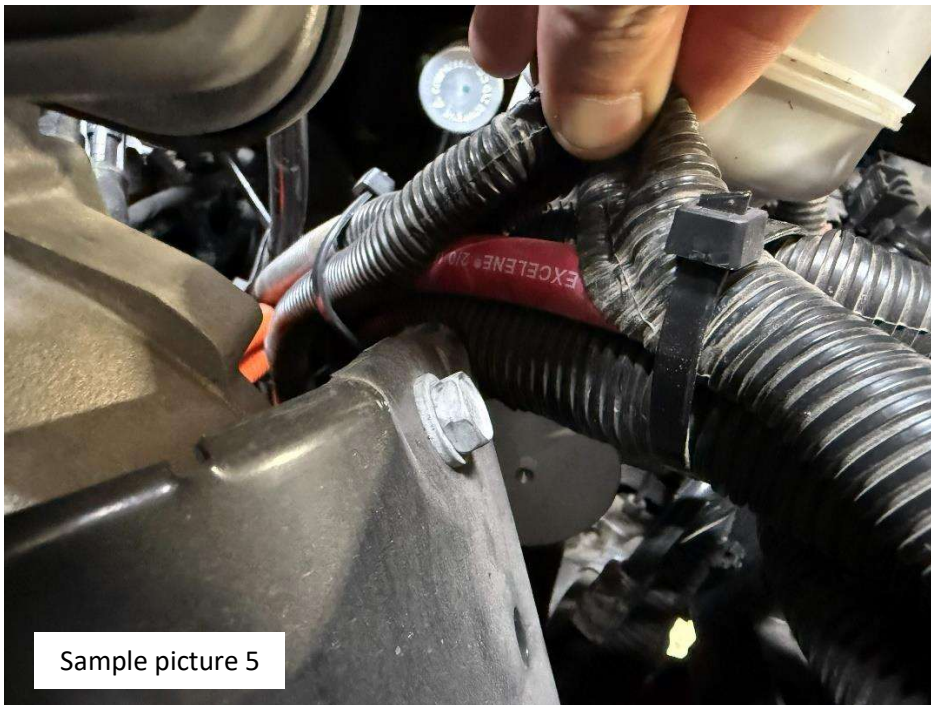
16. Carefully remove the last large wire shown from the sheathing through the split in the plastic
17. Inspect for any visible damage of wire Insulation
18. Take picture Identical to "sample picture 5"

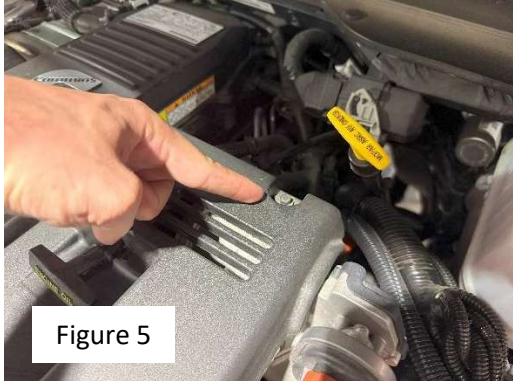
Figure 5

1. Remove engine cover bolt (Figure 5)
2. Attach supplied bracket with engine cover bolt In orientation shown. Torque to 89 in-lbs (Figure 6)

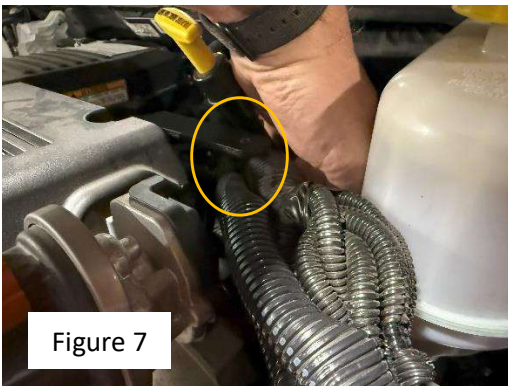
Figure 7

3. Lift harness to test slack. If It can make contact with bracket, skip to step 6 (Figure 7)
4. Cut zip ties on dipstick tube and re-do step 3 (Figure 8)

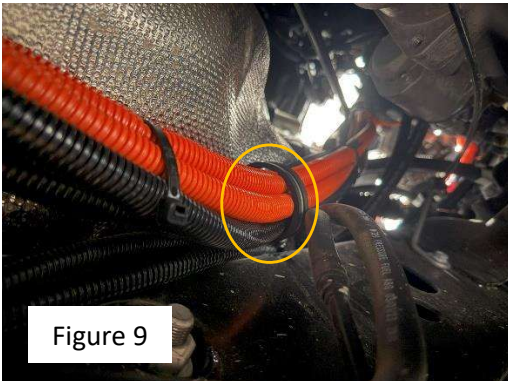
Figure 9

5. Loosen P-clamp and re-do step 3 (Figure 9)
6. Wrap anti-chafe around the bottom of the bundle centered at the bracket (Figure 10)

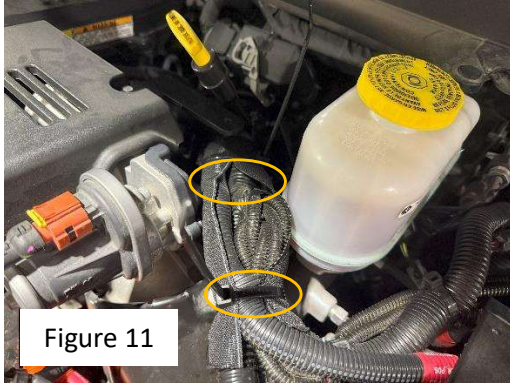
Figure 11

7. Secure with two supplied heavy duty zip ties (Figure 11)
8. Wrap supplied P-clamp around bundle and secure to supplied bracket using M6 nut and bolt (Figure 12)

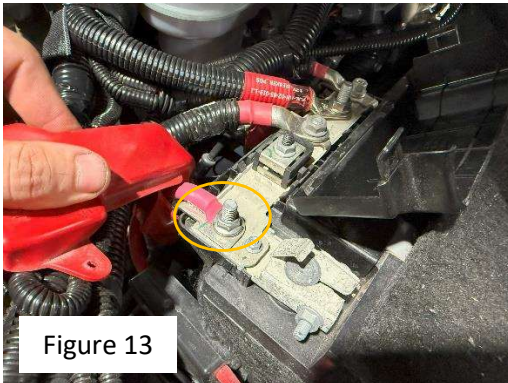
Figure 13

9. Open the cover on the driver's side battery positive
10. Remove the 12mm nut and washer next to the battery post attachment
11. Remove the red wire from the stud (Figure 13)
12. Place the supplied double fuse holder on the stud, place red wire on top, and then attach with the removed washer and nut (Figure 14)
13. Torque nut to **50 In-lbs**

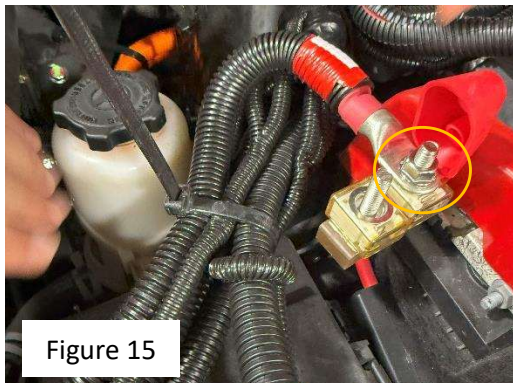
Figure 15

14. Remove the large wire that leads to the 150A breaker labeled "**Battery Pos**" from the battery using 13mm socket and attach to the double fuse holder on the 175A fuse (Figure 15)
15. Remove the slightly smaller wire labeled "**Battery Pos**" from the battery using 10mm socket and attach to the double fuse holder on the 100A fuse (Figure 16)

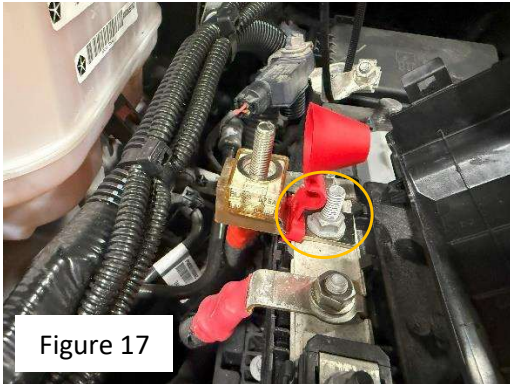
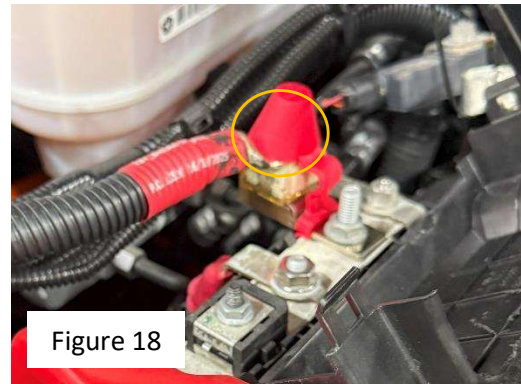
16. Torque both nuts to **107 In-lbs**
17. Remove the nut from the third stud from the cab of the truck on the battery and place the supplied single fuse holder on the stud. Reattach nut and torque to **50 In-lbs** (Figure 17)
18. Remove the large wire labeled "**Breaker_Pos**" from the battery and attach to the single fuse holder on the 175A fuse (Figure 18)
19. Torque nut to **107 In-lbs**

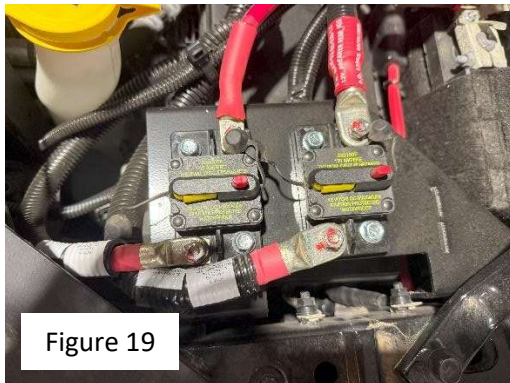
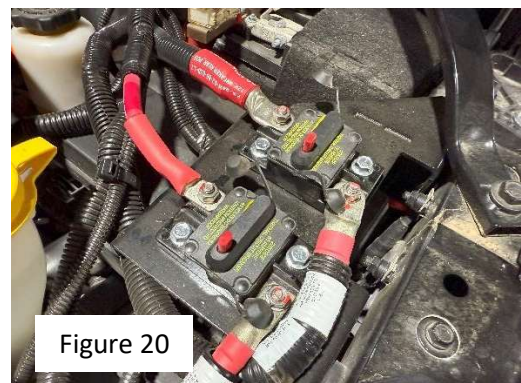
20. Inspect the breakers towards the front of the engine compartment. If the yellow reset bar is facing the drivers side fender, proceed to next step (Figure 19). If it is facing the engine, skip to step 30 (Figure 20)

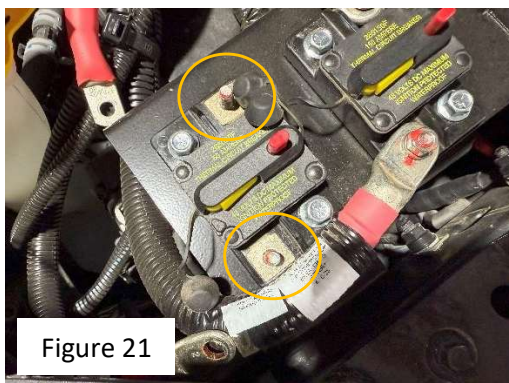
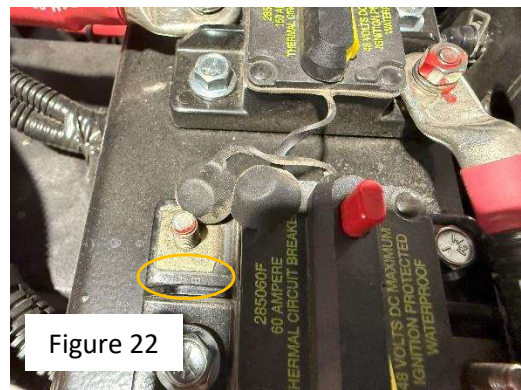
21. Undo nuts and washers on both wires from the front breaker (60A) using 10mm socket and set aside (Figure 21)
22. Verify that the molded plastic says "**BAT**" towards the engine (Figure 22)

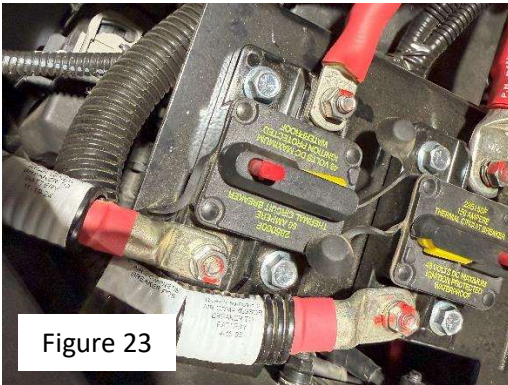
Figure 23

23. If so, unbolt the two bolts holding breaker In place, rotate breaker 180 degrees, and re-Install
24. Re-Install two wires on breaker with the wire labeled "battery" towards the fender (Figure 23)
25. Next, undo nuts and washers on both wires from the rear breaker (150A) and set aside (Figure 24)

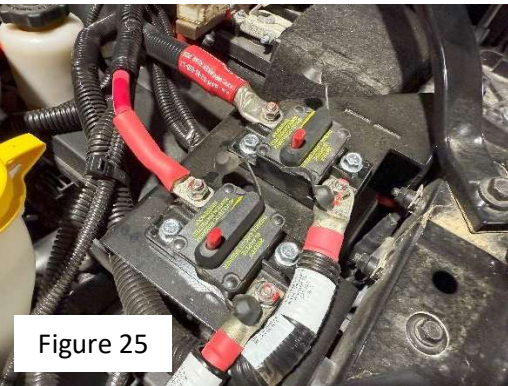
Figure 25

26. Verify that the molded plastic says "BAT" towards the engine
27. If so, unbolt the two bolts holding breaker In place, rotate breaker 180 degrees, and re-Install
28. Re-Install two wires on breaker with the wire labeled "battery" towards the fender (Figure 25)
29. Torque all connections with 10mm socket to 50 In-lbs (Figure 26)

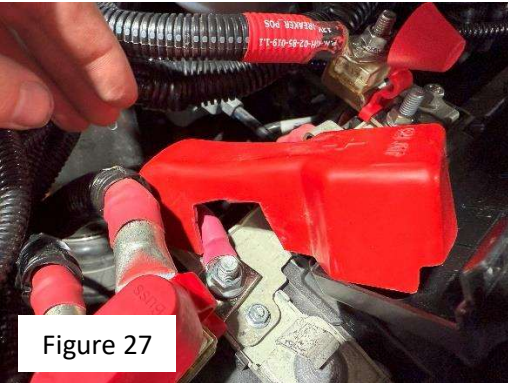
Figure 27

30. Notch the rubber boot as shown to clear the double fuse block (Figure 27)
31. Notch the plastic cover as shown to clear the single fuse block (Figure 28)

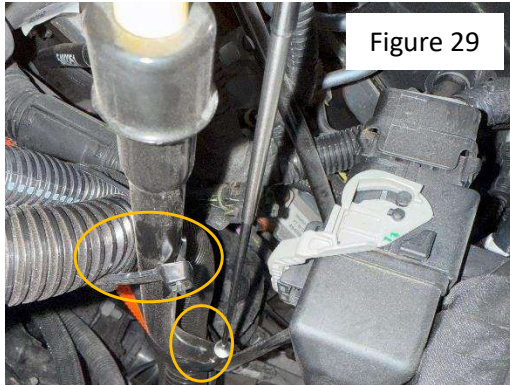
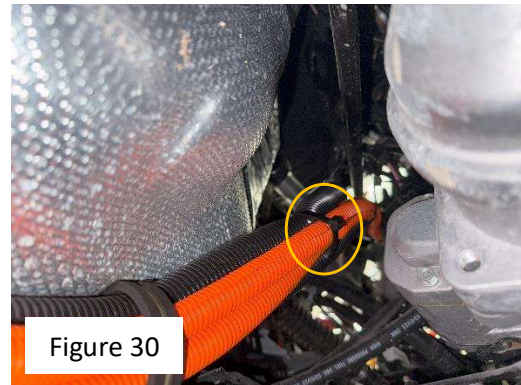
- 32. Ensure there are two zip ties on the dipstick as shown. If not, use supplied heavy duty zip ties to secure like picture (Figure 29)
- 33. From underneath the truck, add a supplied heavy duty zip tie securing the wire bundle to the dipstick towards the bottom of the firewall (Figure 30)

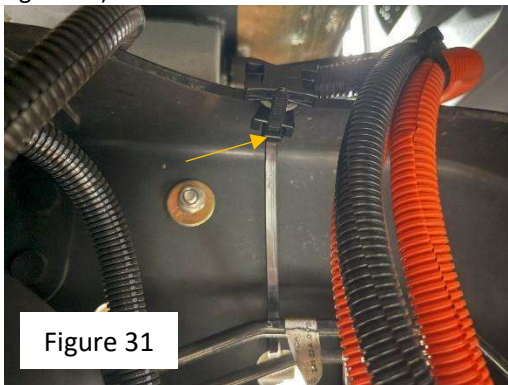
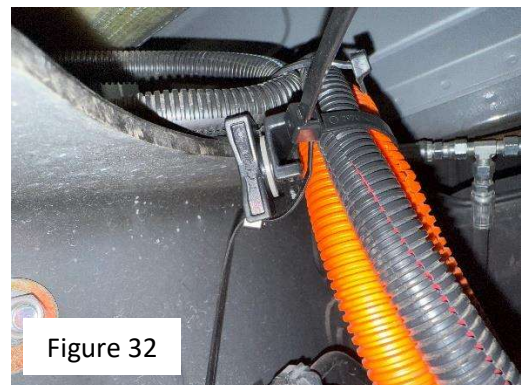
- 34. From underneath the truck, just behind the cab of the vehicle on the driver's side, look for where four wires go over the frame rail. Attach the supplied zip tie swivel through the hole in the frame rail and around the top, with the swivel tight against the top inner corner of frame rail. NOTE: the head of the zip tie should be placed against the swivel to prevent it from sliding downward (Figure 31)
- 35. Using another heavy duty zip tie, secure the four wires to the swivel to hold the wires off of the frame rail (Figure 32)

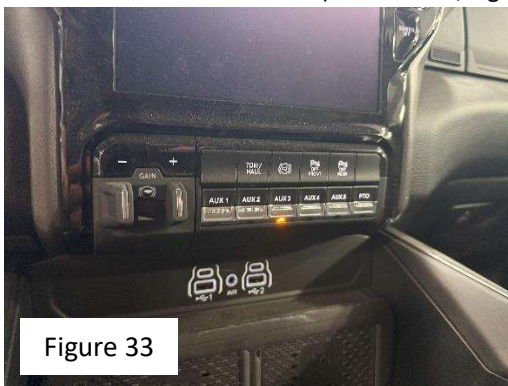
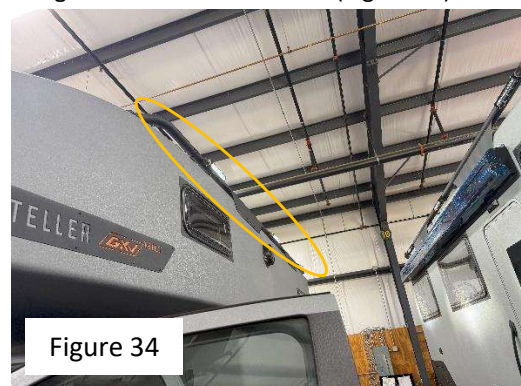
- 36. Clip all zip ties
- 37. Re-attach grounds on both driver and passenger chassis batteries
- 38. Start truck and turn on Aux 3 (below radio, Figure 33). Ensure lights on roof rack turn on. (Figure 34)

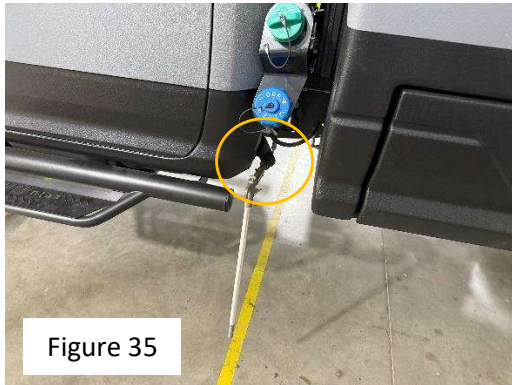
Figure 35

40. Place air tool In chuck between chassis and capsule on drivers side. Discharge air. (Figure 35)

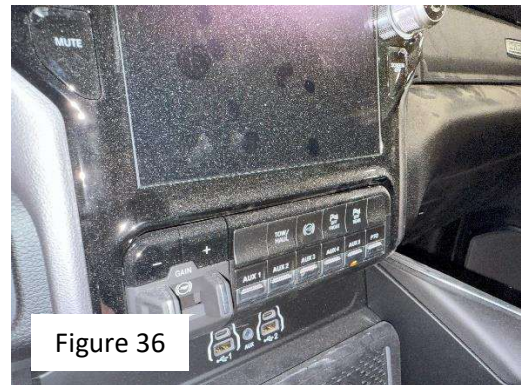
Figure 36

41. Turn on Aux 5 and listen to make sure compressor at rear of vehicle turns on. (Figure 36)

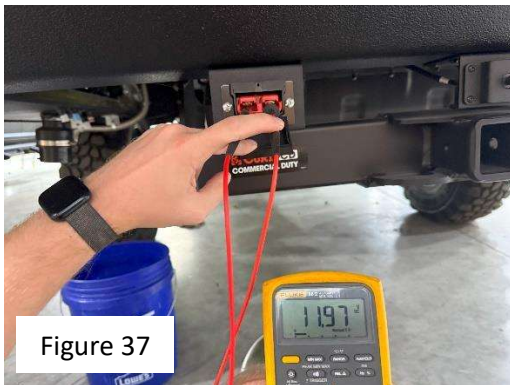
Figure 37

43. Using multimeter, check voltage across the plug at the rear left of the bottom of capsule as shown.

44. Verify ~12V (Figure 37)

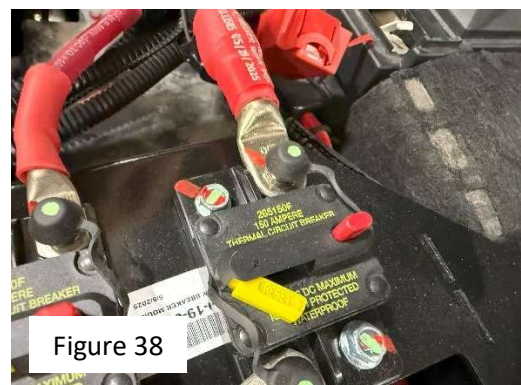
Figure 38

45. Go to engine compartment and push red button on the 150A breaker (Figure 38)

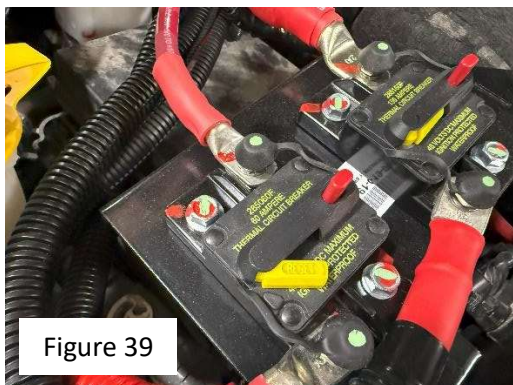
Figure 39

47. Go to engine compartment and close the 150A breaker. Press red button on 60A breaker (Figure 39)

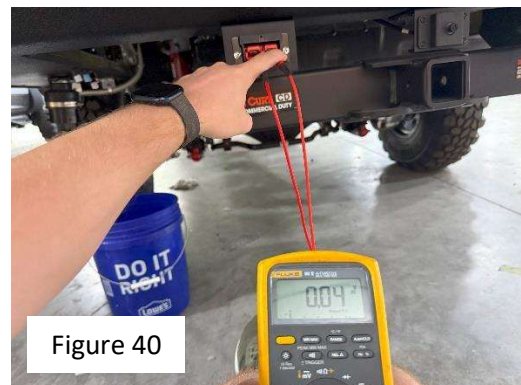
Figure 40

48. Repeat steps 43-44, voltage should be **0V** (Figure 40)

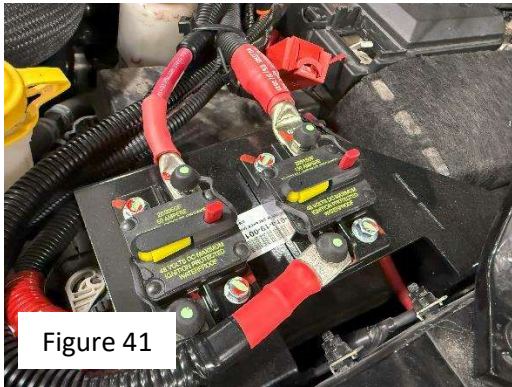
Figure 41

49. Return 60A breaker to closed state (Figure 41)
