Service Engineering Operations
Customer Service Division

SUBJECT: **NEW VEHICLE DEMONSTRATION / DELIVERY HOLD – Supplement #1**
Safety Recall 25S91
 Certain 2016-2019 Model Year Taurus Vehicles
 Exterior B-Pillar Applique Trim Repair/Replacement

CERTAIN 2016-2019 MODEL YEAR TAURUS VEHICLES — EXTERIOR B-PILLAR APPLIQUE TRIM REPAIR/REPLACEMENT

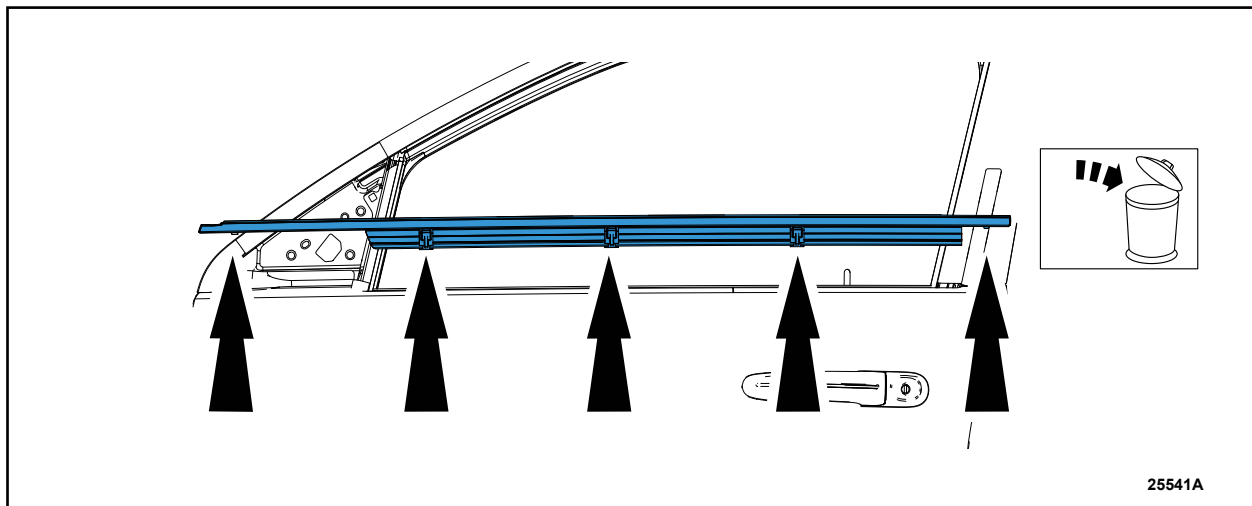
FIGURE 1

5. Using a non-marring trim tool, release the tabs, then lift up and remove and discard the exterior window glass moulding. See Figure 1.

15. Let the adhesive dry for a total of 4 hours. After one (1) hour of dry time, remove the tape and continue to the next step. Then, let it dry for the other 3 hours before returning the vehicle to the customer.
16. Position back and install the upper B-pillar portion of the glass top run back into the run channel. See Figure 2.
17. Install the *new* exterior window glass moulding by reversing Step 5. See Figure 1.

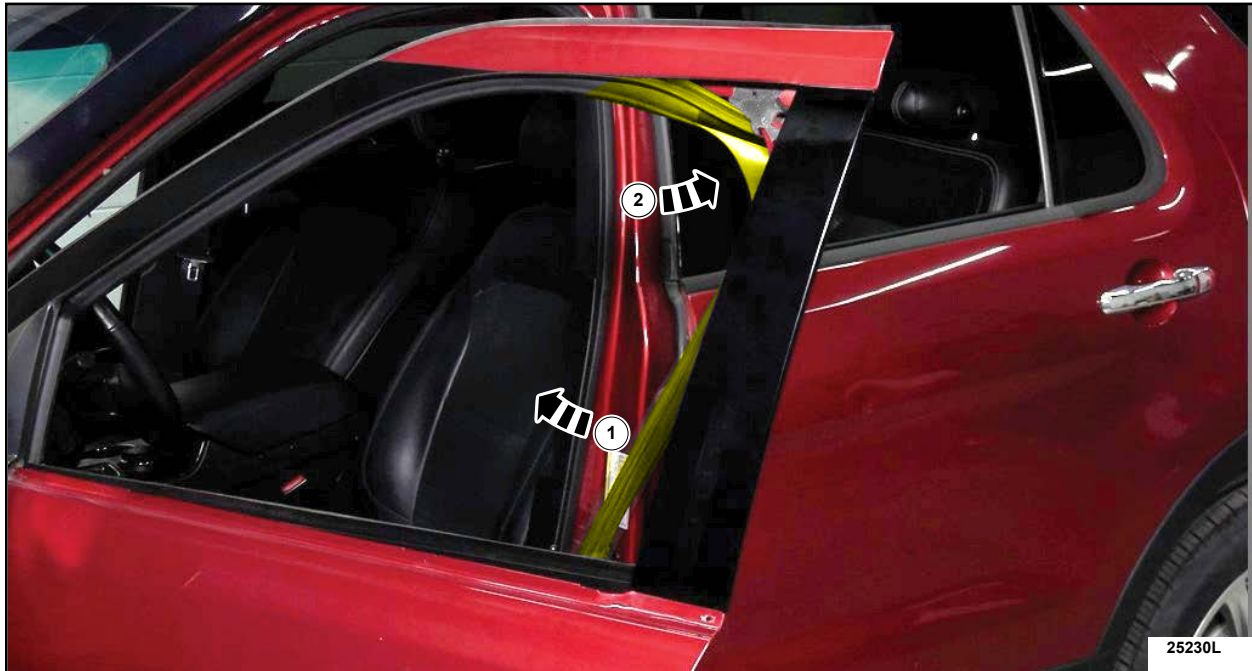
FIGURE 2

6. Position the front door glass fully open. Using care, remove just the upper B-pillar portion of the glass top run from the run channel and position aside as shown in Figure 2. Make sure the glass top run is positioned towards the inboard side of the door.

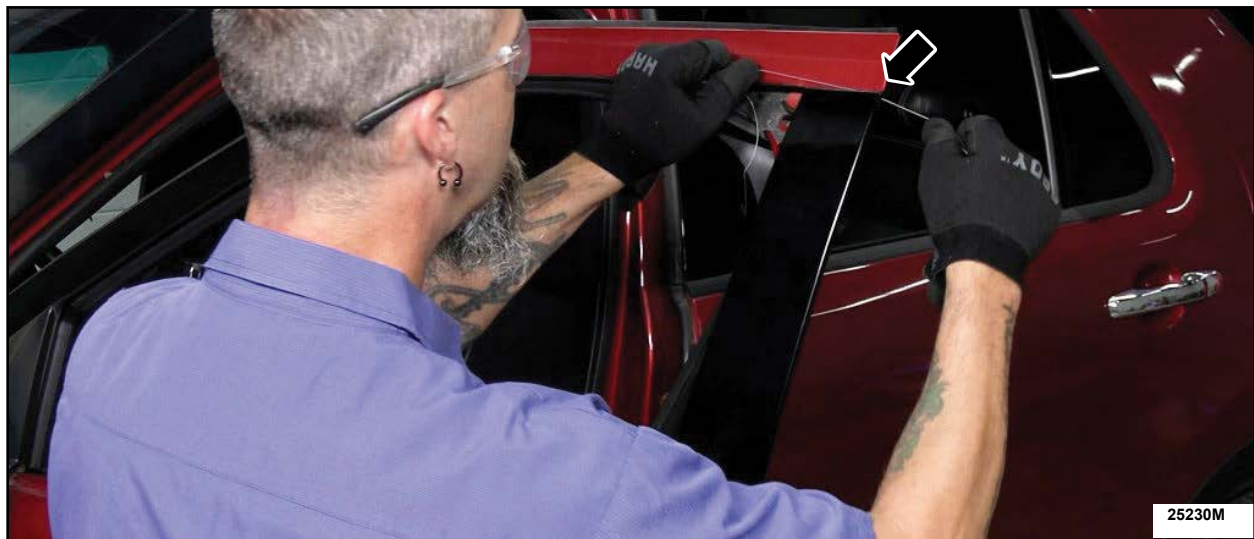
FIGURE 3

- a. Loop the fishing line around the top of the applique and in a sawing/back and forth motion, break through the tape adhesive until you feel resistance at the applique locator pin. See Figures 3 and 4.

NOTE: Left-hand side shown, right-hand side similar.

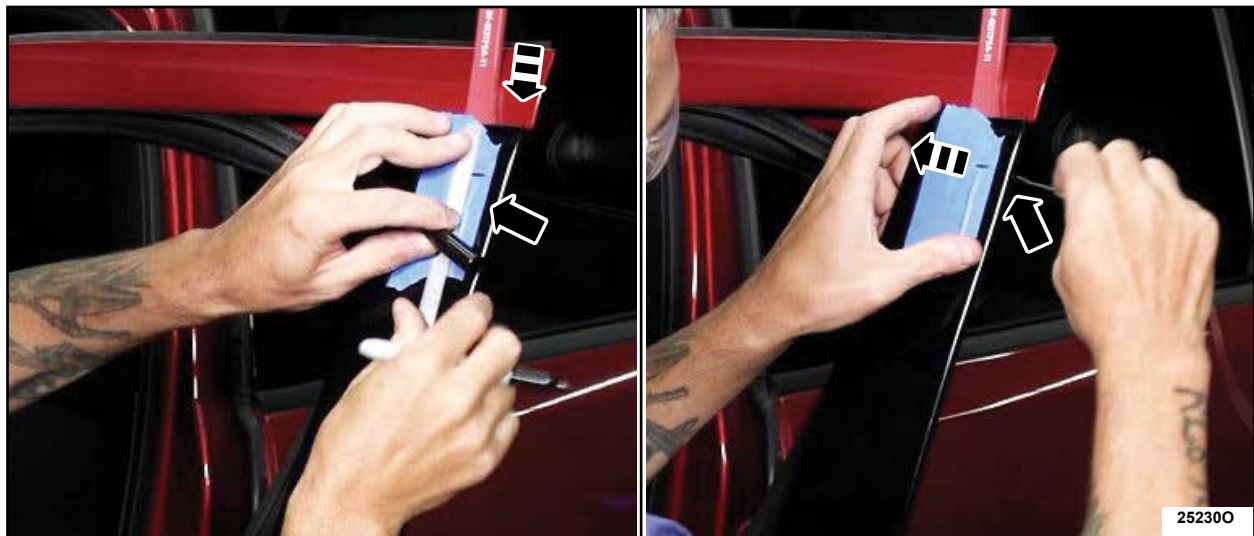
FIGURE 5

- d. Under the vertical line drawn on the masking tape, insert the mechanics wire or crochet hook vertically behind the applique. See Figure 5.
- e. Make a loop with the fishing line and attach it to the mechanics wire or crochet hook. Pull the mechanics wire or crochet hook behind the applique until the fishing line can be grabbed on the opposite side. Finish pulling the loop fully through and use scissors to cut the fishing line from the mechanics wire. See Figures 6 and 7, continue to the next step.

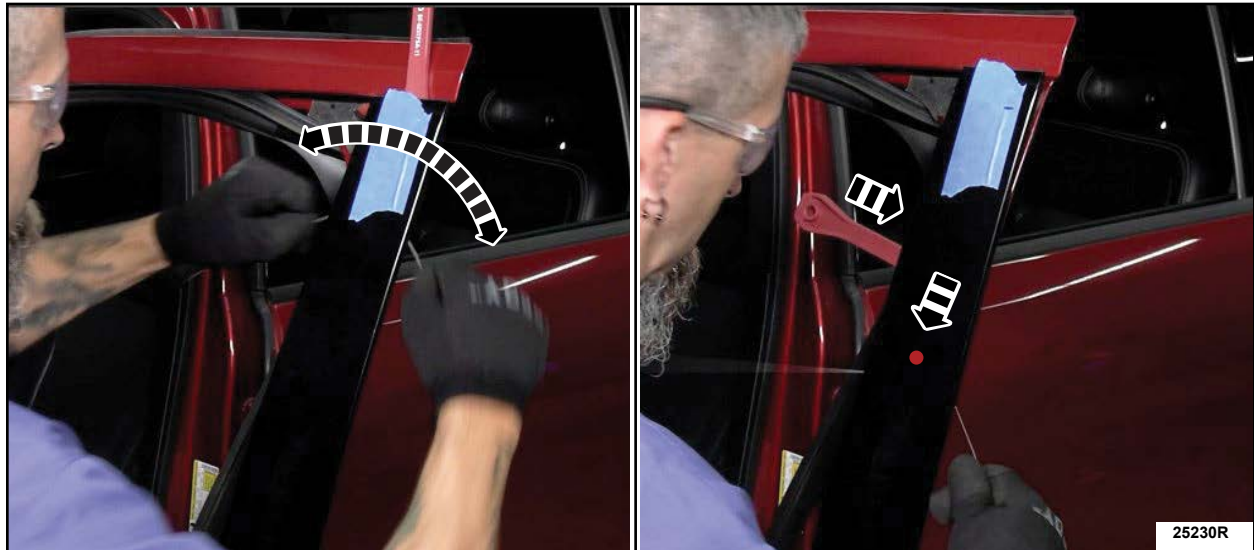
FIGURE 8

8. Continue using the fishing line to break the adhesive bond until you get half way down the applique and, if equipped with keyless entry keypad, make sure to stop above the keypad. See Figure 8.

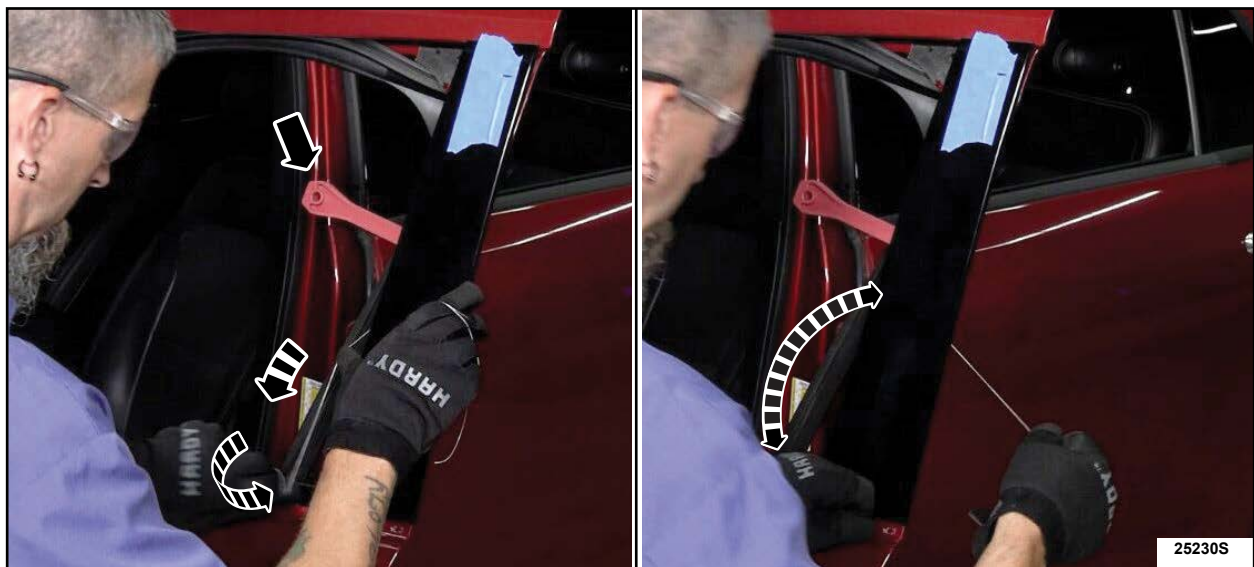
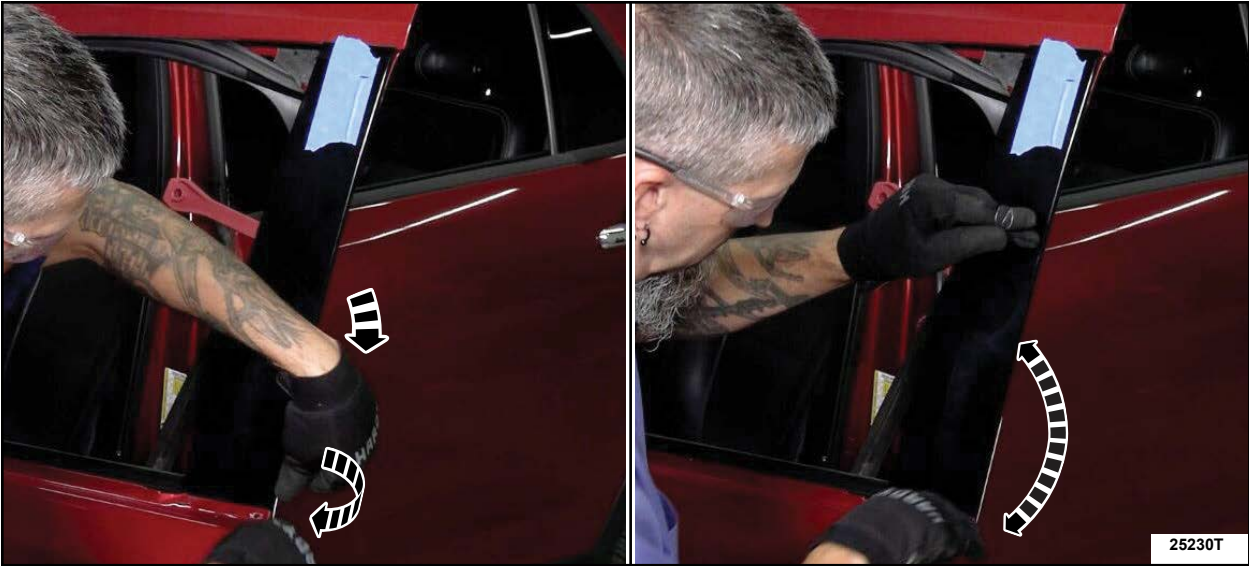
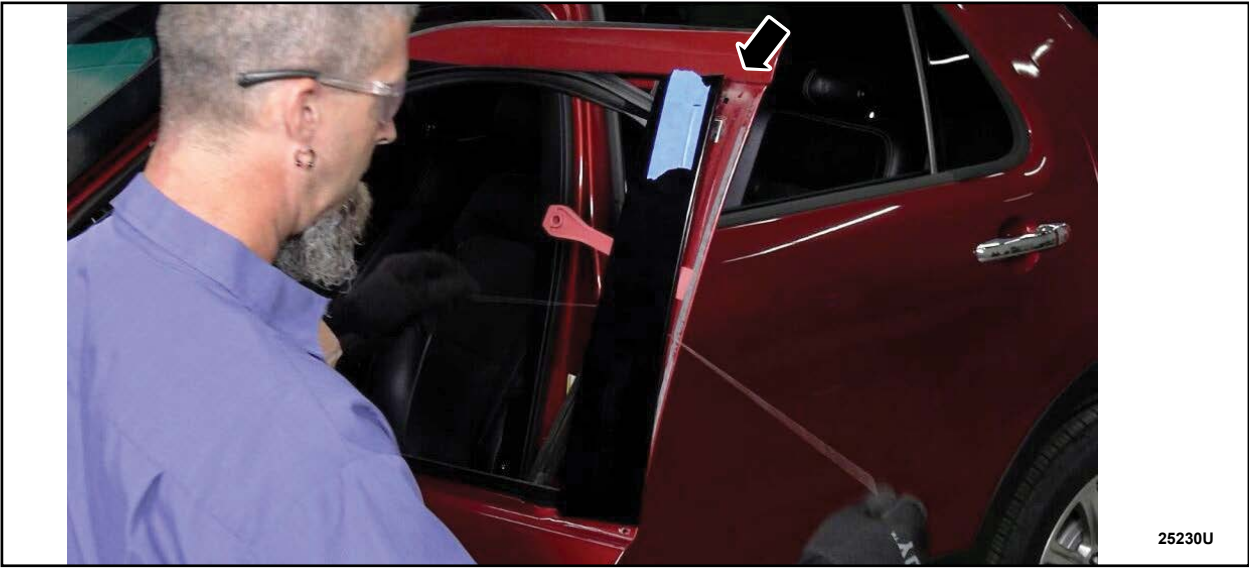
9. Wrap the inboard portion of the fishing line around the inboard lower portion of the applique and continue working around the applique releasing the inboard side of the applique then, wrap the outboard portion of the fishing line around the outboard lower portion of the applique and continue working around the applique until the applique releases from the door. See Figures 9, 10, and 11.

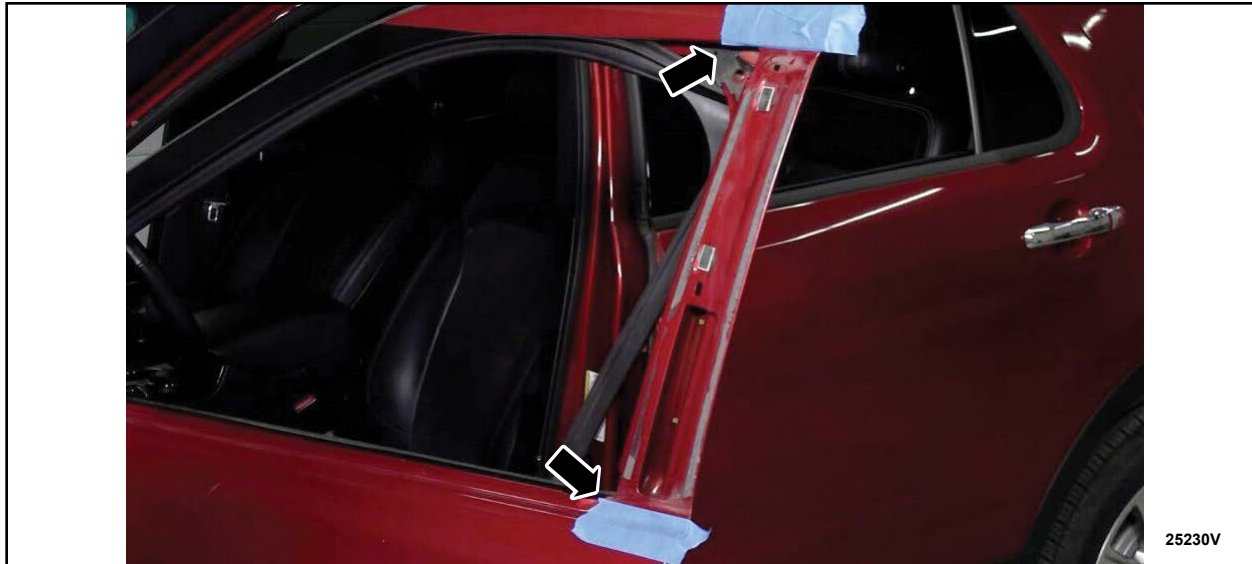
FIGURE 12

1. Apply masking/body tape to the painted surfaces above and below the front B-pillar applique trim as shown in Figure 12.

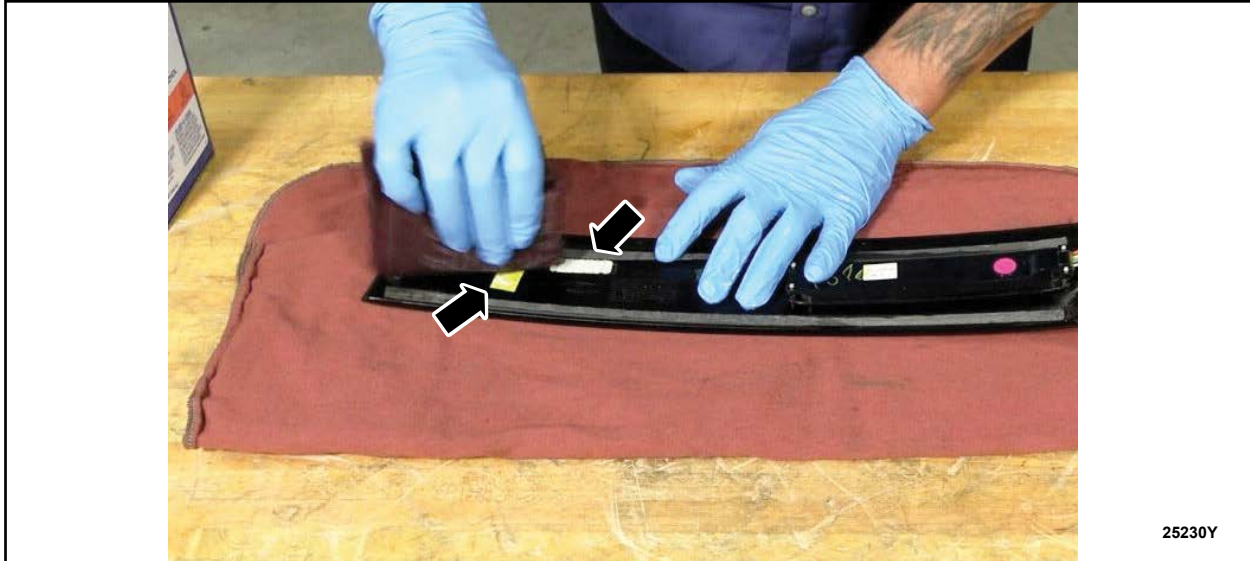
FIGURE 14

4. Remove the masking tape from the painted surfaces that were applied to painted surfaces above and below the applique.
5. Using care, lay the front B-pillar applique trim on a shop cloth with the back side up. See Figure 14.
6. Using isopropyl alcohol and a Scotch-Brite™ 7447 pad, remove the stickers on the back side of the applique as shown in Figure 14.

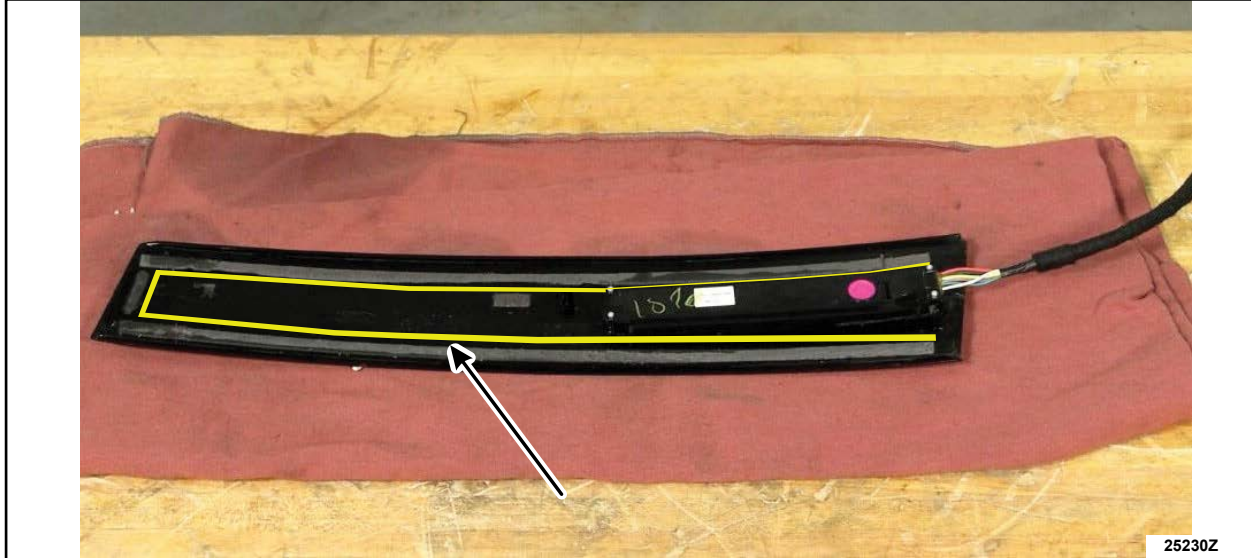
FIGURE 15

7. Using isopropyl alcohol and a Scotch-Brite™ 7447 pad, scuff up the areas on the back side of the applique as shown in Figure 15.

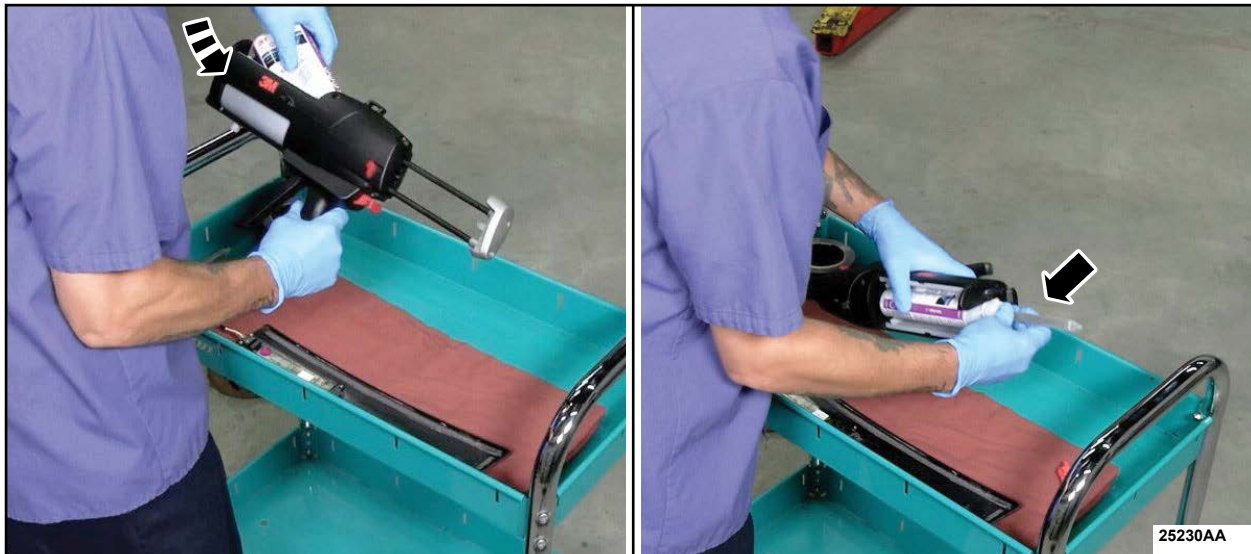
FIGURE 16

9. Load the repair adhesive (3M 08237) into the adhesive applicator gun and install the adhesive mixer nozzle (3M 8193) or equivalent. See Figure 16.

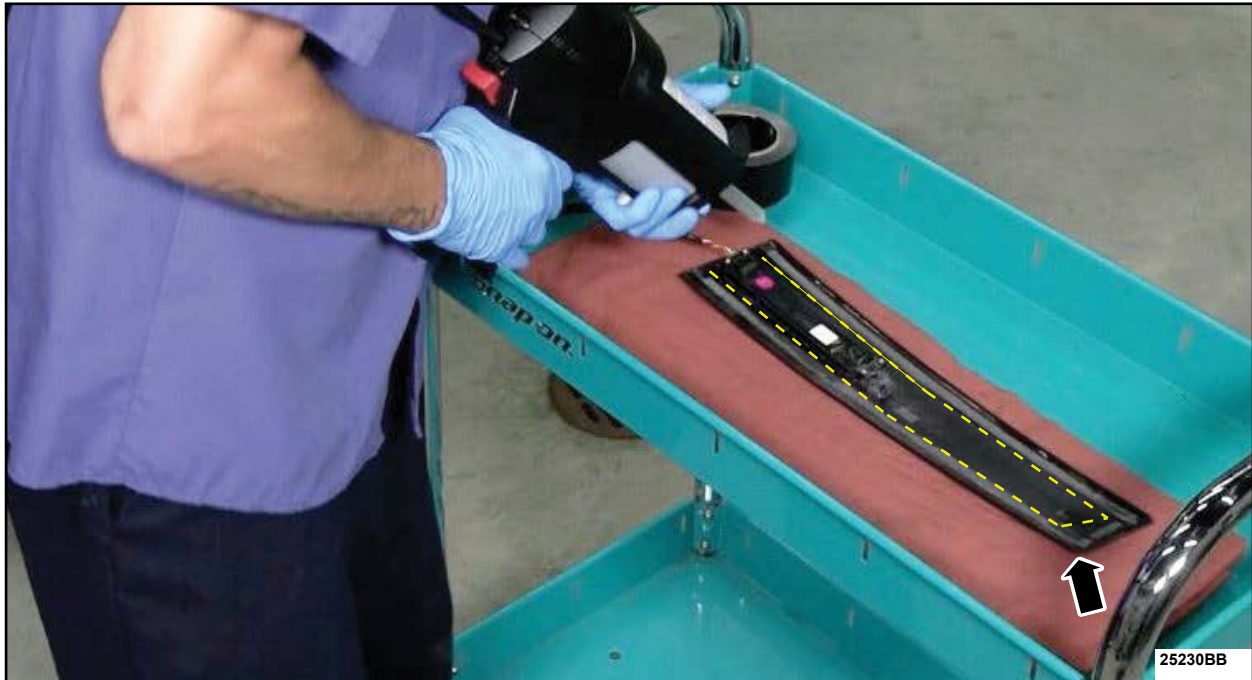
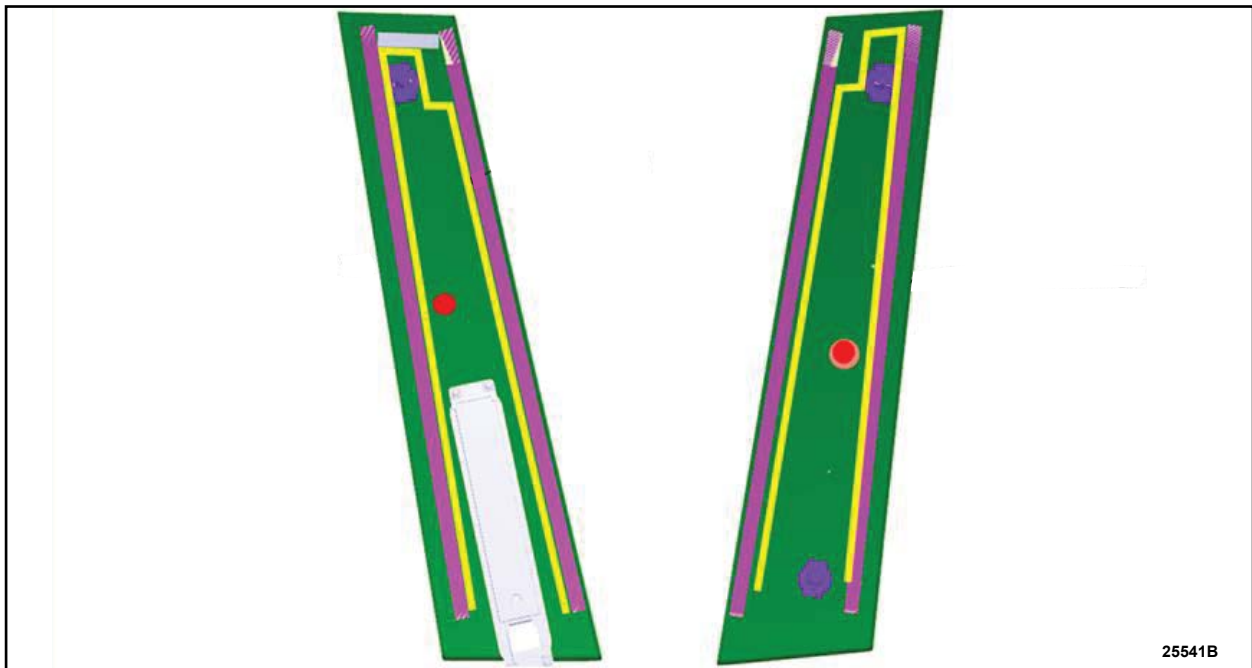
10. Using the adhesive applicator gun, apply the adhesive inboard of the original adhesive in the areas that were scuffed up in the previous step. See Figures 17 and 18.

NOTE: Make sure to follow the bead path shown in Figures 17 and 18. No adhesive should enter the window channel. The adhesive path should run close to the upper locator pin.

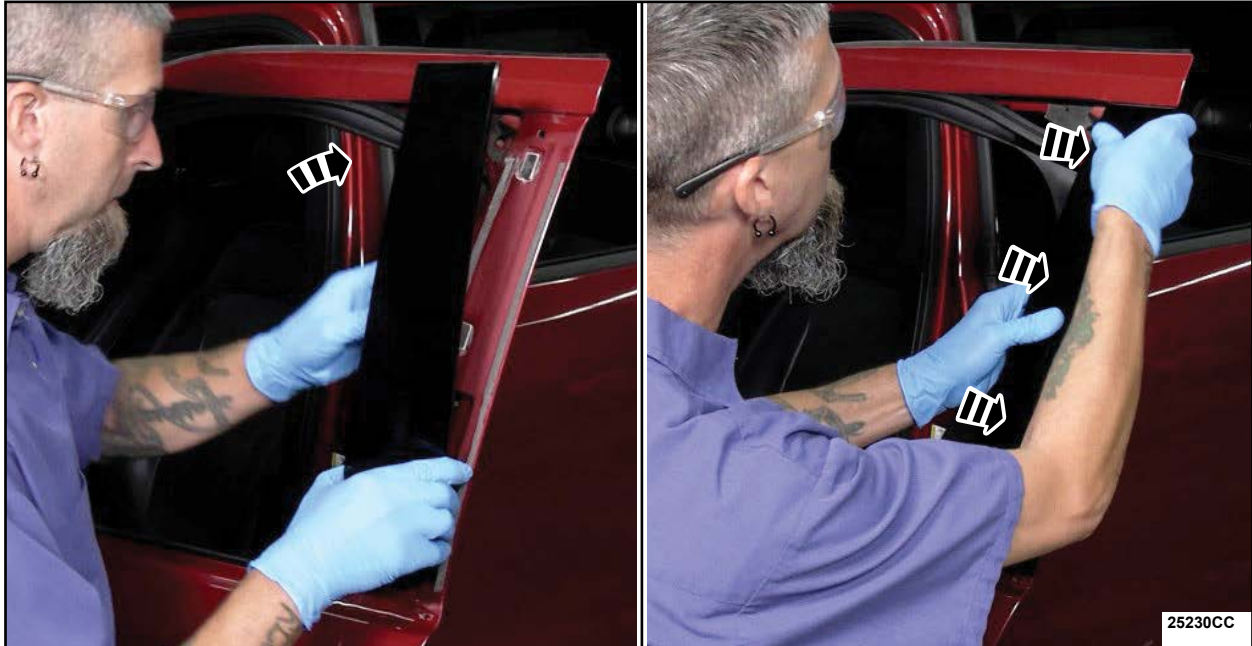
FIGURE 19

11. Install the B-pillar applique trim in place. Make sure the applique is adhered by pressing firmly on the applique from top to bottom. See Figure 19.

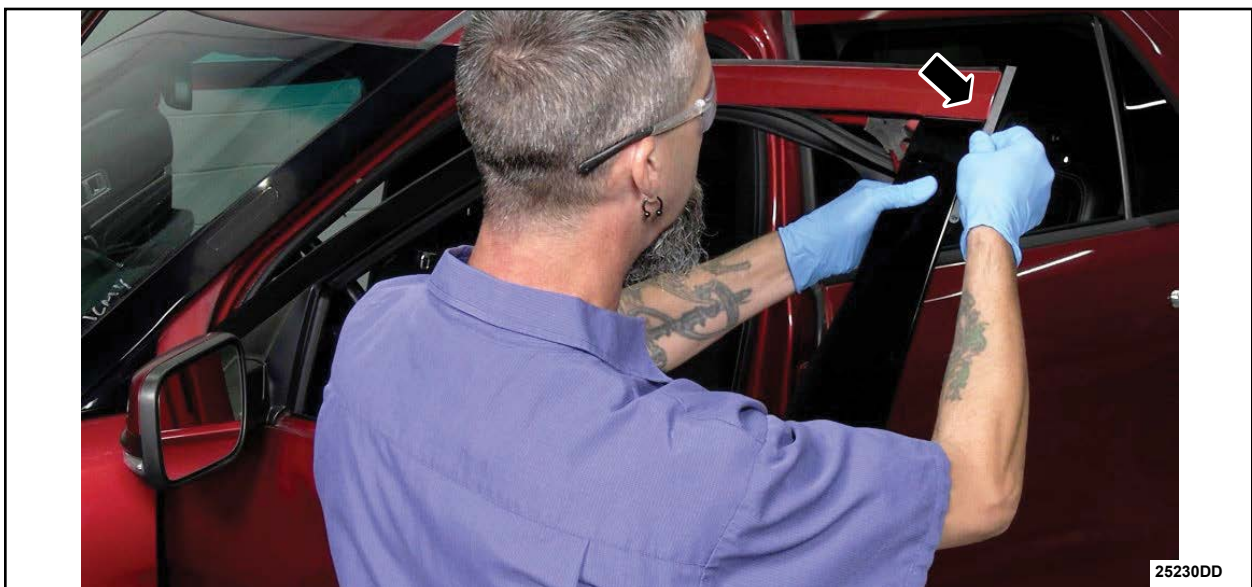
FIGURE 20

12. Using a ruler, align the outboard most upper edge of the B-pillar applique trim to the door panel as shown in Figure 20.

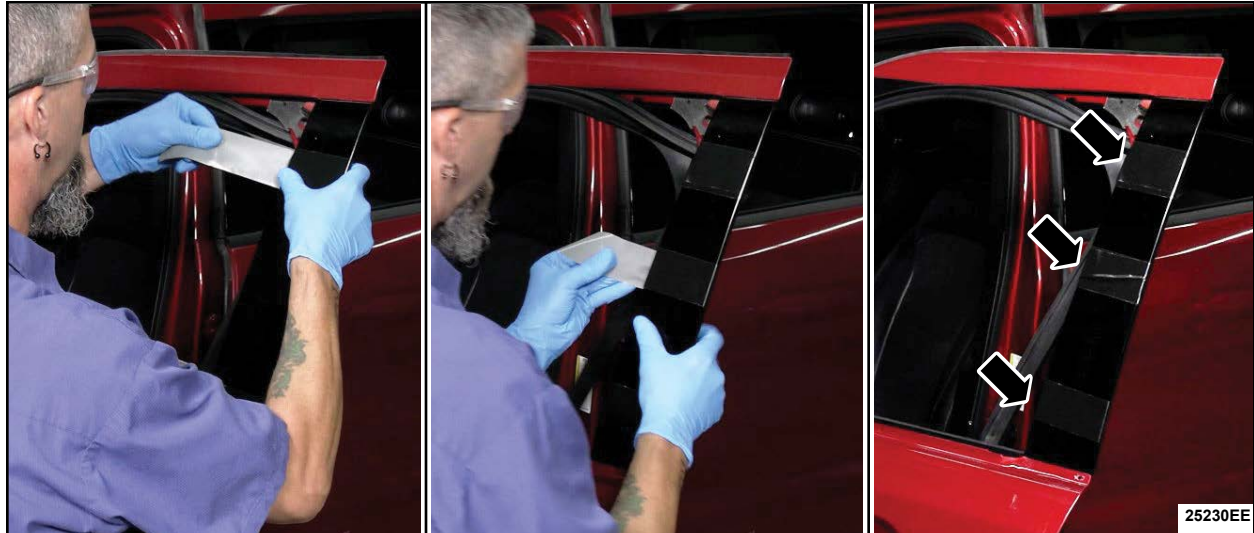
FIGURE 21

13. Clean off any excess adhesive.
14. Using body tape or equivalent, tape (at least 2 revolutions) around the top, middle, and bottom of the front B-pillar applique trim as shown in Figure 21.

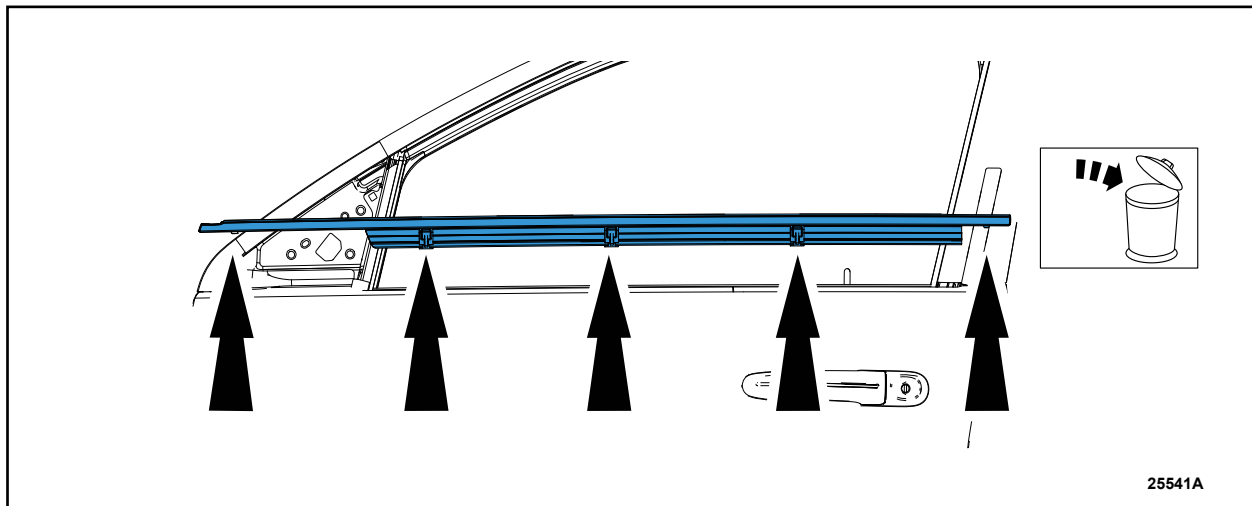
FIGURE 22

5. Using a non-marring trim tool, release the tabs, then lift up and remove and discard the exterior window glass moulding. See Figure 22.

23. Install the *new* exterior window glass moulding by reversing Step 5. See Figure 22.

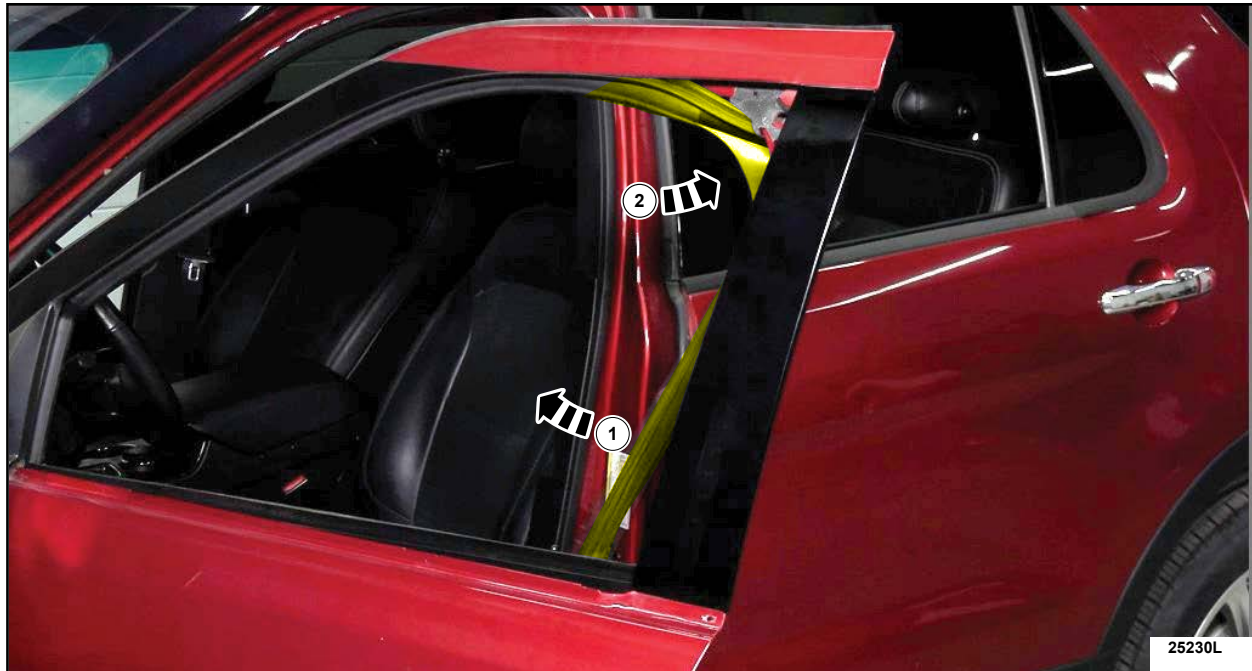
FIGURE 23

6. Position the front door glass fully open. Using care, remove just the upper B-pillar portion of the glass top run from the run channel and position aside as shown in Figure 23. Make sure the glass top run is positioned towards the inboard side of the door.

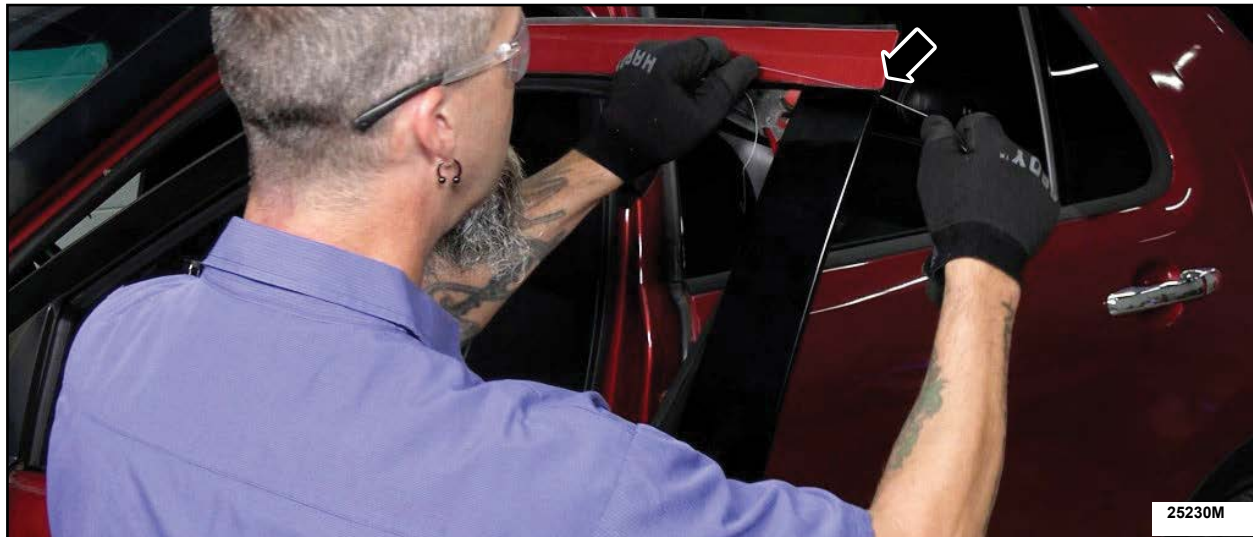
FIGURE 24

- a. Loop the fishing line around the top of the applique and in a sawing/back and forth motion, break through the tape adhesive until you feel resistance at the applique locator pin. See Figures 24 and 25.

NOTE: Left-hand side shown, right-hand side similar.

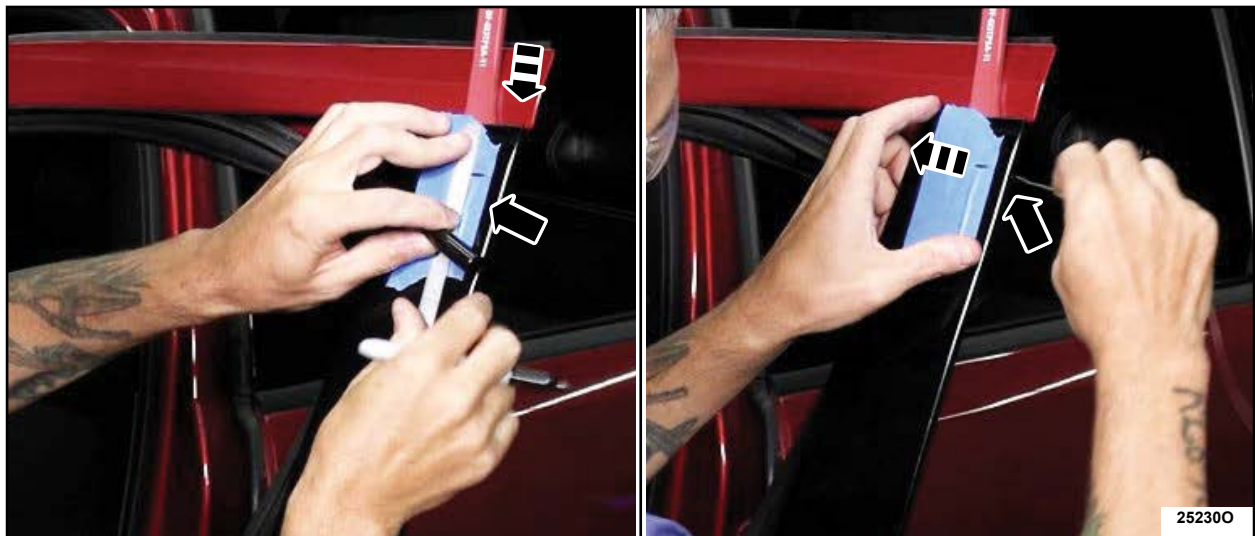
FIGURE 26

- d. Under the vertical line drawn on the masking tape, insert the mechanics wire or crochet hook vertically behind the applique. See Figure 26.
- e. Make a loop with the fishing line and attach it to the mechanics wire or crochet hook. Pull the mechanics wire or crochet hook behind the applique until the fishing line can be grabbed on the opposite side. Finish pulling the loop fully through and use scissors to cut the fishing line from the mechanics wire. See Figures 27 and 28, continue to the next step.

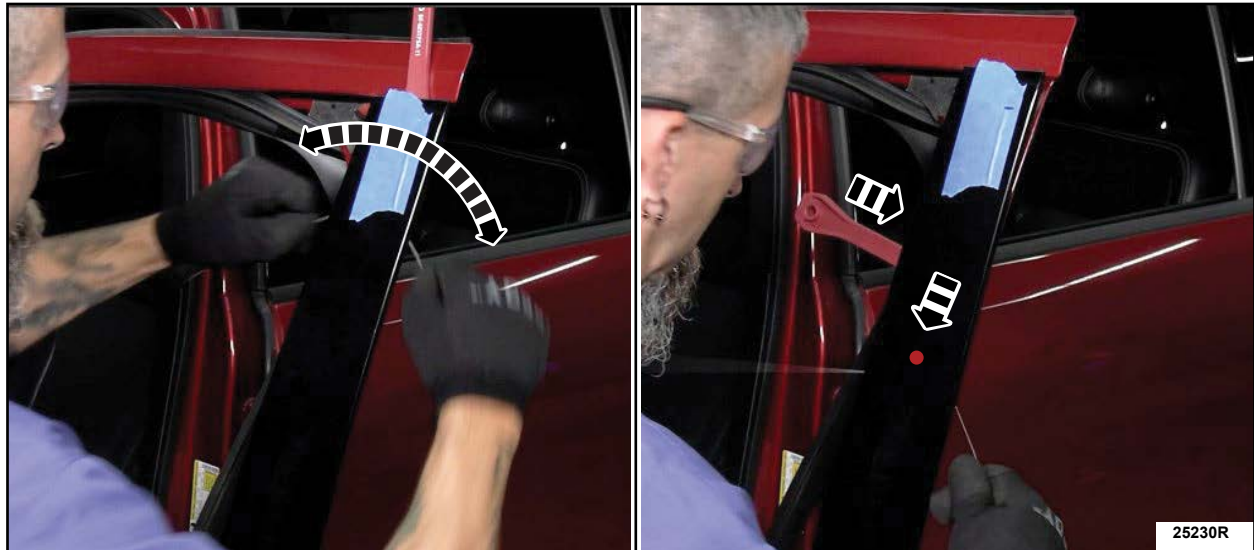
FIGURE 29

8. Continue using the fishing line to break the adhesive bond until you get half way down the applique and, if equipped with keyless entry keypad, make sure to stop above the keypad. See Figure 29.

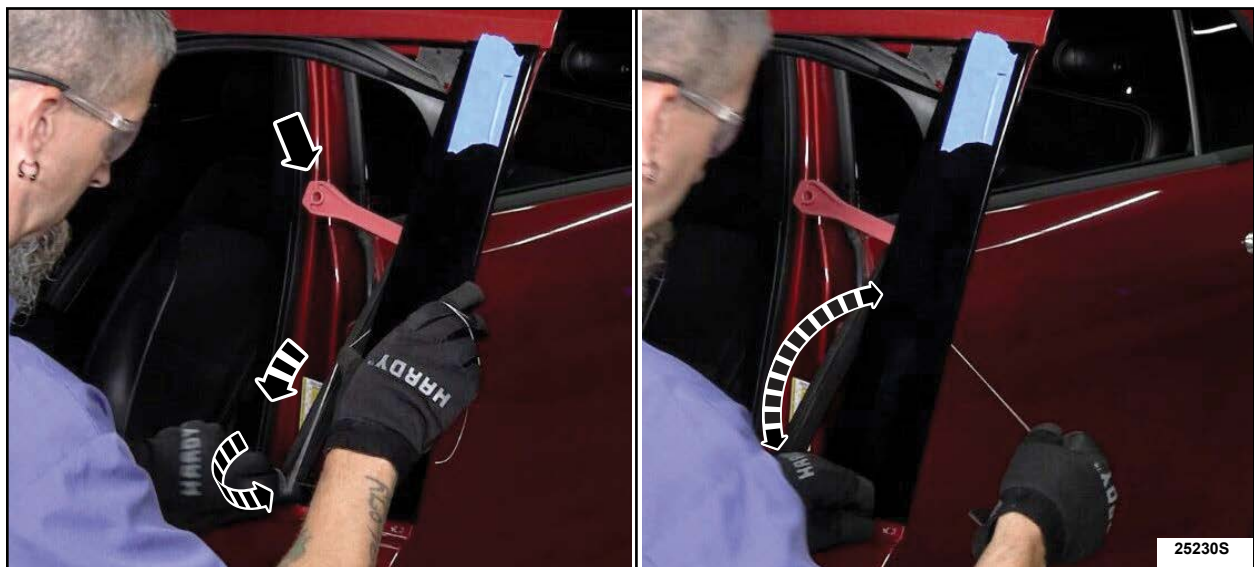
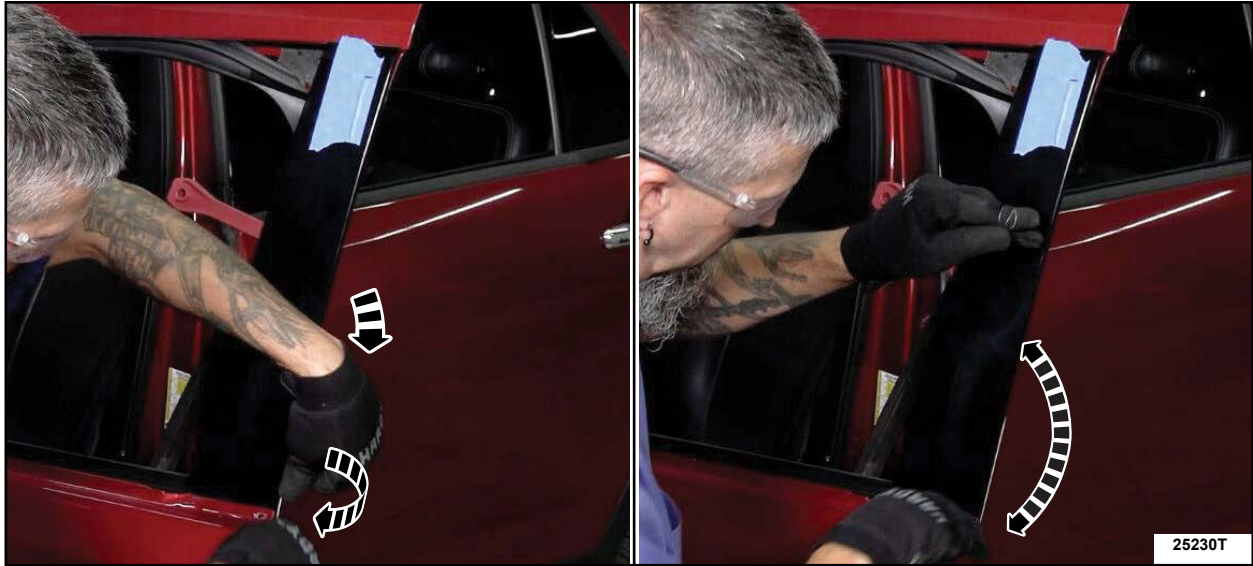
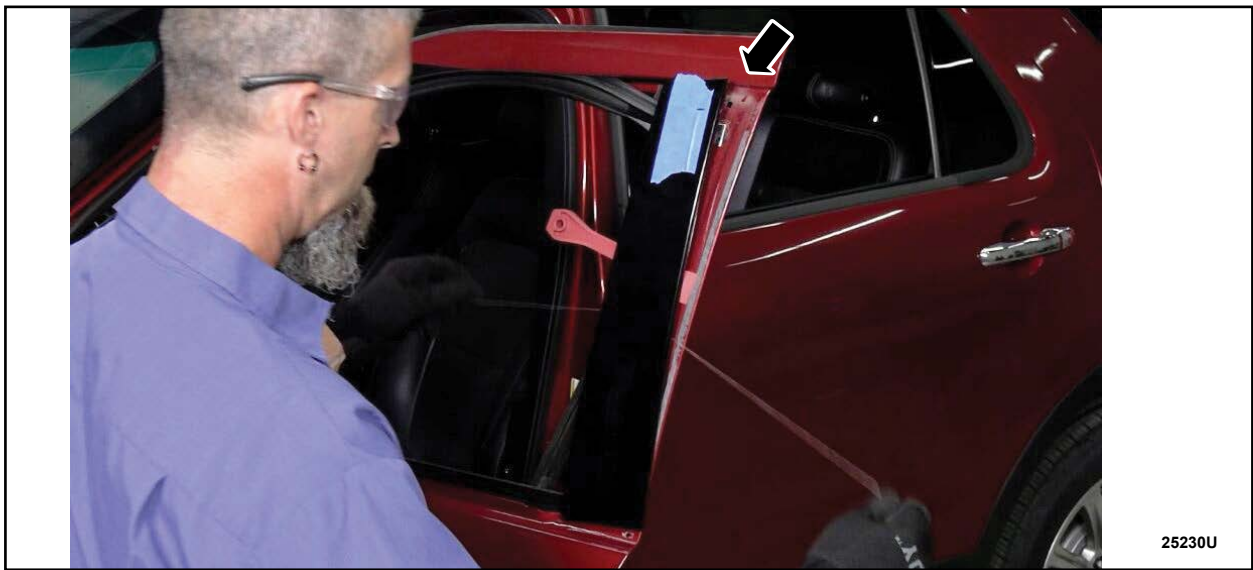
9. Wrap the inboard portion of the fishing line around the inboard lower portion of the applique and continue working around the applique releasing the inboard side of the applique then, wrap the outboard portion of the fishing line around the outboard lower portion of the applique and continue working around the applique until the applique releases from the door. See Figures 30, 31, and 32.

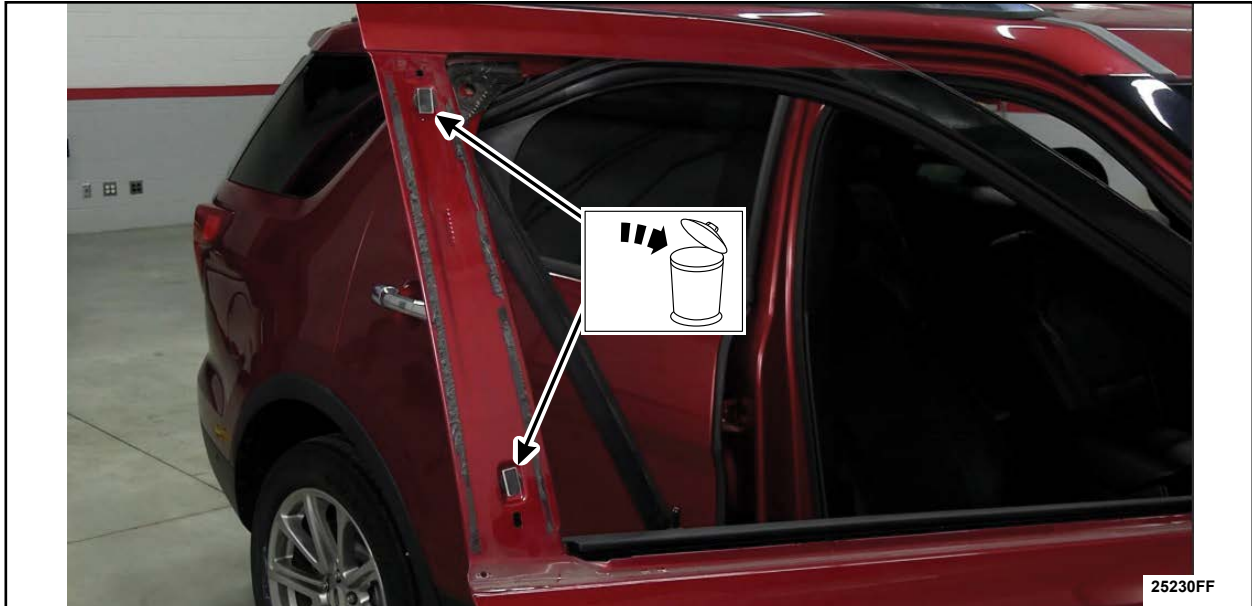
FIGURE 33

10. Remove and discard both retaining clips. See Figure 33.

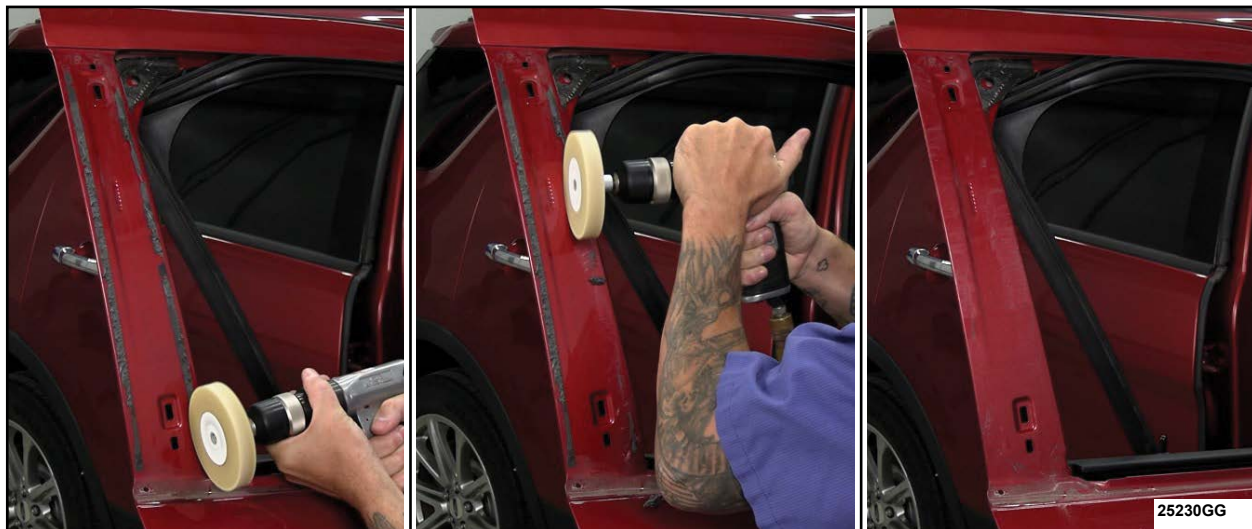
FIGURE 34

11. Using the stripe off wheel, remove the adhesive left behind from removing the applique. See Figure 34.

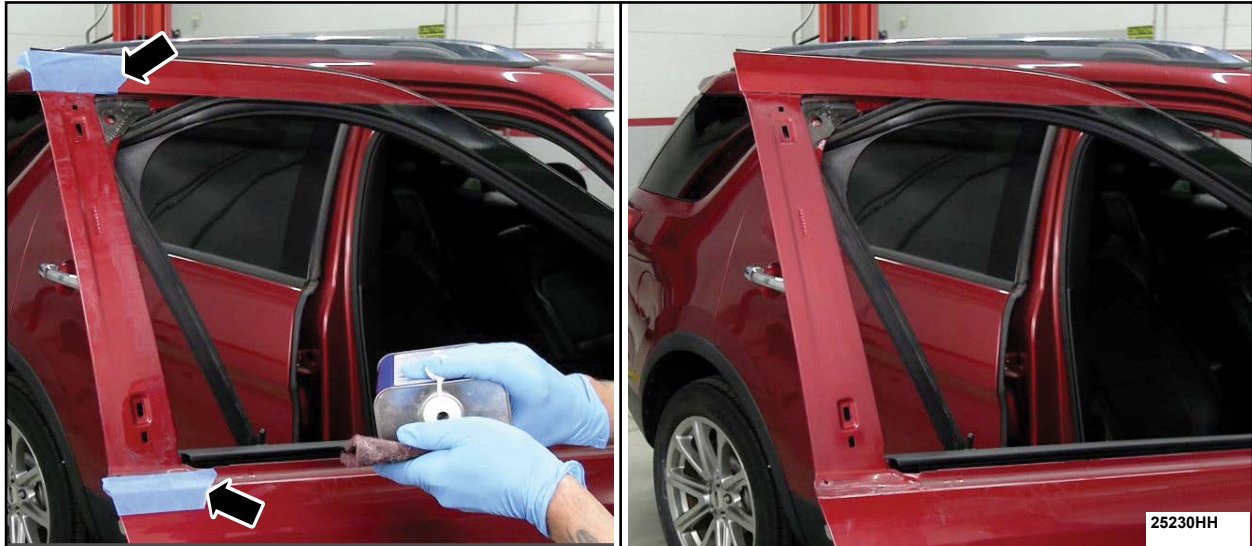
FIGURE 35

12. Apply masking/body tape to the painted surfaces above and below where the applique was removed from. Using isopropyl alcohol and a Scotch-Brite™ 7447 pad, thoroughly scuff the area where the applique was removed from. Then, using isopropyl alcohol and a shop towel, thoroughly clean and dry the area. See Figure 35.

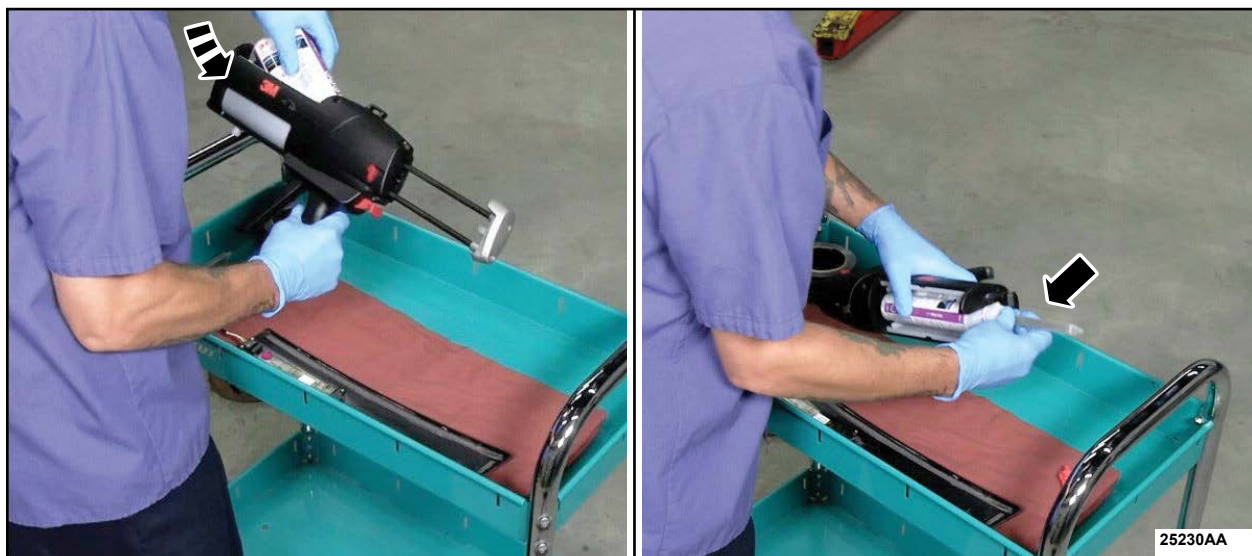
FIGURE 37

17. Load the repair adhesive (3M 08237) into the adhesive applicator gun and install the adhesive mixer nozzle (3M 8193) or equivalent. See Figure 37.
