Service Engineering Operations
Customer Service Division

SUBJECT: **NEW VEHICLE DEMONSTRATION / DELIVERY HOLD – Supplement #1**
Safety Recall 25S91
 Certain 2016-2019 Model Year Taurus Vehicles
 Exterior B-Pillar Applique Trim Repair/Replacement

CERTAIN 2016-2019 MODEL YEAR TAURUS VEHICLES — EXTERIOR B-PILLAR APPLIQUE TRIM REPAIR/REPLACEMENT

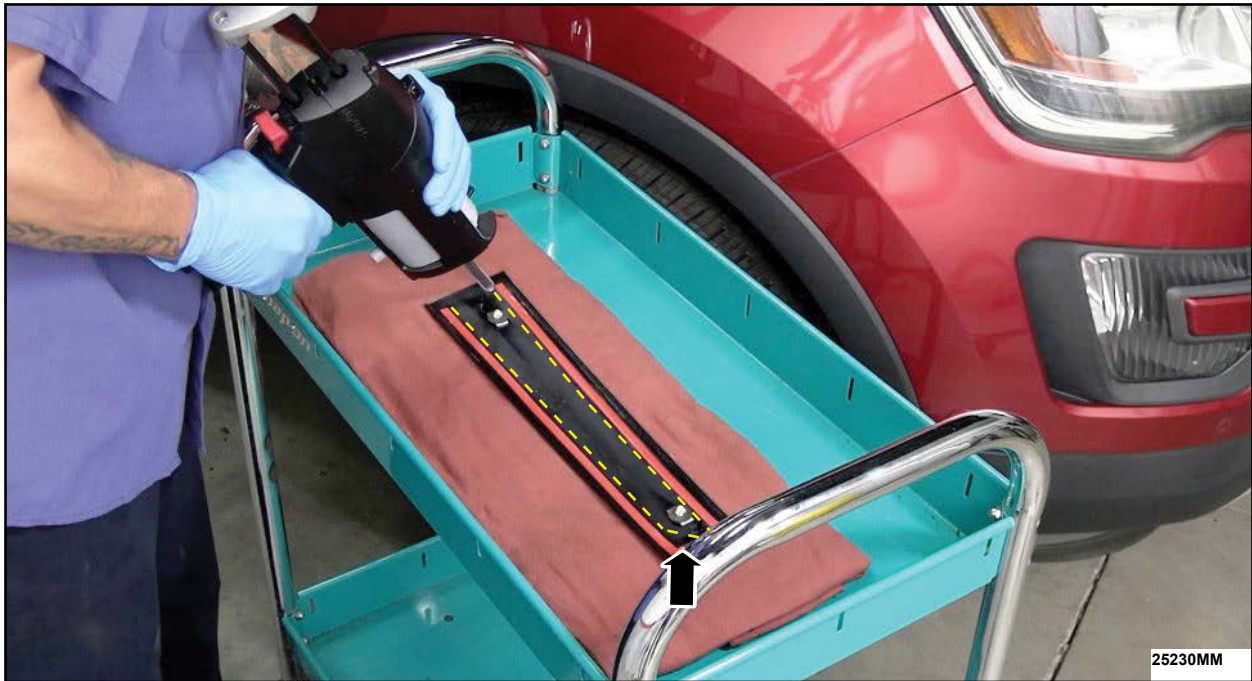
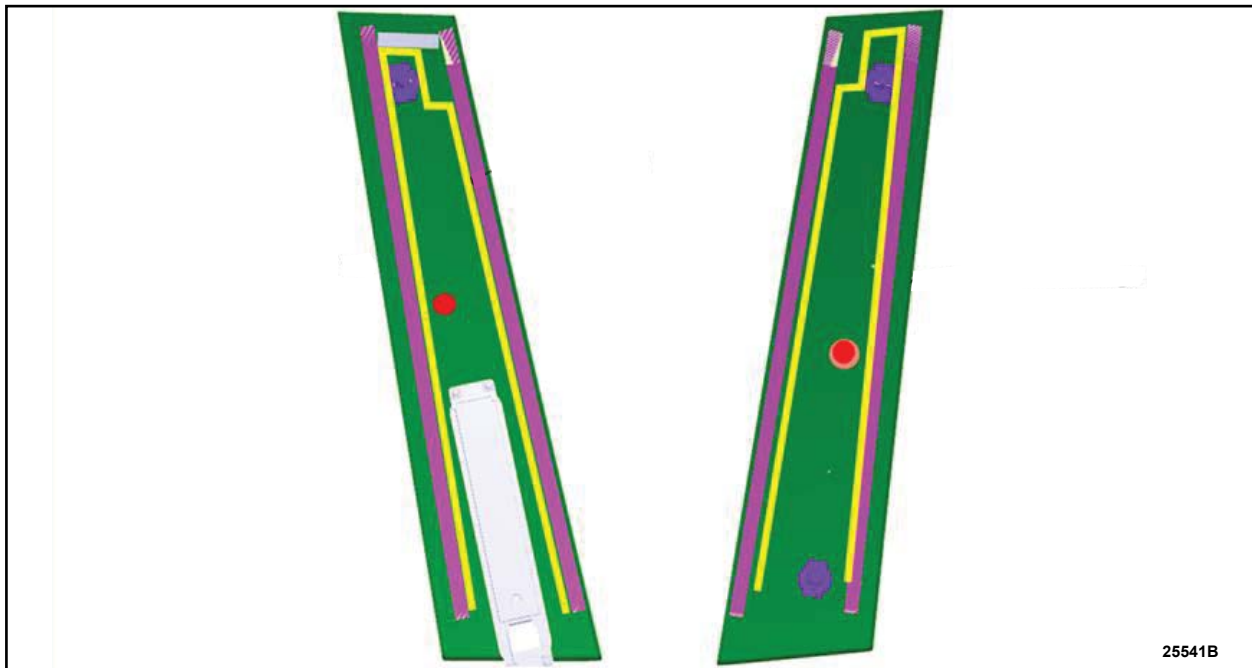
18. Using the adhesive applicator gun, apply the adhesive inboard of the original adhesive in the areas that were scuffed up in the previous step. See Figures 38 and 39.

NOTE: Make sure to follow the yellow highlighted bead path shown in Figures 38 and 39. No adhesive should enter the window channel. The adhesive path should run close to the upper locator pin.

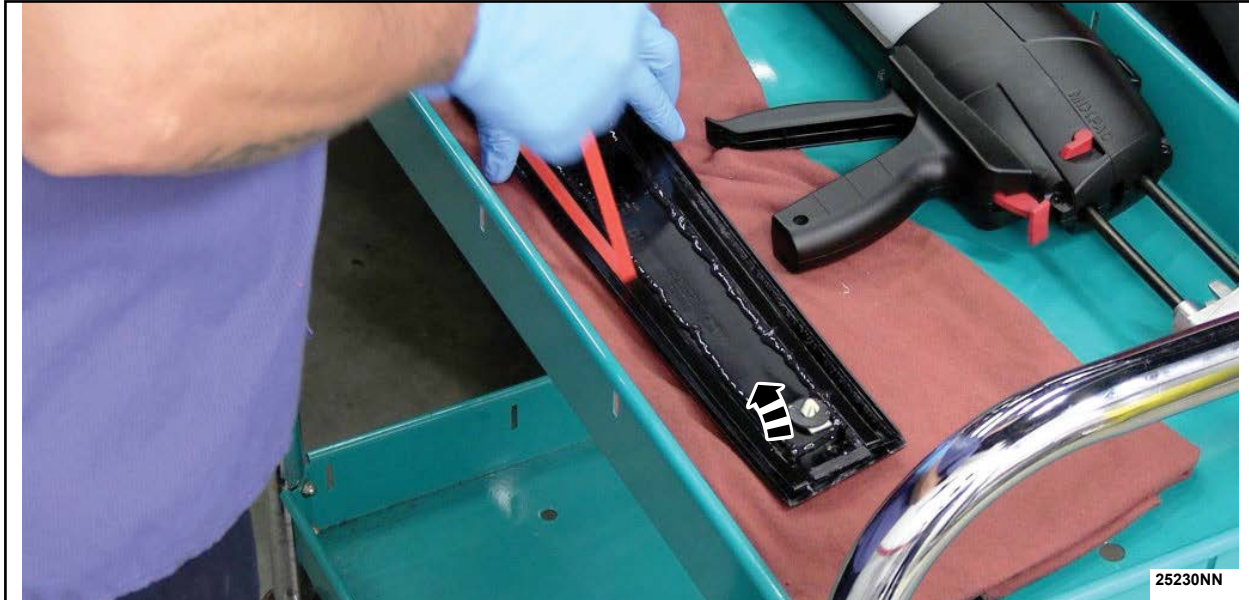
FIGURE 40

19. Remove the tapes protective film. See Figure 40.

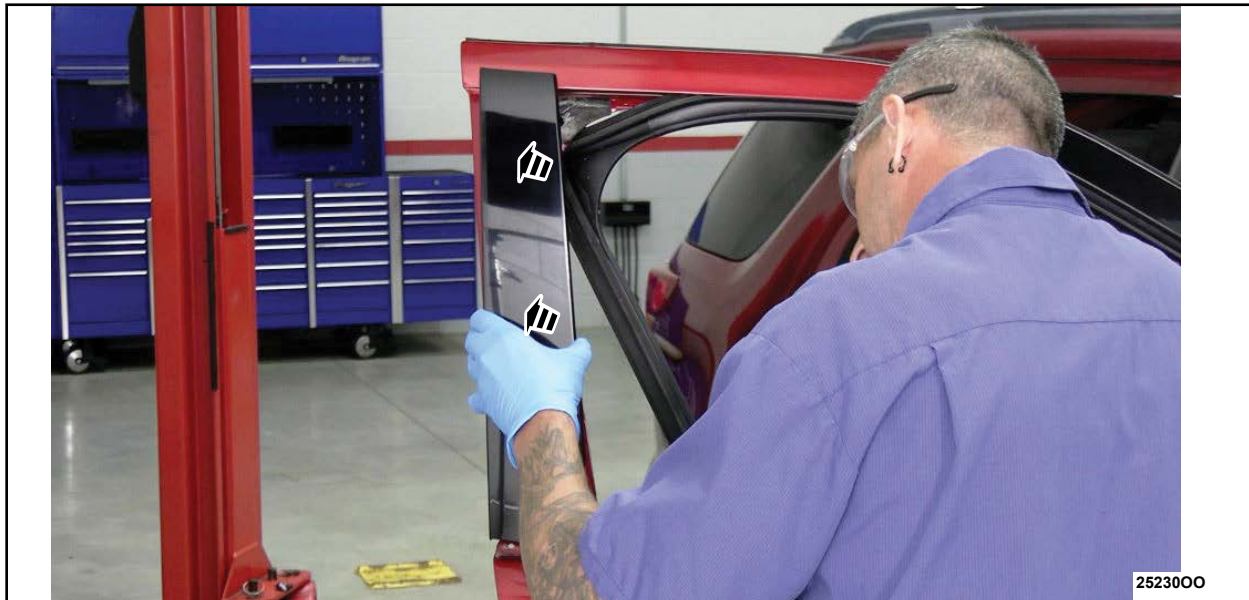
FIGURE 41

20. Align the alignment tabs and install the front door trim applique in place. Make sure the applique is adhered by pressing firmly on the applique from top to bottom. See Figure 41.

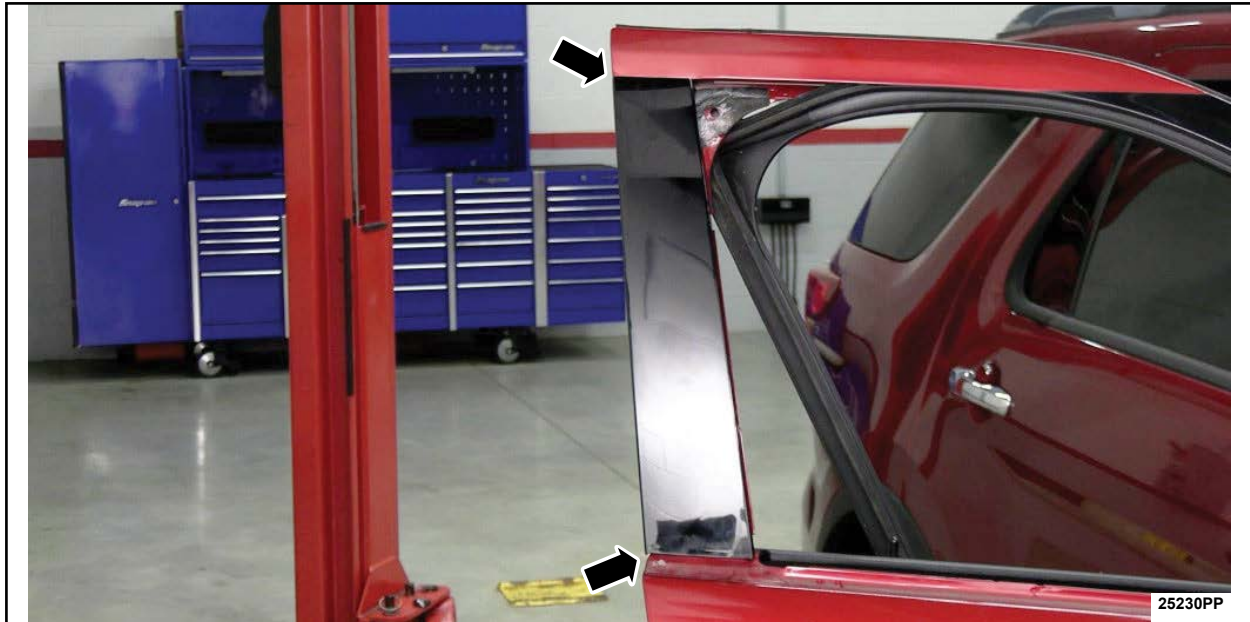
FIGURE 42

21. Clean off any excess adhesive. See Figure 42.
22. Let the adhesive dry for a total of 4 hours. After one (1) hour of dry time, continue to the next step. Then, let it dry for the other 3 hours before returning the vehicle to the customer.
