Service Engineering Operations
Customer Service Division

SUBJECT: **NEW VEHICLE DEMONSTRATION / DELIVERY HOLD**
Safety Recall 25S92
Certain 2015-2017 Model Year Mustang Vehicles
Seat Belt Anchor Pretensioner Inspection

REF : **NEW VEHICLE DEMONSTRATION / DELIVERY HOLD - Advance Notice –**
Safety Recall 25S92 - Supplement #1
Dated: October 16, 2025

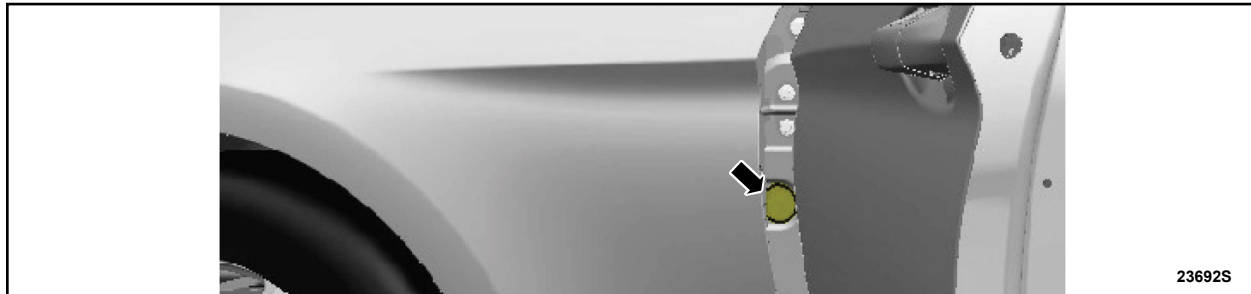
FIGURE 1

1. On both sides, fully open the front doors.
2. On both sides, inspect the A-pillar body hole. See Figure 1.

NOTE: Left hand (LH) side shown, right hand (RH) side similar.

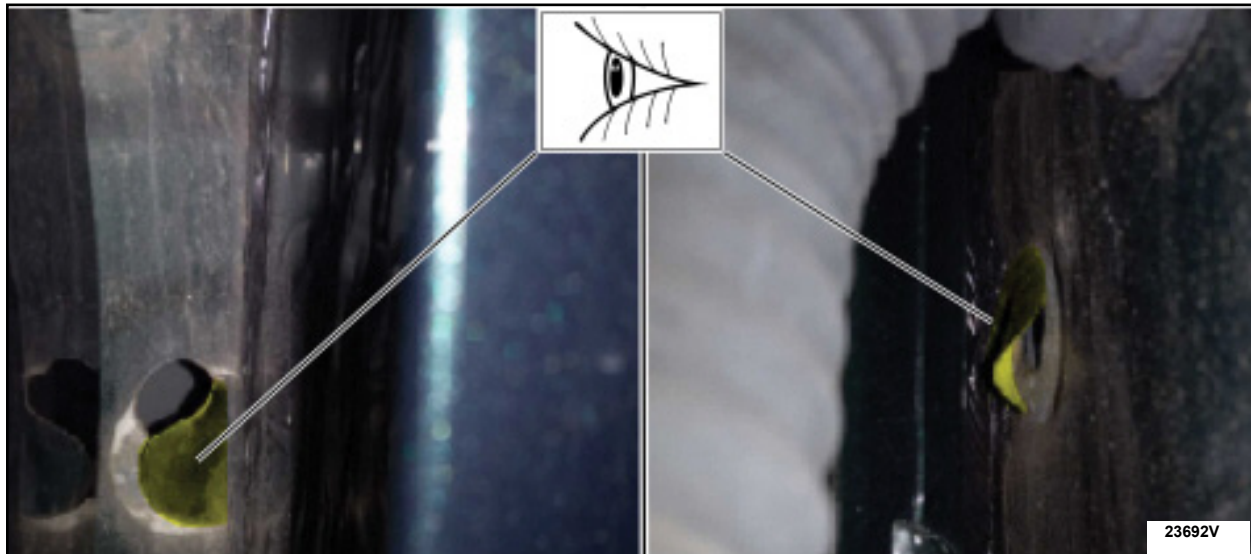
FIGURE 2

3. On both sides, inspect the fender insulator to be sure it does not restrict access to the A-pillar body sticker seal. If the fender insulator covers any portion of the A-pillar body sticker seal, the foam fender insulator can be slightly indented to allow for unobstructed access to the A-pillar body sticker seal.
4. On both sides, inspect and record the condition (complete 360-degree adhesion to the sheet metal, loose and/or missing) of the A-pillar body sticker seal. See Figure 2.

NOTE: The A-pillar body sticker seals are an adhesive patch that seals a 19 mm (0.75 in.) diameter hole in the sheet metal.

NOTE: Loose A-pillar body sticker seals shown.

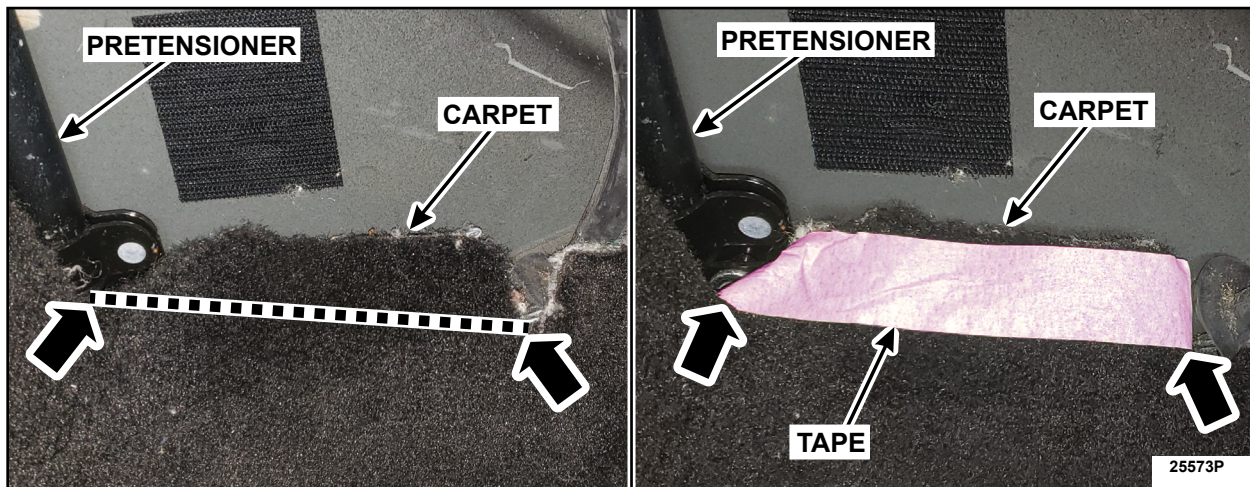
FIGURE 3

11. On both sides, remove the loadspace trim panel. Follow Workshop Manual (WSM) procedures in Section 501-05.
 12. On both sides, apply tape to the carpet in the area shown. See Figure 3.

NOTE: LH side shown, RH side similar.

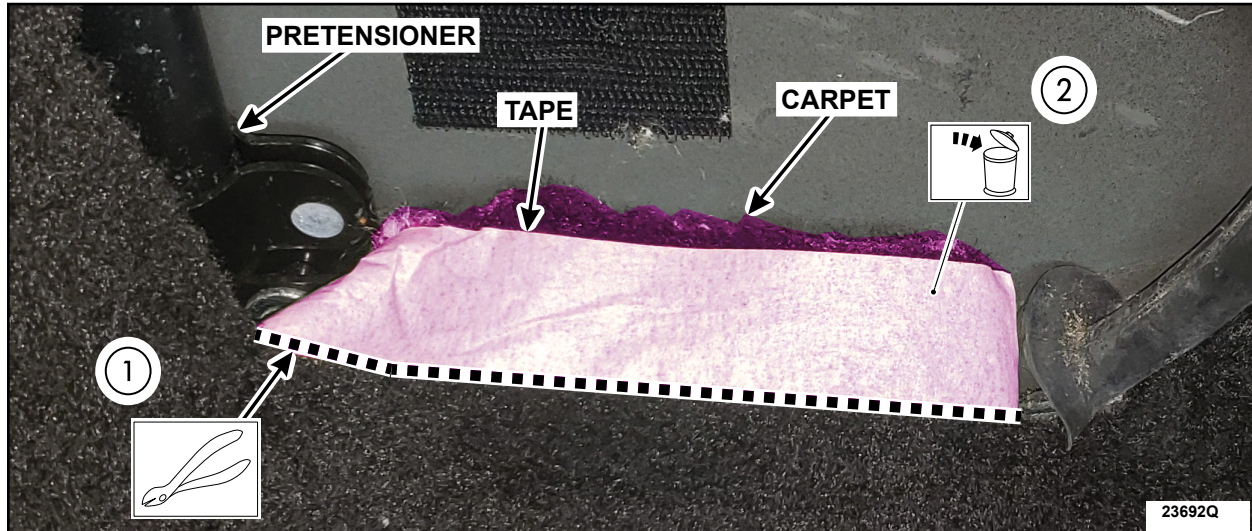
FIGURE 4

13. On both sides, carefully cut the carpet along the tape (1). Remove and discard the cut section of carpet (2). See Figure 4.

NOTE: LH side shown, RH side similar.

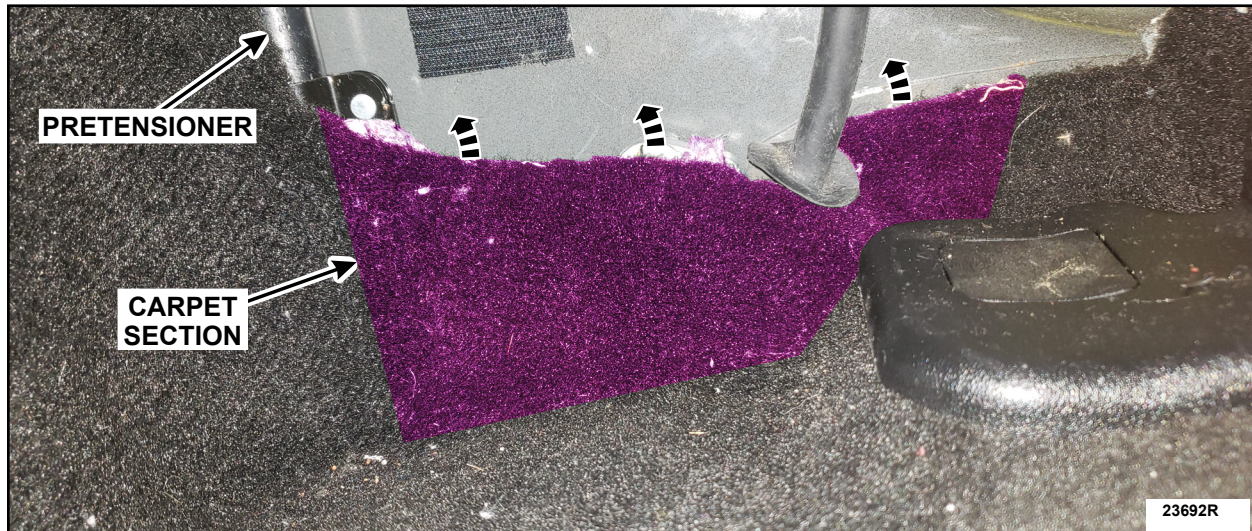
FIGURE 5

14. In the specified carpet section, position the carpet and remove and discard the foam insulation from the underside on both sides of the vehicle. See Figure 5.

NOTE: It is possible to remove the foam insulation by hand by pulling it off the underside of the carpet.

NOTE: LH side shown, RH side similar.

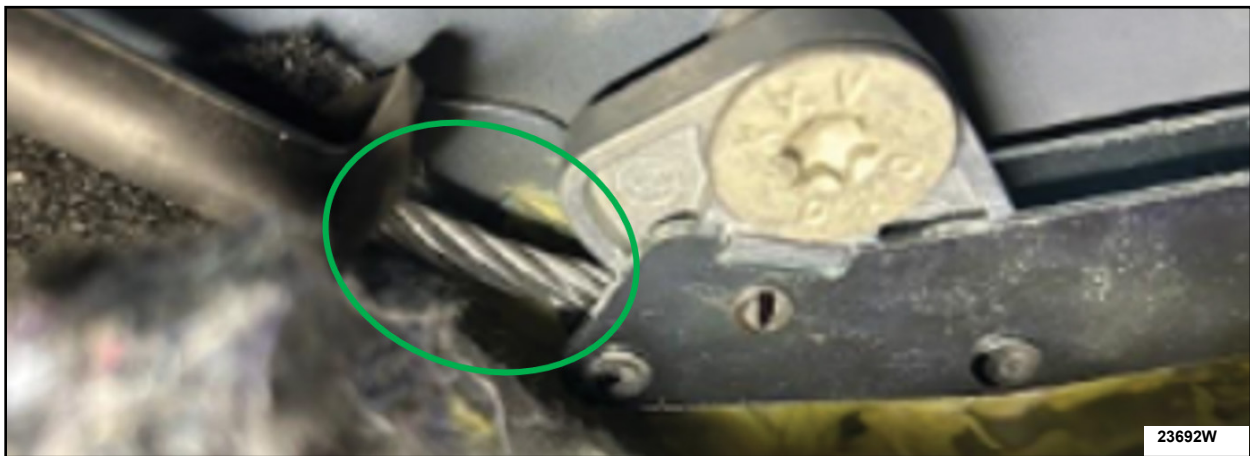
FIGURE 6

15. On both sides, visually inspect the steel braided cable on the seat belt pretensioner and the surrounding area for signs of rust and/or corrosion. See Figures 6-9.

- On either side, is red rust present on the steel braided cable of the seat belt pretensioner and/or a significant amount of corrosion present on the surrounding components?

NOTE: RH side shown, LH side similar.

Yes - Red rust is present on the steel braided cable of the seat belt pretensioner and/or a significant amount of corrosion is present on the steel braided cable and/or surrounding components - Does not pass inspection - Proceed to Step 16.

No - There is no red rust present on the steel braided cable of the seat belt pretensioner and there is not a significant amount of corrosion present on the steel braided cable and/or surrounding components - Passes Inspection - Proceed to Step 17.

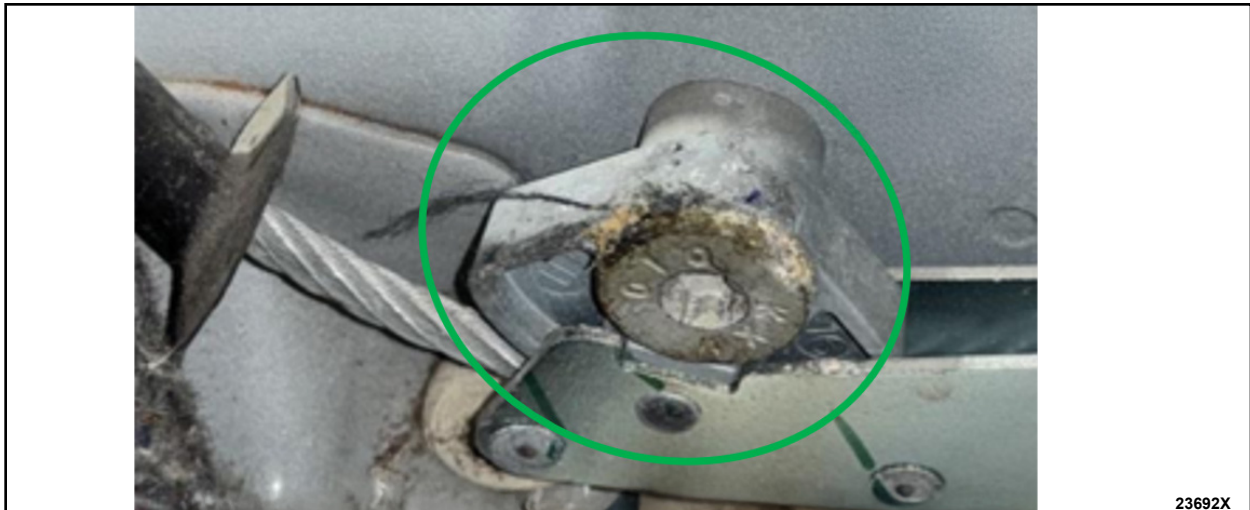
FIGURE 7

NOTE: A small amount of white dusty surface rust on the steel braided cable and surrounding components is acceptable. See Figure 7.

NOTE: RH side shown, LH side similar.

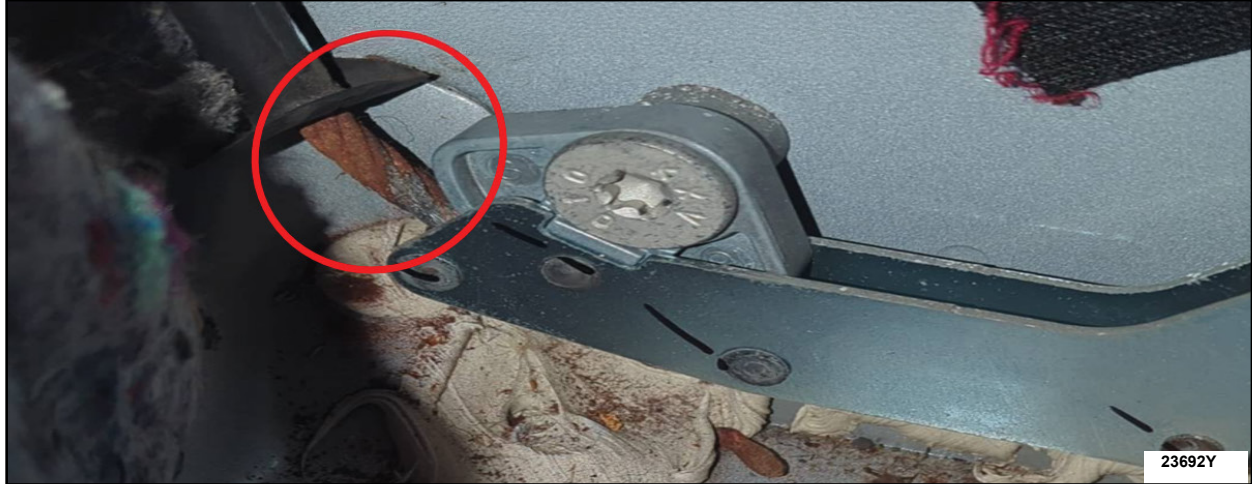
FIGURE 8

NOTE: Any amount of red rust on the steel braided cable is NOT acceptable and does not pass inspection. See Figure 8.

NOTE: RH side shown, LH side similar.

16. Capture a clear photo of the red rust that is present on the steel braided cable of the seat belt pretensioner(s) and/or the significant amount of corrosion that is present on the steel braided cable(s) and/or surrounding components.

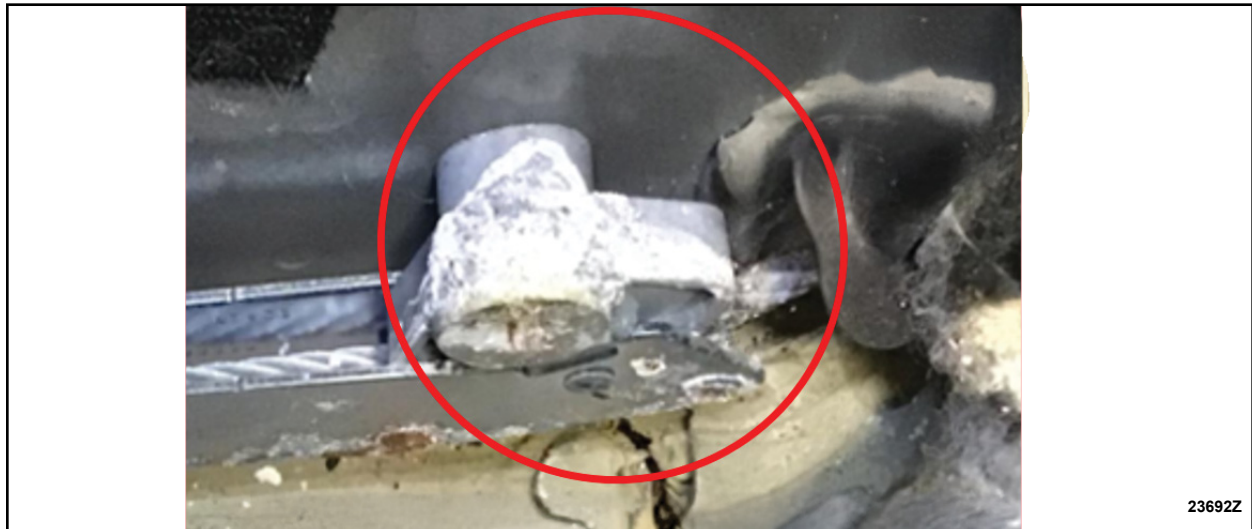
FIGURE 9

NOTE: A significant amount of white rust on the steel braided cable and/or surrounding components is NOT acceptable and does not pass inspection. See Figure 9.

NOTE: RH side shown, LH side similar.

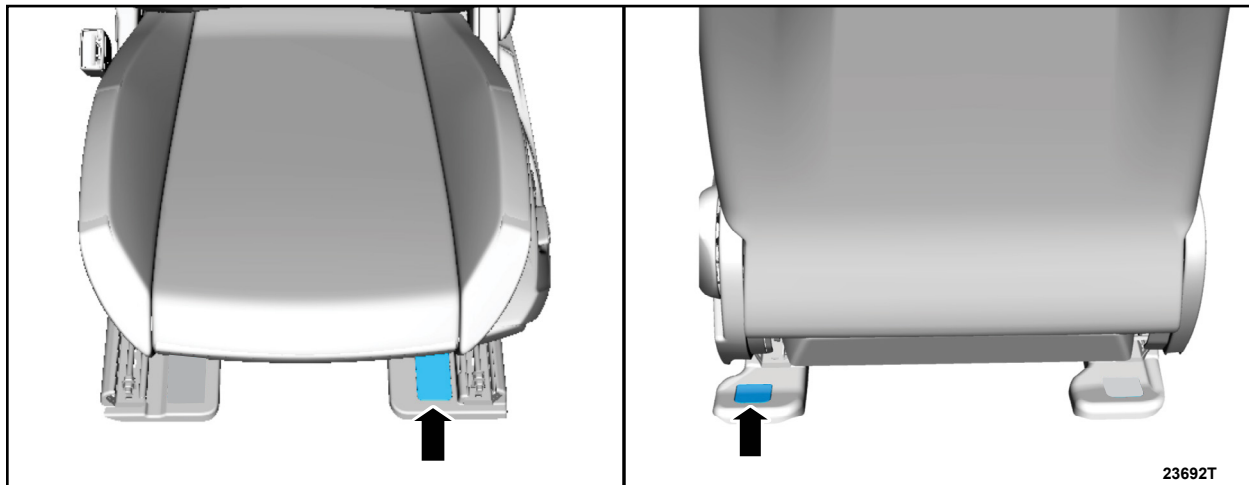
FIGURE 10

18. On both sides, remove the front seat outboard shield bolt caps. See Figure 10.

NOTE: LH side shown, RH side similar.

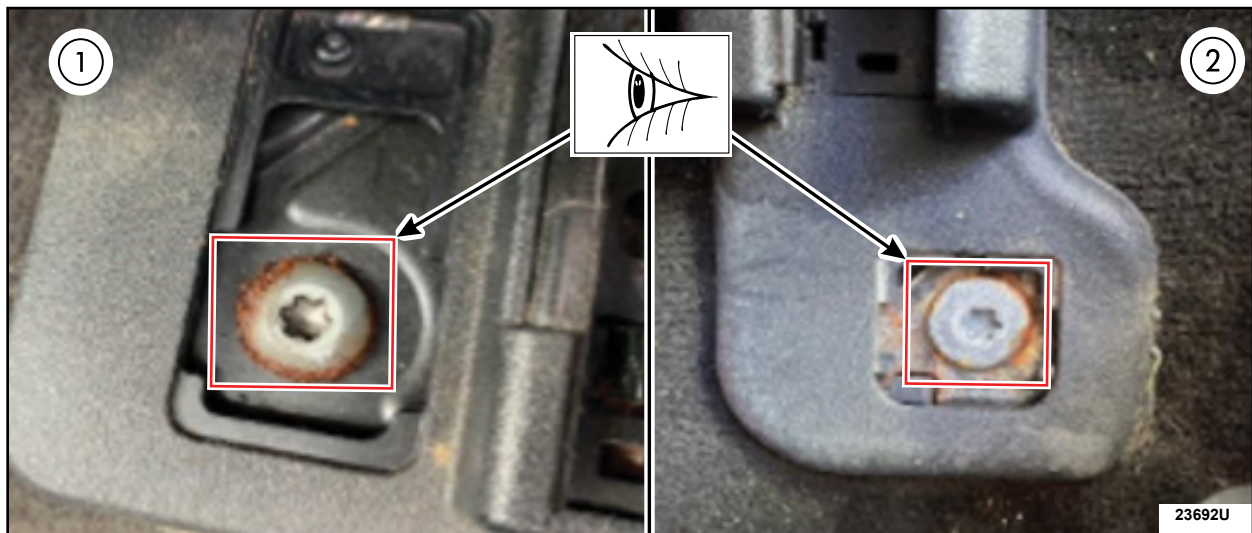
FIGURE 11

19. On both sides, inspect the outboard seat track bolts for rust.

- Is red rust present on the lower surface of the bolt and seat track bracket mounting surface? See Figure 11.

NOTE: On the LH side seat, the bolts being inspected for rust are the left front and the left rear outboard seat track bolts. On the RH side seat, the bolts being inspected for rust are the right front and the right rear outboard seat track bolts.

NOTE: Front LH side outboard seat track bolt (1) shown on left, Rear RH side seat track bolt shown (2) on right, all others similar.

20. Only replace the affected outboard seat track bolt(s) one at a time.

NOTE: It may be necessary to replace up to 4 (four) bolts in total.
