Service Engineering Operations  
Customer Service Division

**TO:** All U.S. Ford and Lincoln Dealers  
**SUBJECT:** **NEW VEHICLE DEMONSTRATION / DELIVERY HOLD**  
**Safety Recall 25SD9**  
Certain 2022-2025 Model Year Transit Battery Electric Vehicles (BEV)  
Left-Hand Rear Halfshaft Inspection

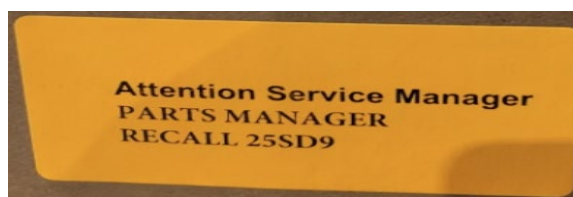
**NOTE:** Due to initial limited availability of the 25SD9 special tools, one (1) tool set will be seed stocked starting with dealers that have Unsold VINs assigned on their FSA VIN List. All dealers with an unsold VIN will receive their tool set by April 10, 2026. The box will have an orange label with "Attention Service Manager / PARTS MANAGER / RECALL 25SD9".

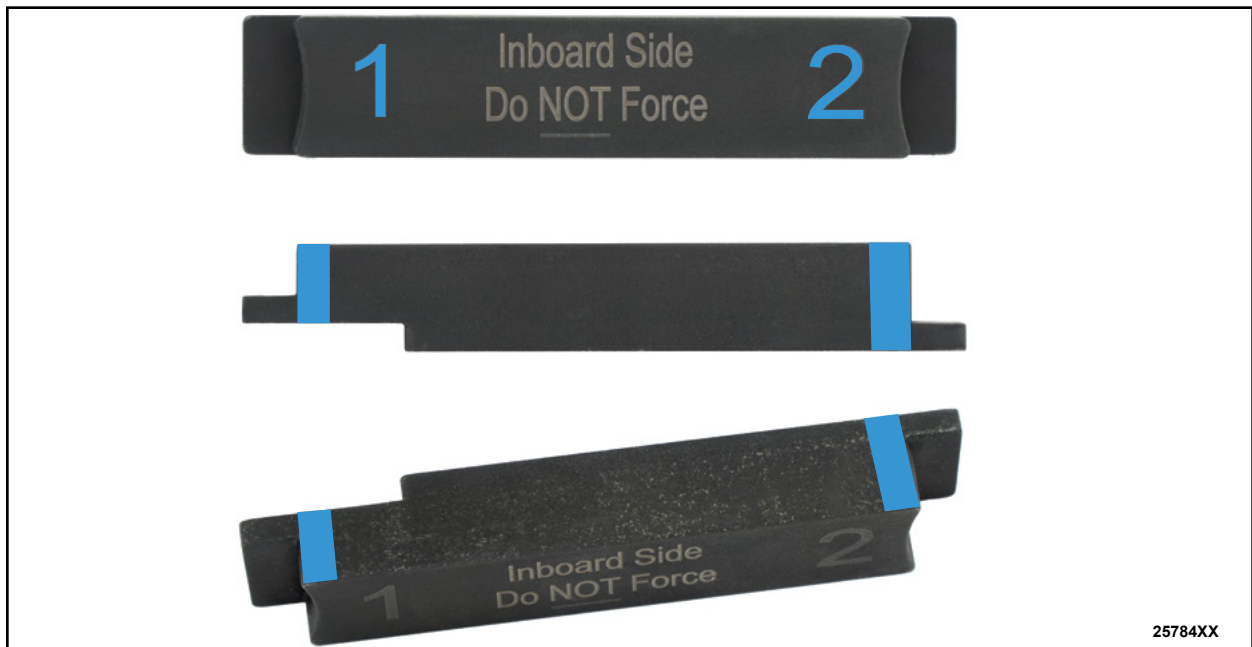
FIGURE 1

1. Position on a **DRIVE-ON** hoist is recommended. Follow the WSM procedures in Section 100-02.
  - Place the Vehicle in "Stay in Neutral Mode", Follow the WSM procedure in 307-05A.
  - Set the Parking Brake to off and **CHOCK** the wheels.
2. Inspect two-sided gauge details and see Figure 1:
  - **Do Not** force gauge to fit.
  - The gauge has two gauging ends (1 and 2).
  - The side with the gauge numbers on it (1 or 2) goes towards the inboard side of vehicle.
  - The blue highlighted areas, on the lower 2 gauges in Figure 1, are the critical measurements.

25SD9 Tool List	
Two-Sided Gauge - OTC SR-300648 See Technical Instruction, Figure 1 for a picture.	Metal Band Clamp 3.5 - 5.0 in. Diameter (89 - 139MM). Replacements to be obtained locally as needed.

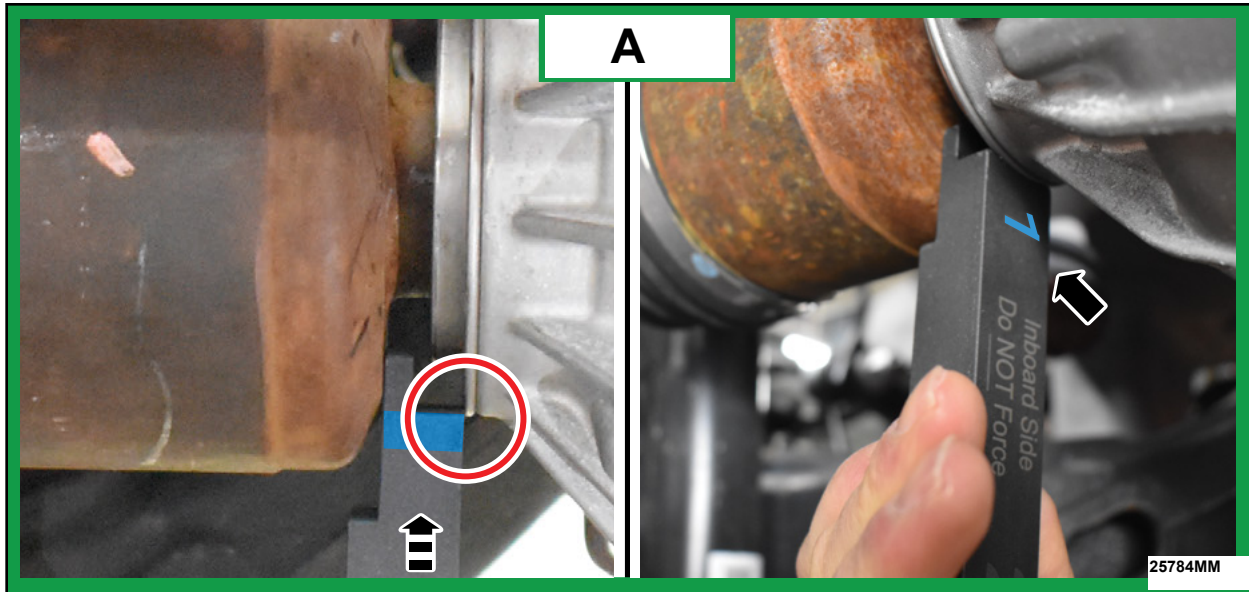
FIGURE 2

[ **A** ] **Does NOT fit** - Side 1 does NOT fit in gap, interference. Proceed to Step 47.

[ **B** ] **Fits** - Side 1 fits in gap. Proceed to the next Step.

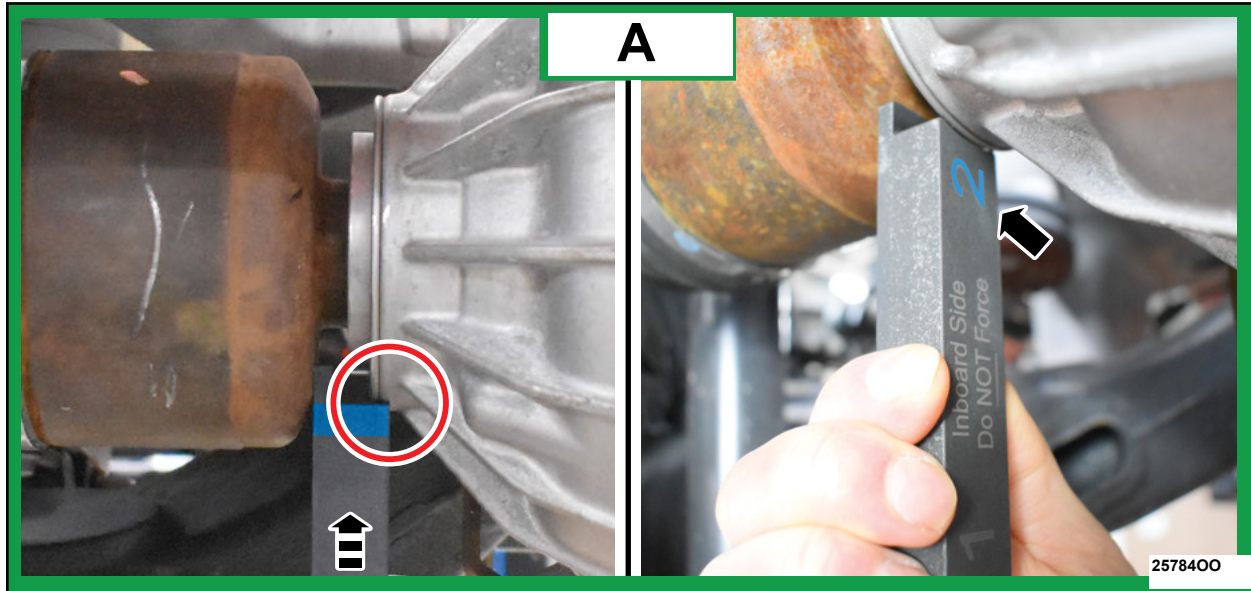
FIGURE 4

5. Without forcing, does gauge **Side 2** fit in the gap as shown in Figures 4 and 5?  
- Between the bottom (6 o'clock position) of the LH rear halfshaft and rear electric drive assembly.

[ **A** ] **Does NOT Fit** - Side 2 does NOT fit in gap, interference. Proceed to the next Step.  
[ **B** ] **Fits** - Side 2 fits in gap. Proceed to Step 9 (Page 6).

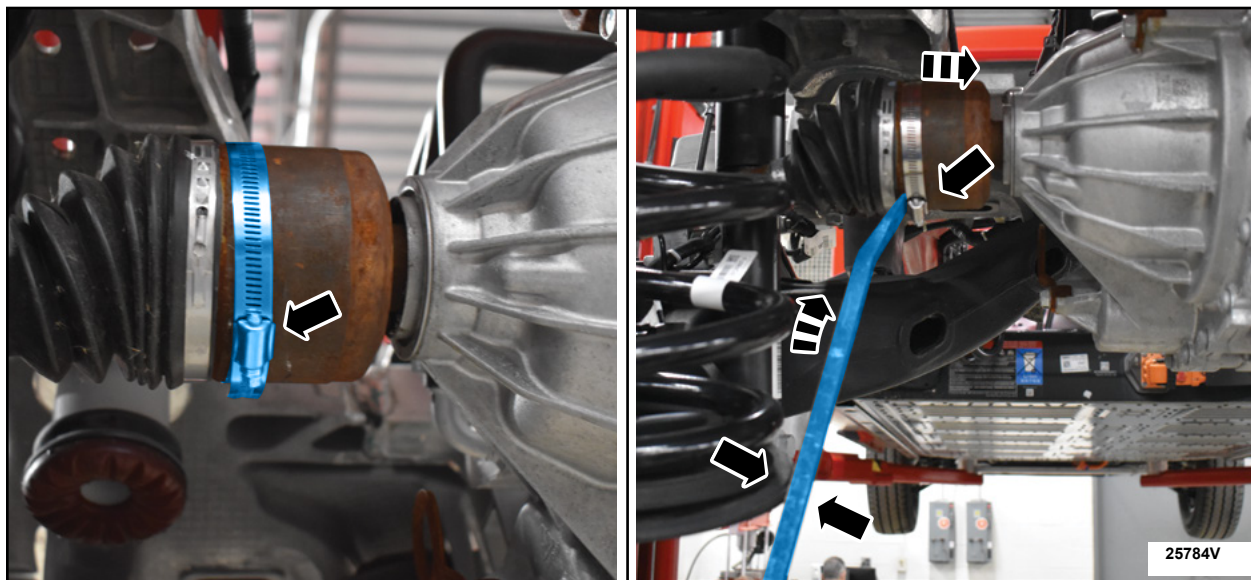
**FIGURE 6**

**NOTE:** Position worm nut as shown in Figure 6 to avoid damage to rubber boot.

- Position a long pry bar, to pivot off of the rear lower spring plate.
- The halfshaft should visibly move inboard and a noticeable click from circlip may be heard.
- If resistance, rotate halfshaft and readjust clamp position.
- See Figure 6. Proceed to next Step.

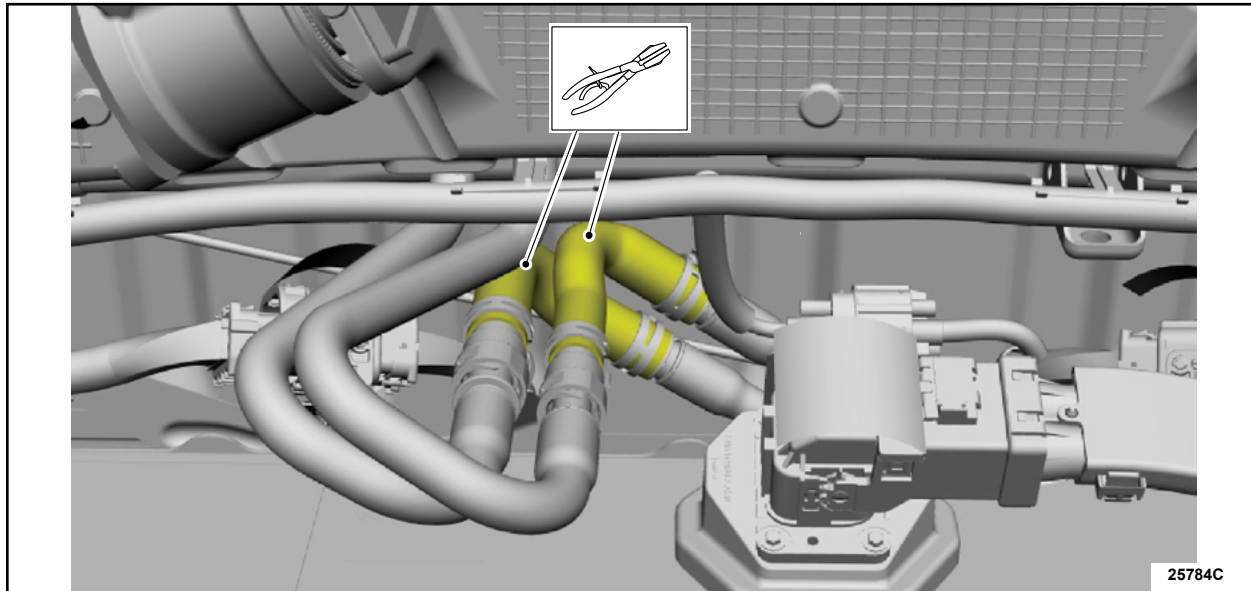
**FIGURE 7**

11. Clamp the cooling hoses to the rear electric drive assembly. See Figure 7.

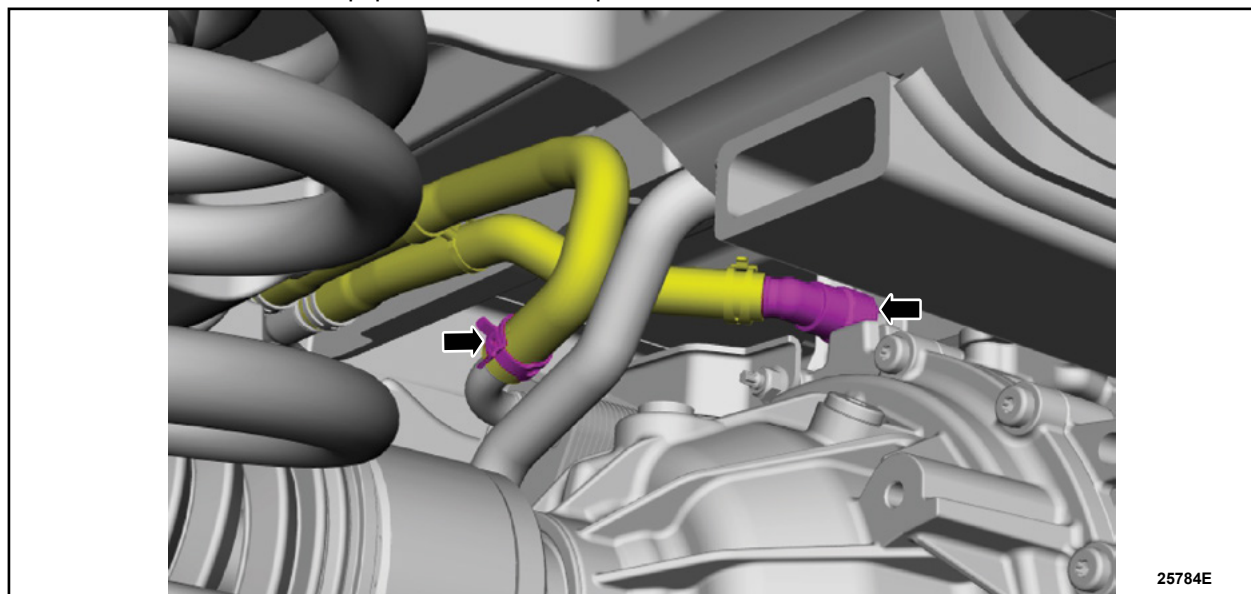
**FIGURE 8**

12. Disconnect the rear electric drive assembly cooling hoses. See Figure 8.

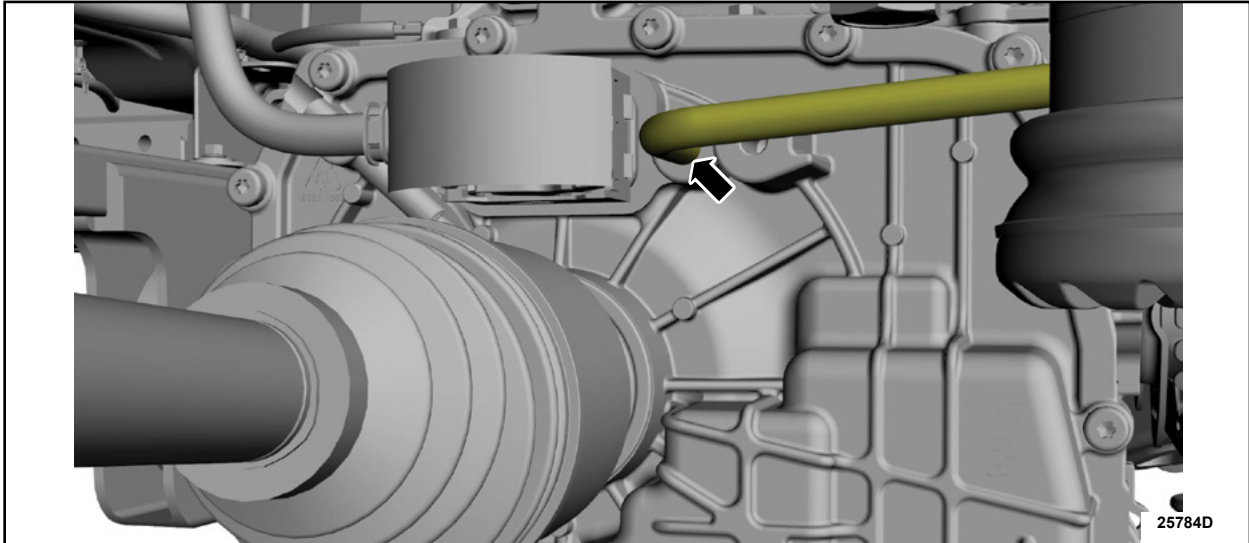
**FIGURE 9**

13. Disconnect the rear electric drive assembly vent hose and position aside. See Figure 9.

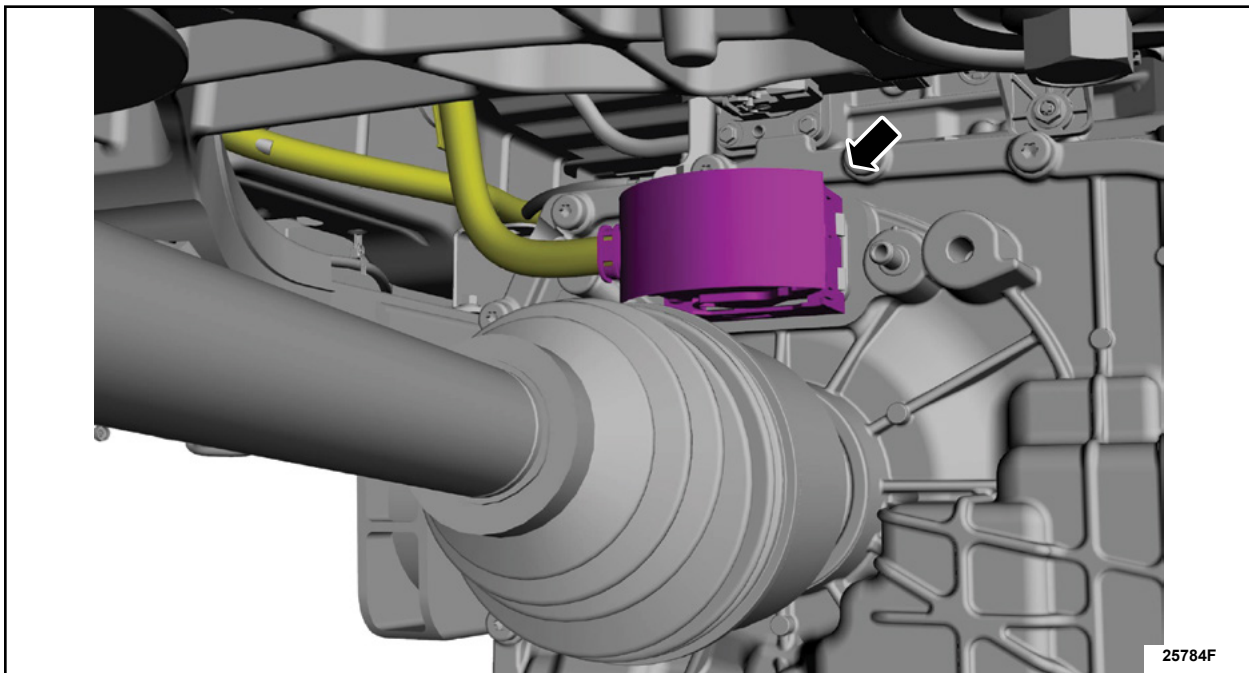
**FIGURE 10**

14. Clean the electrical connector with a nylon brush and compressed air. Then, release the lock lever and disconnect the electrical connector. See Figure 10.

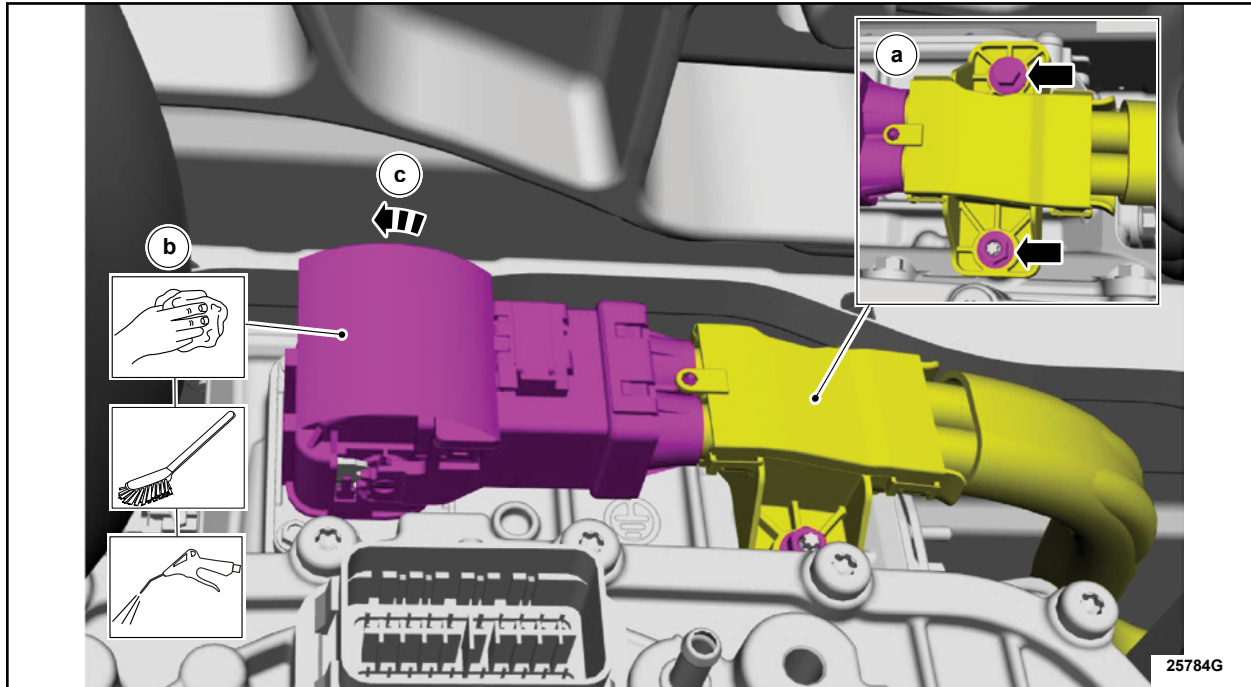
FIGURE 11

b. Clean the high voltage battery electrical connector with a nylon brush and compressed air.  
c. Release the lock lever and disconnect the high voltage electrical connector.

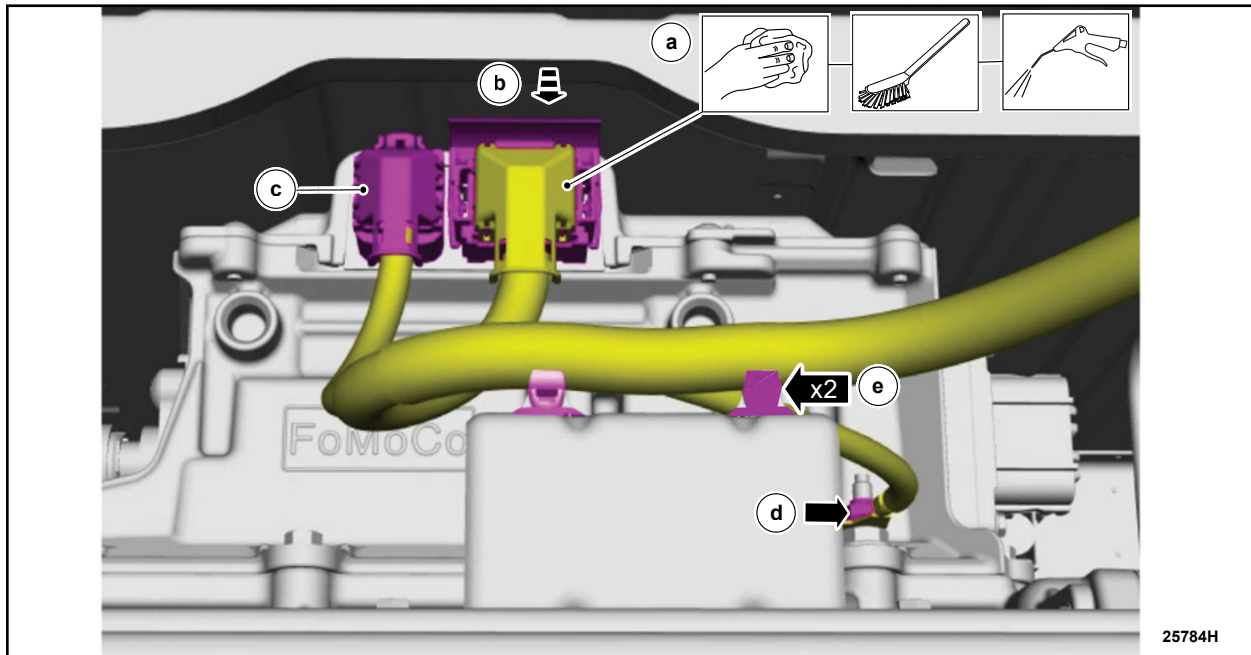
FIGURE 12

16. Position aside the electrical connector. See Figure 12.

- a. Clean the electrical connector with a nylon brush and compressed air.
- b. Release the lock lever and disconnect the electrical connector.
- c. Release the tabs and disconnect the electrical connector.
- d. Remove the nut and position aside the ground wire.
- e. Detach the harness retainers.

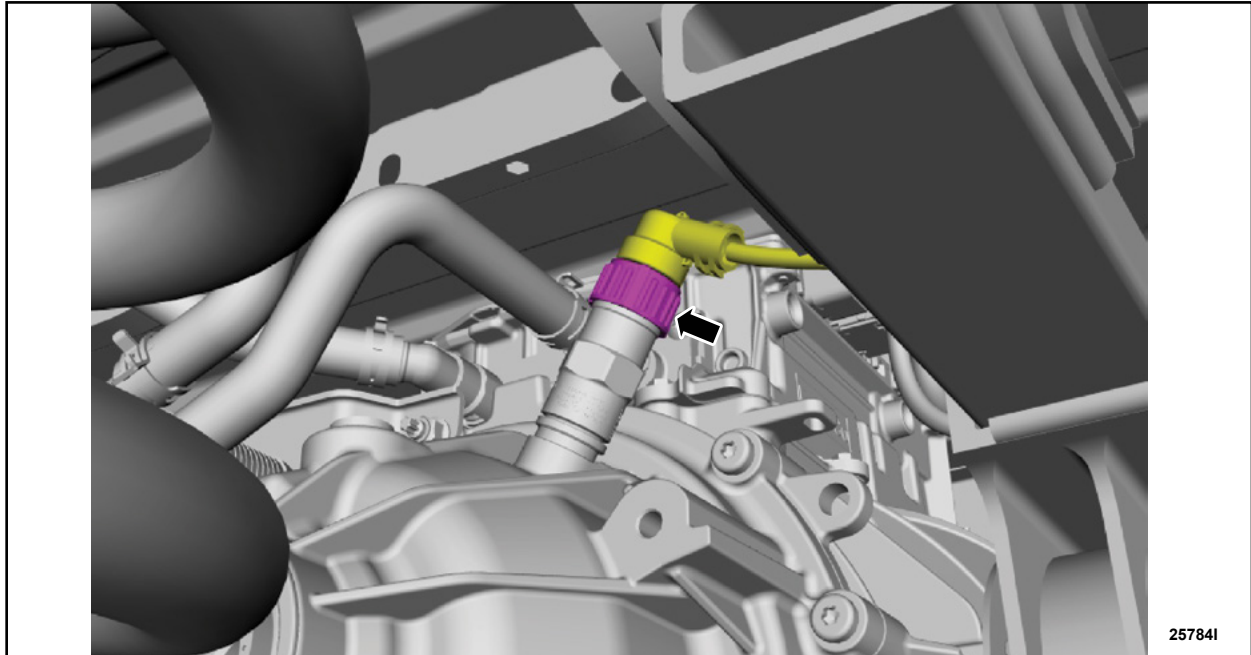
**FIGURE 13**

17. If equipped, disconnect the Output Shaft Sensor (OSS) electrical connector. See Figure 13.

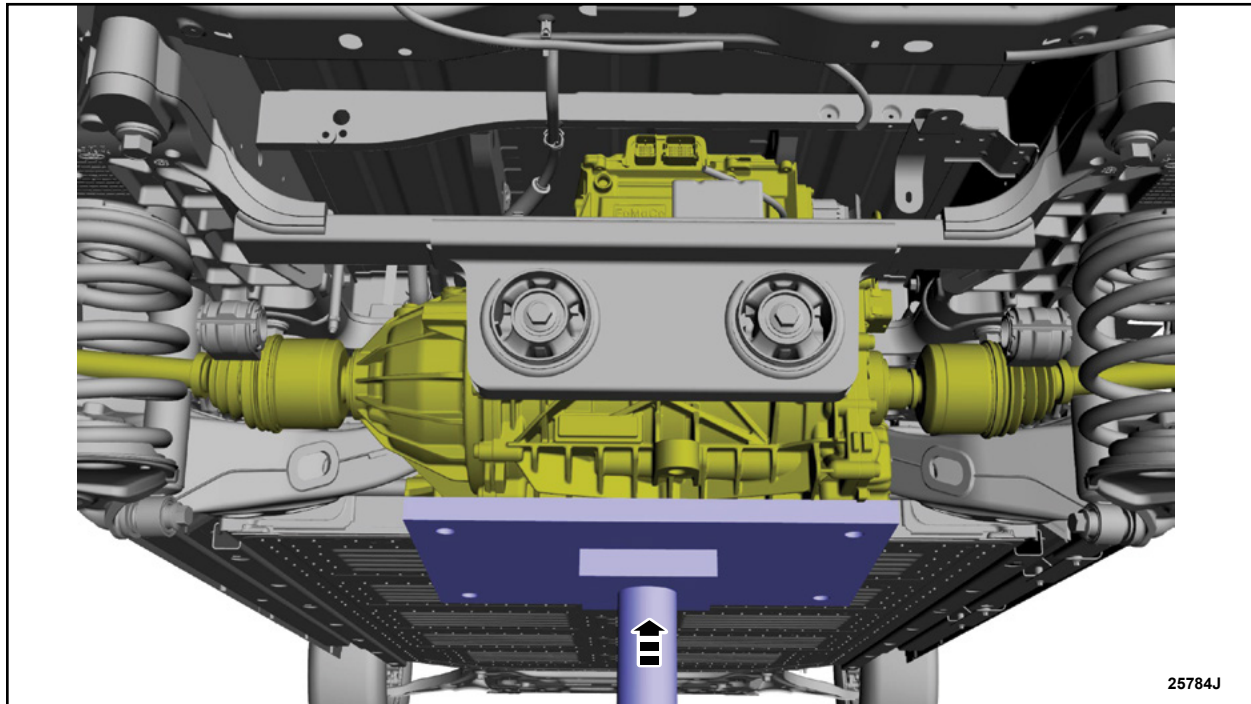
**FIGURE 14**

18. Using a transmission jack and wooden blocks, support the rear electric drive assembly. Install a safety strap. See Figure 14.

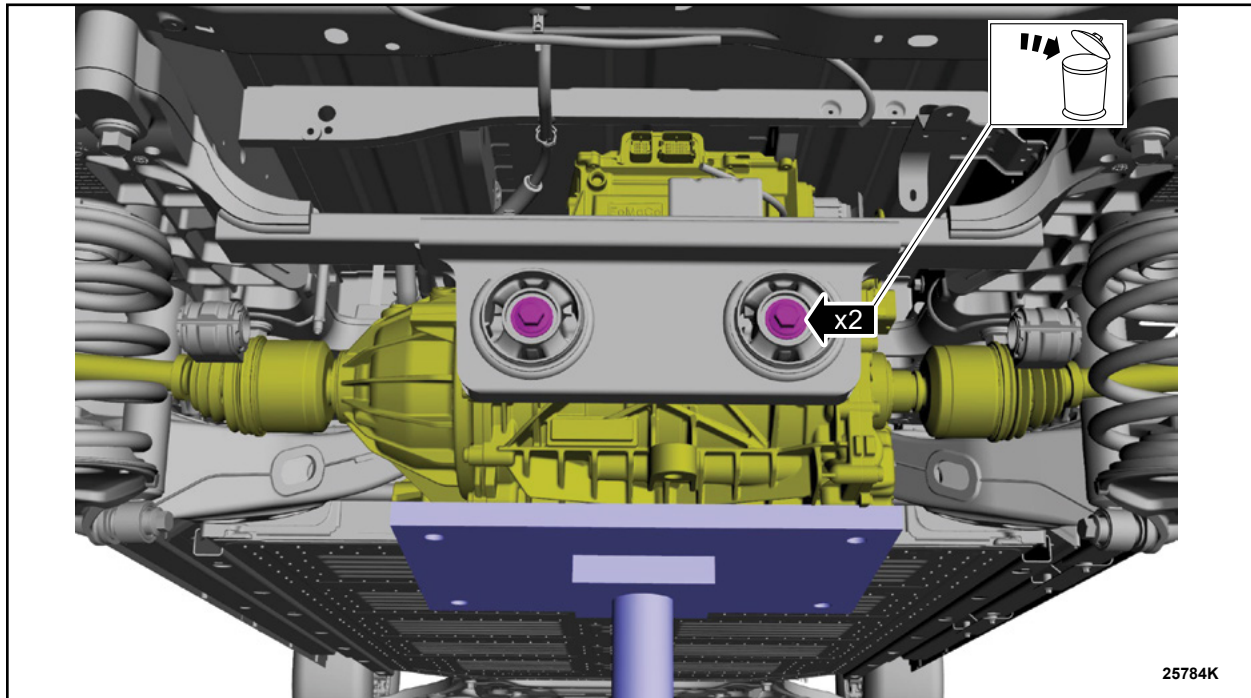
FIGURE 15

19. Remove and discard the rear side bolts from the rear electric drive assembly. See Figure 15.

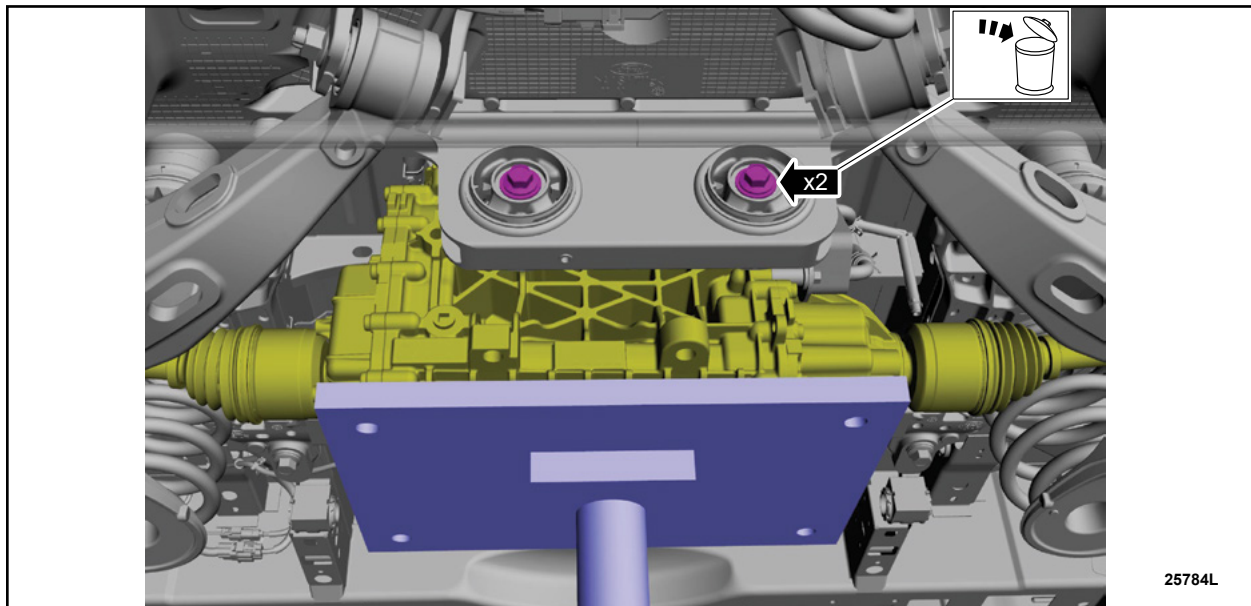
FIGURE 16

20. Remove and discard the front side bolts from the rear electric drive assembly. See Figure 16.

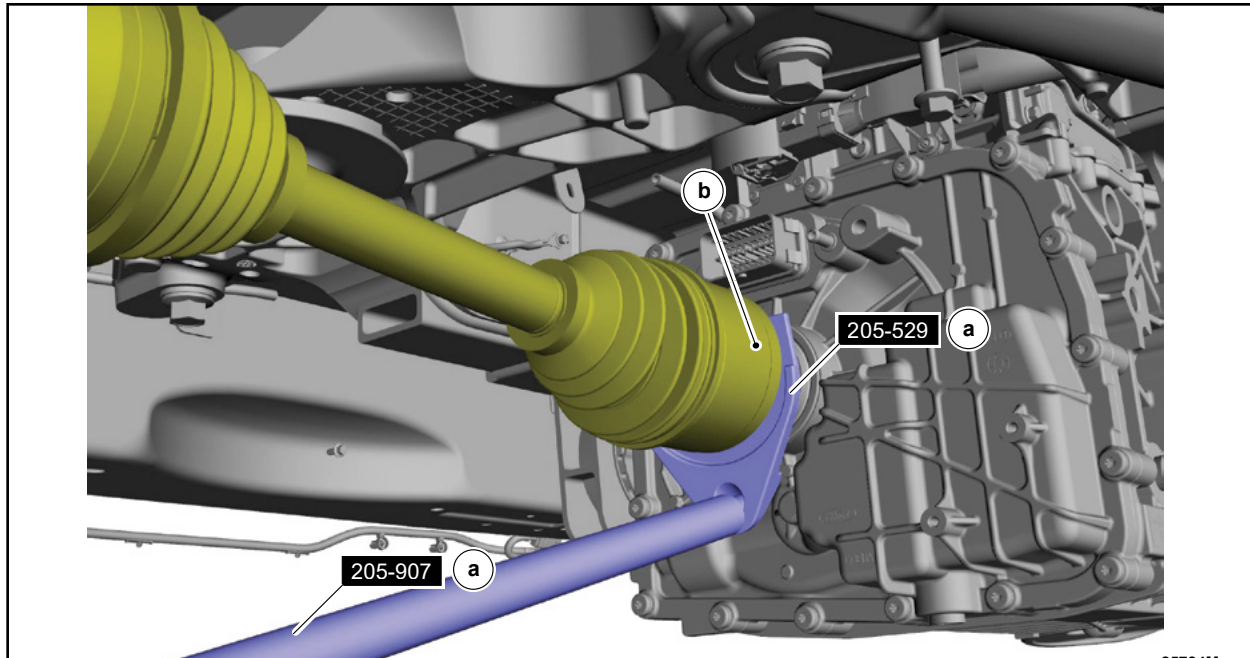
FIGURE 17

- Use Special Service Tool: 205-529 Remover, Halfshaft / 205-907 Handle, 32 Driver.

**NOTE:** The halfshafts stay connected to vehicle for this inspection.

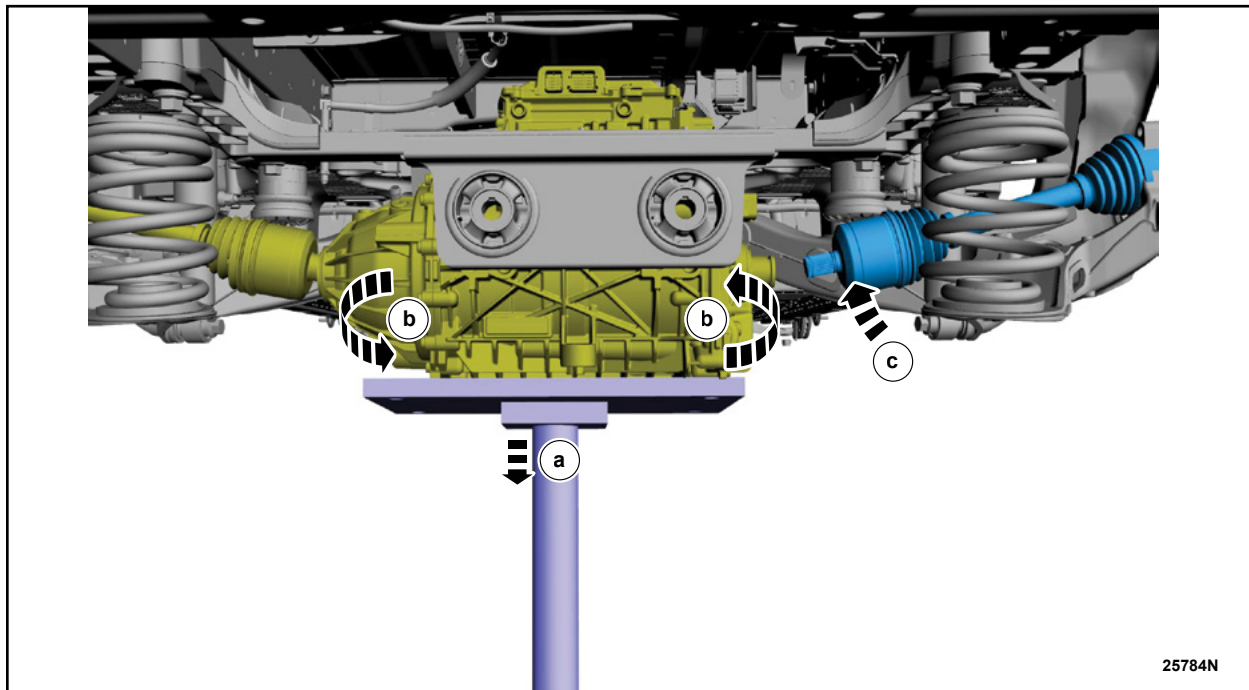
FIGURE 18

- Outboard side of halfshaft remains attached to the hub.

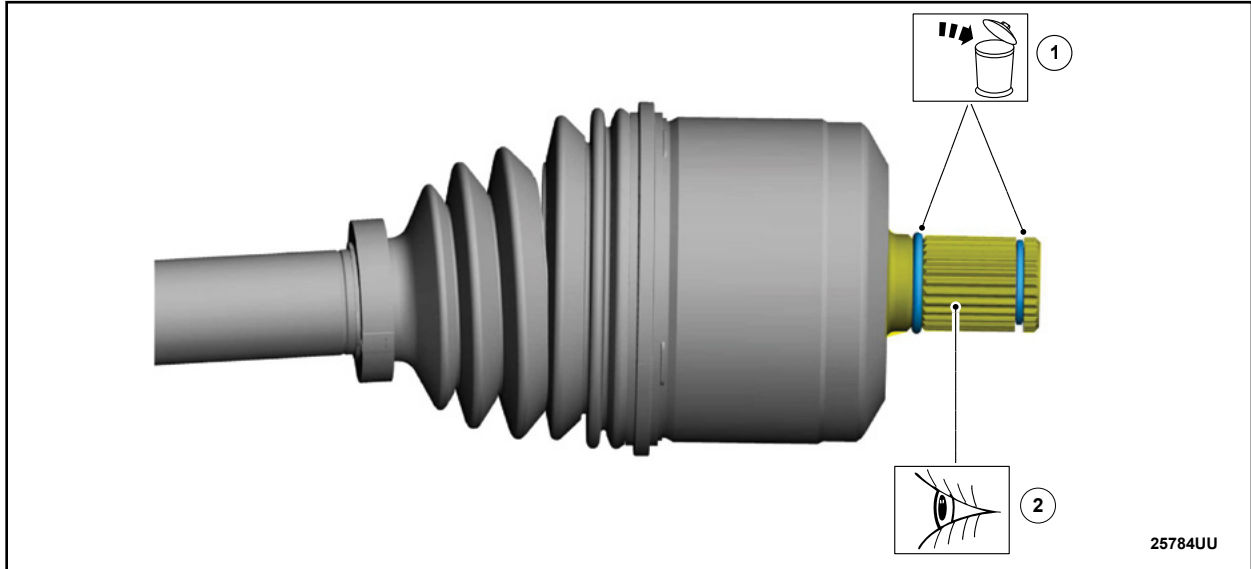
FIGURE 19

23. Perform the following: See Figure 19.

1. Remove and discard the retaining circlip and O-ring on the RH halfshaft.
2. Inspect the halfshaft end for damage.

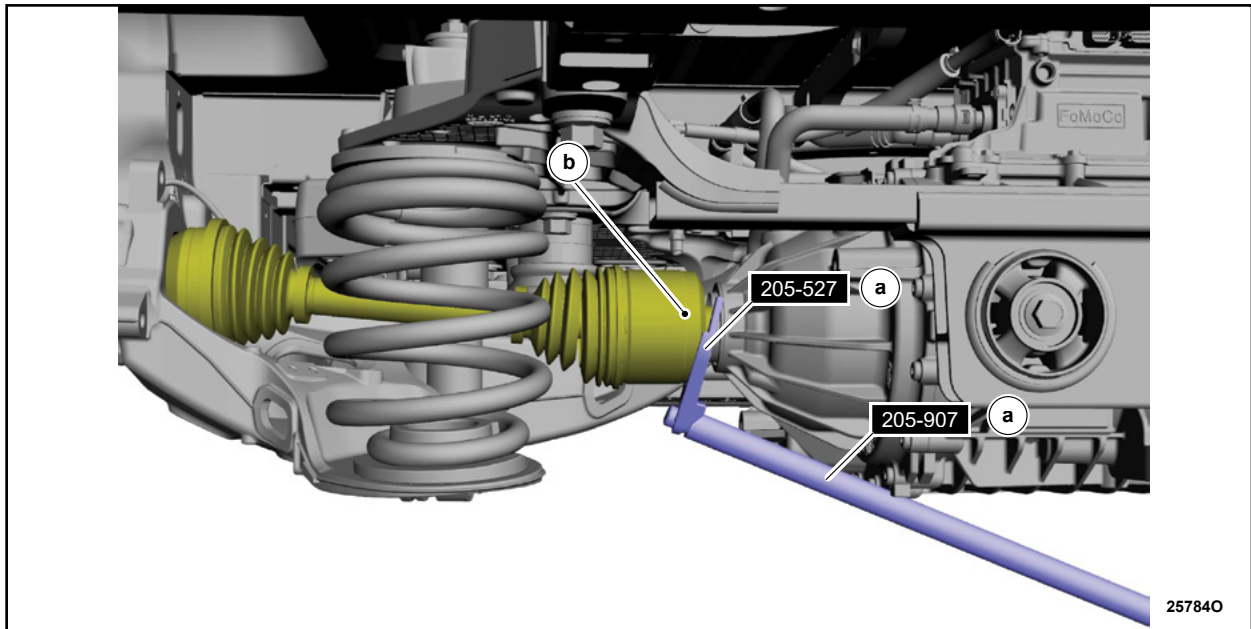
FIGURE 20

24. Using the special tools, release the LH halfshaft from the rear electric drive assembly.  
See Figure 20.

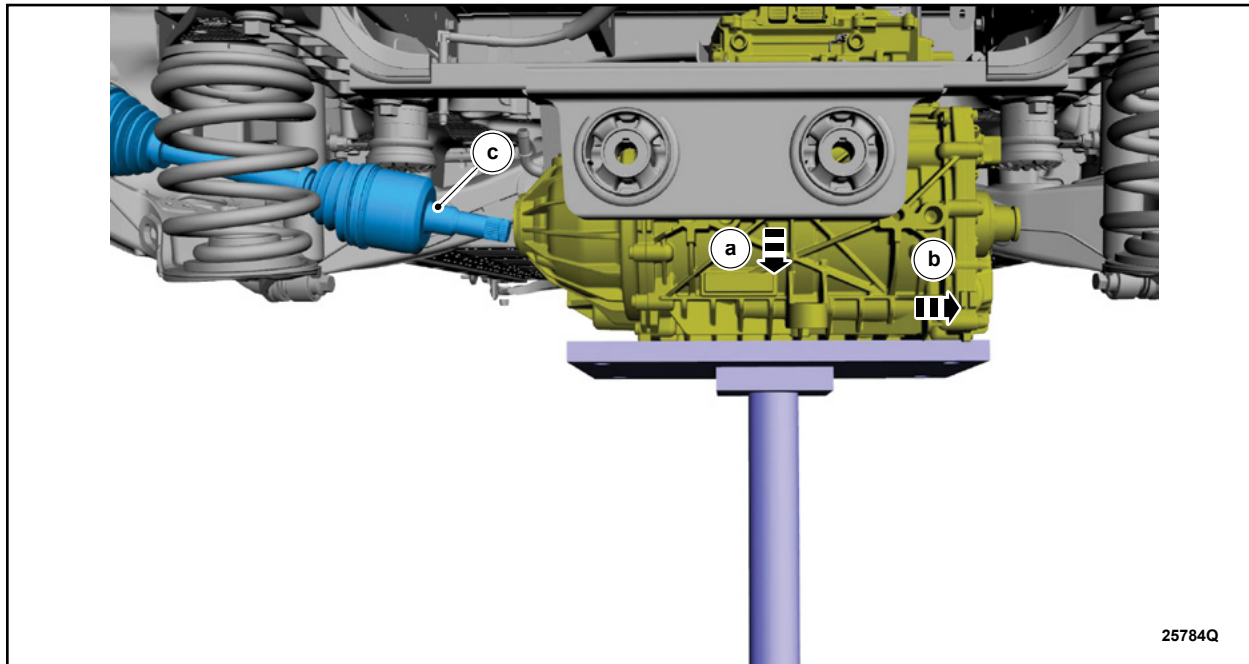
FIGURE 21

- a. Lower the rear electric drive assembly from the vehicle.
- b. Position the rear electric drive assembly to the passenger side of the vehicle.
- c. Remove the LH halfshaft from the rear electric drive.
- d. While still attached to the hub, support the LH halfshaft using mechanics wire or equivalent.

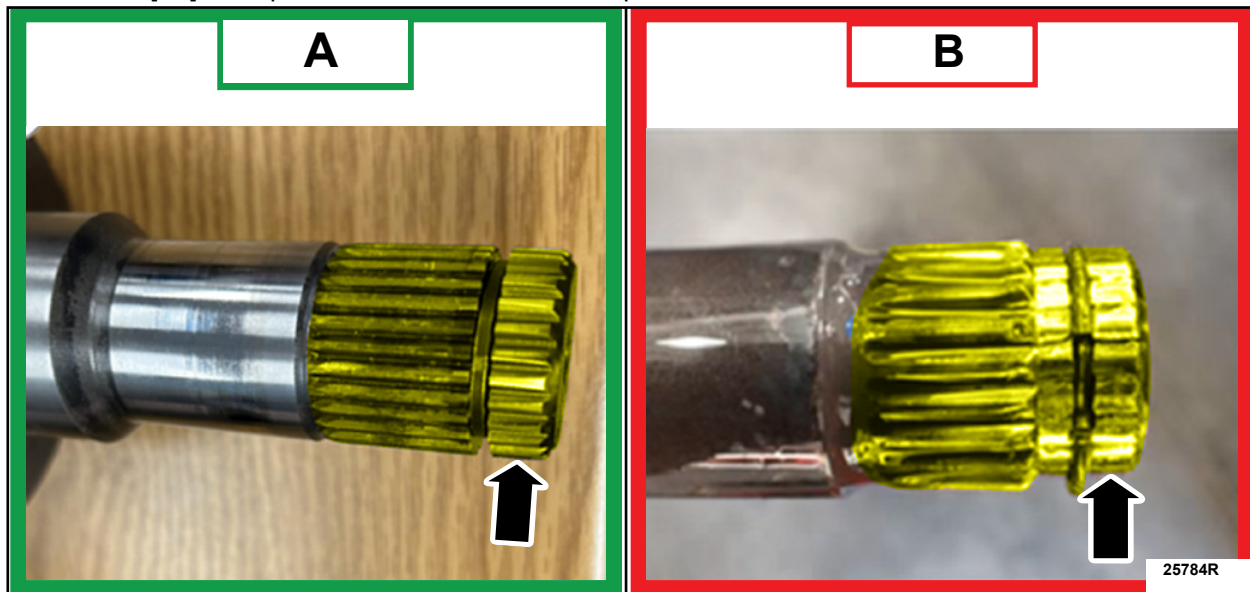
FIGURE 22

[ B ] - Damaged splines. Proceed to the next Step.

**NOTE:** The [ B ] example is a non-Transit reference photo.

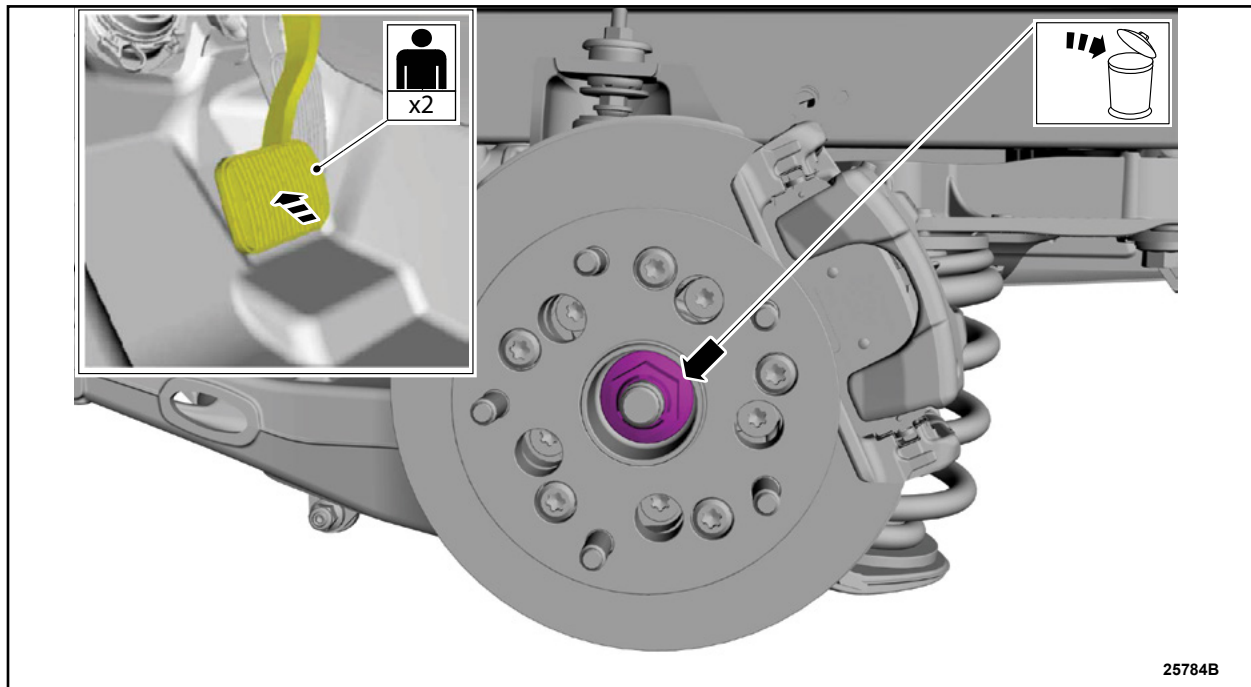
**FIGURE 23**

28. While an assistant applies the brake, remove and discard the wheel hub nut. See Figure 23.

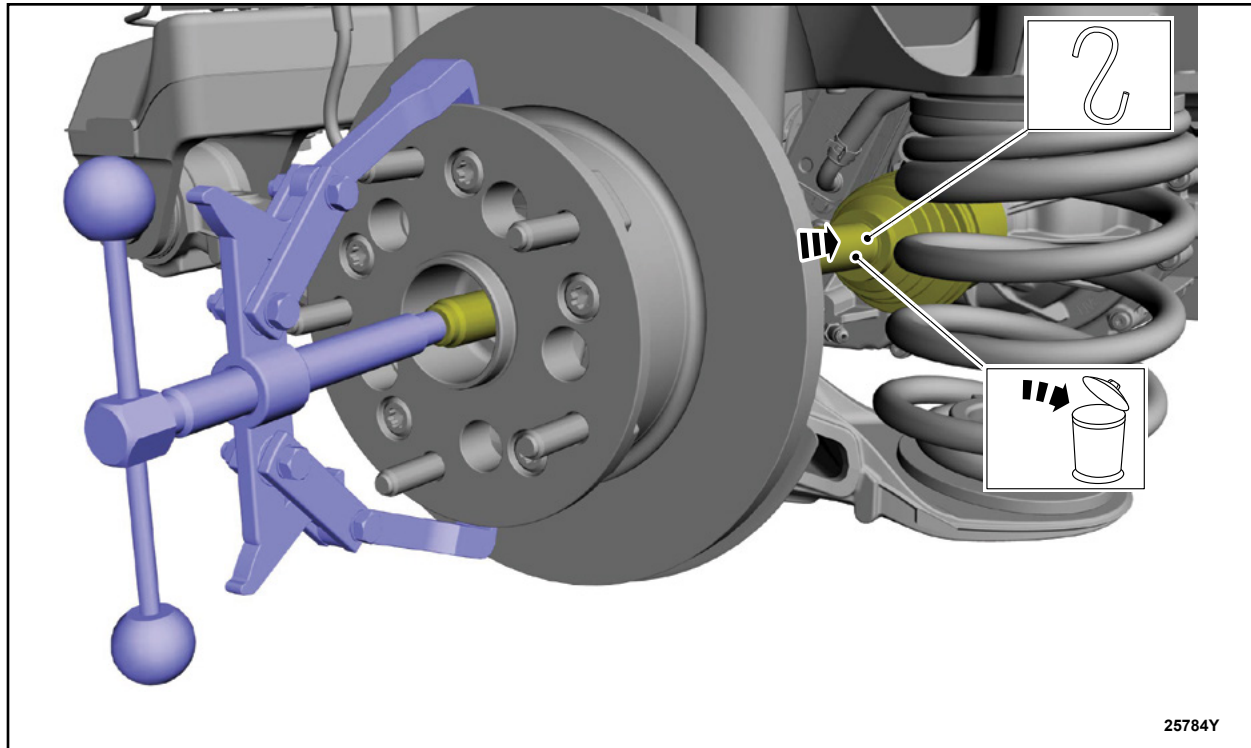
FIGURE 24

29. Support the halfshaft, then using a 2-leg puller, separate the wheel hub and brake disc assembly from the halfshaft. See Figure 24.

- Use the General Equipment: Two Leg Puller. This tool is available through the Rotunda Technician Tool Program (RTTP).
- Discard the damaged halfshaft.

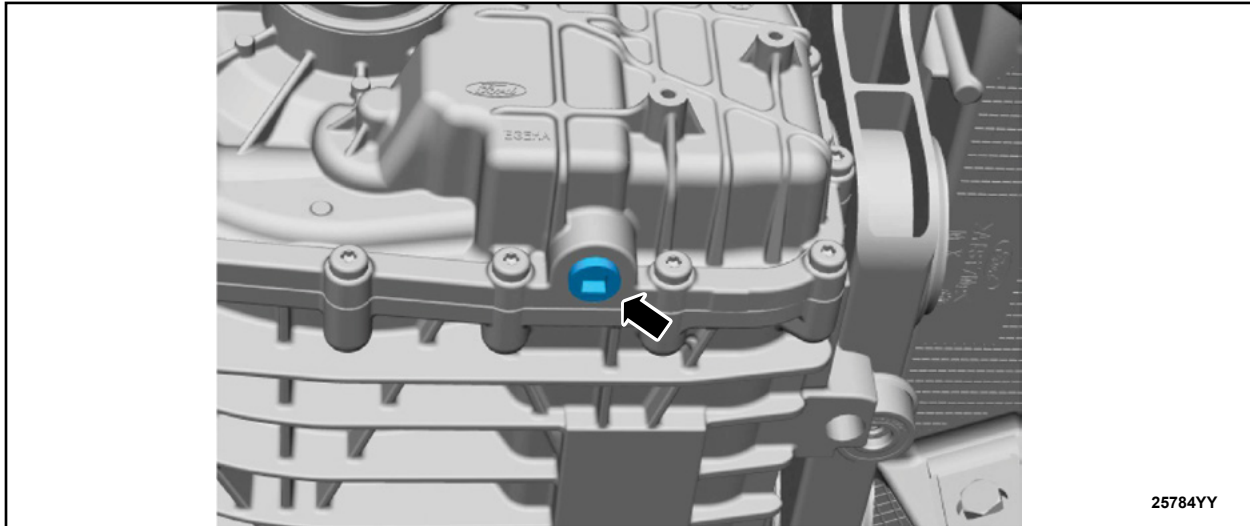
FIGURE 25

30. Remove the drain plug and drain the rear electric drive assembly oil. Install the drain plug.  
See Figure 25.  
- Torque: 18 lb.ft (25 Nm).

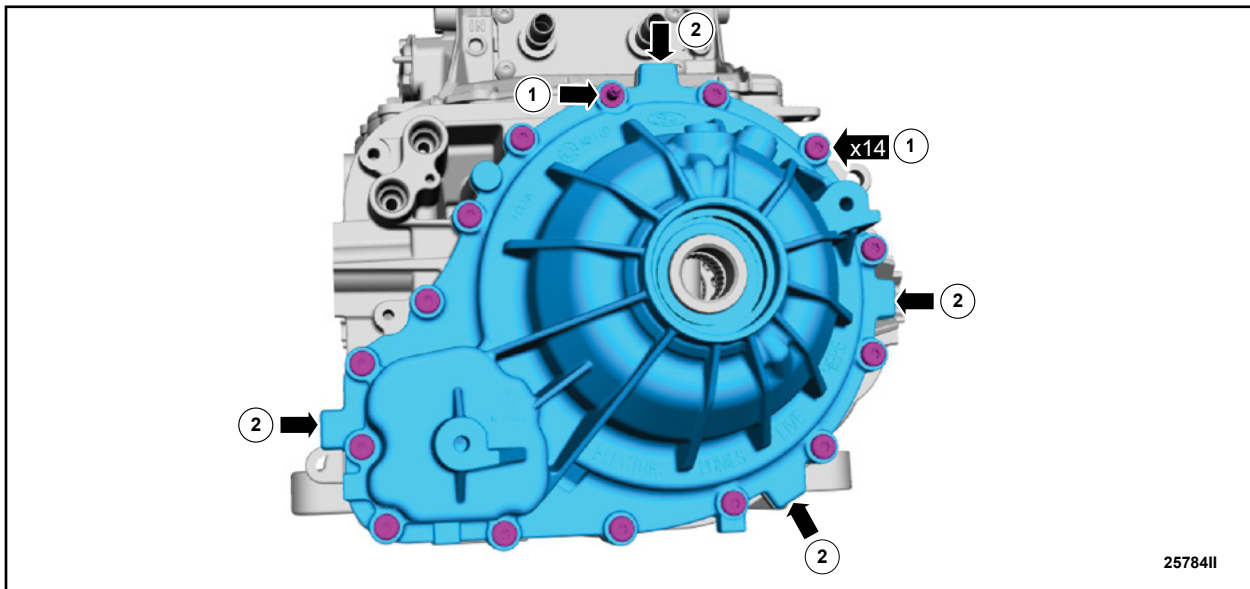
FIGURE 26

31. Perform the following: See Figure 26.

1. Remove the bolts and the stud bolt for the differential case cover.
2. Using the pry pads, remove the differential case cover.

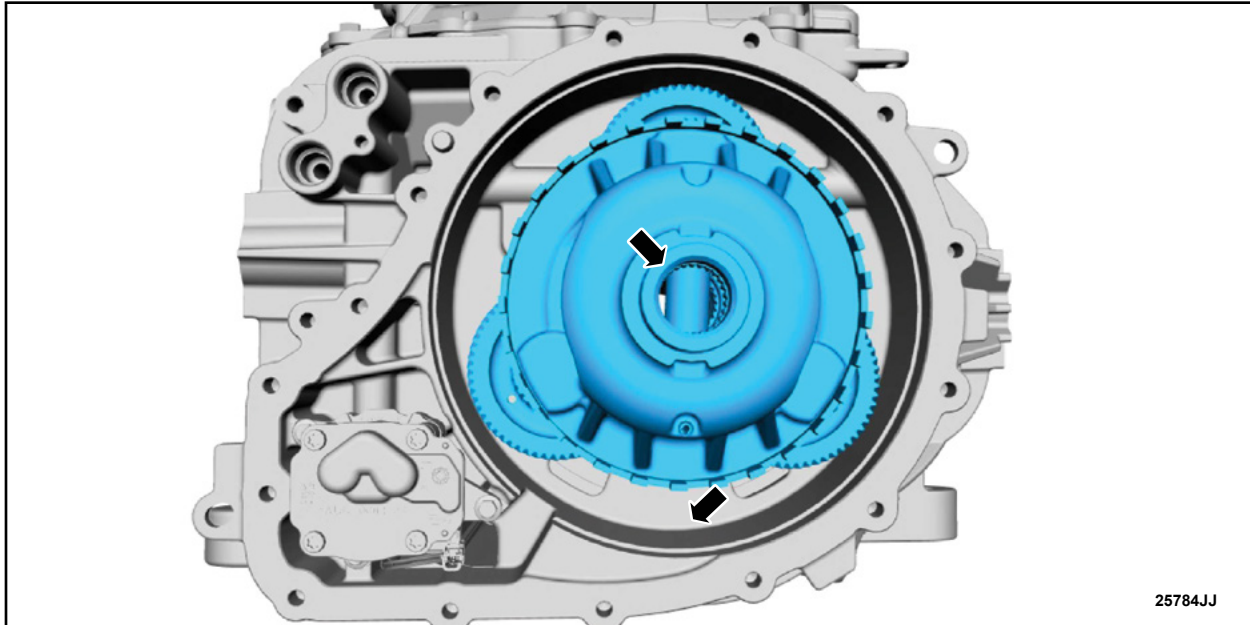
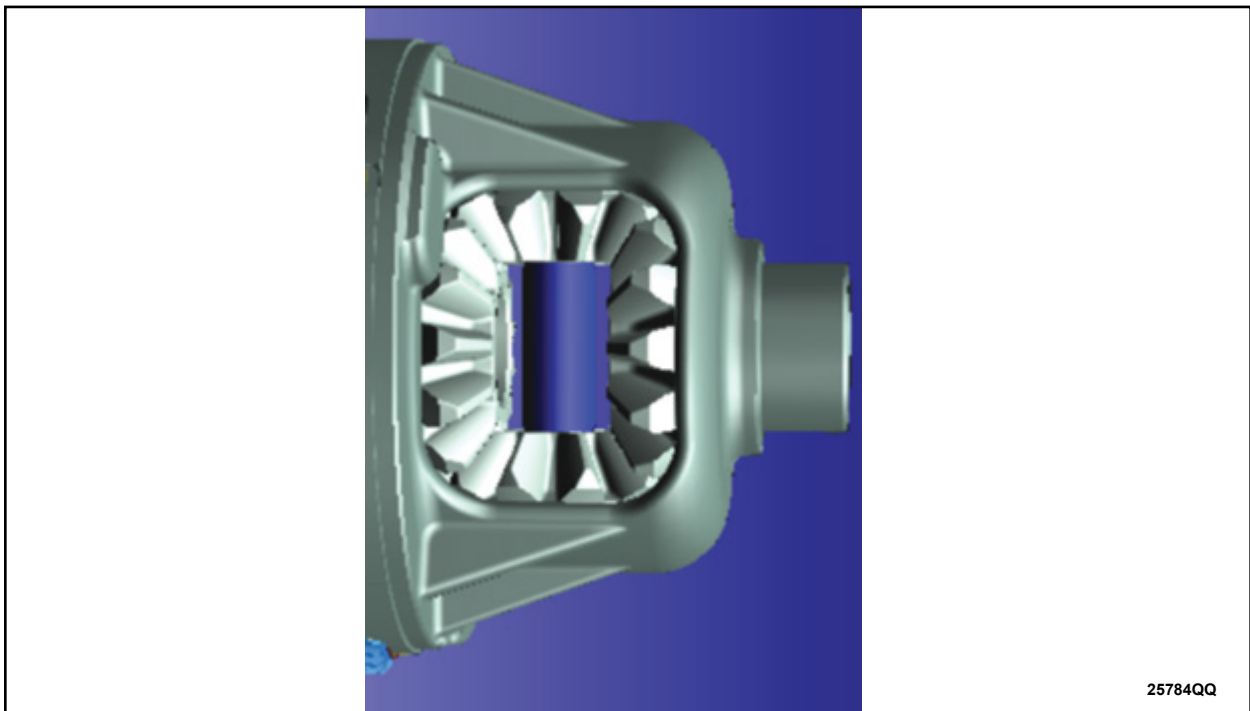
**PASS** - No excess wear, contamination or debris. No further tear-down required. Proceed to the next step.

**FAIL** - Take pictures of suspect parts for requested replacement and contact the Special Service Support Center (SSSC) for further direction.
