Service Engineering Operations  
Customer Service Division

**TO:** All U.S. Ford and Lincoln Dealers  
**SUBJECT:** **NEW VEHICLE DEMONSTRATION / DELIVERY HOLD**  
**Safety Recall 25SD9**  
Certain 2022-2025 Model Year Transit Battery Electric Vehicles (BEV)  
Left-Hand Rear Halfshaft Inspection

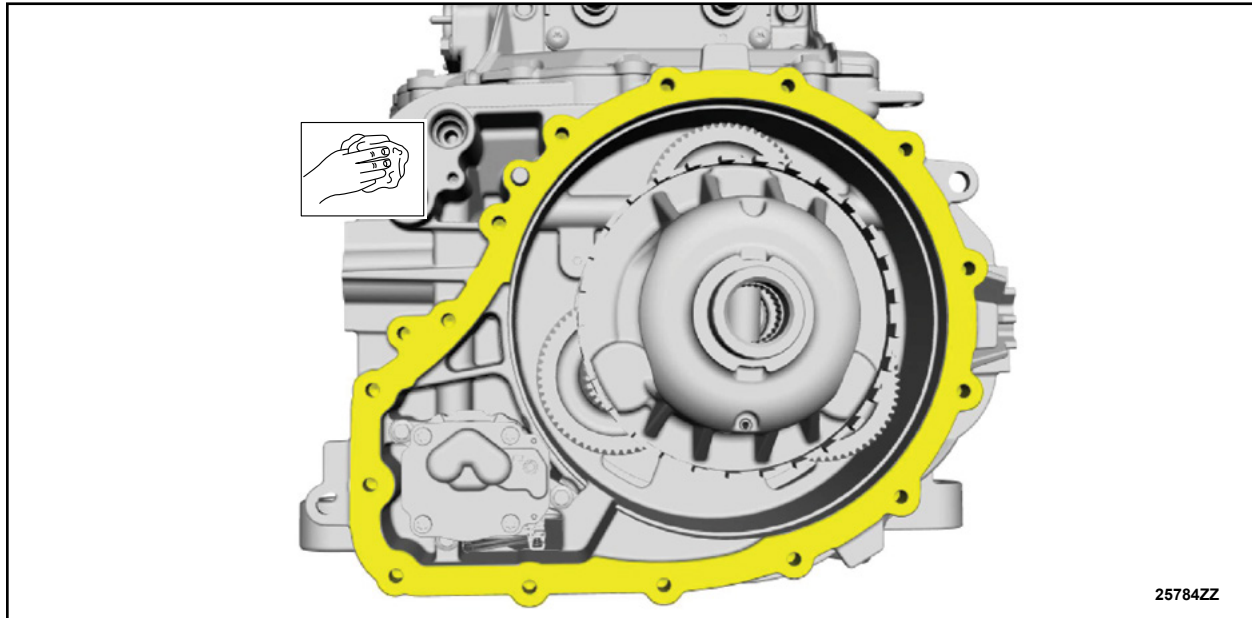
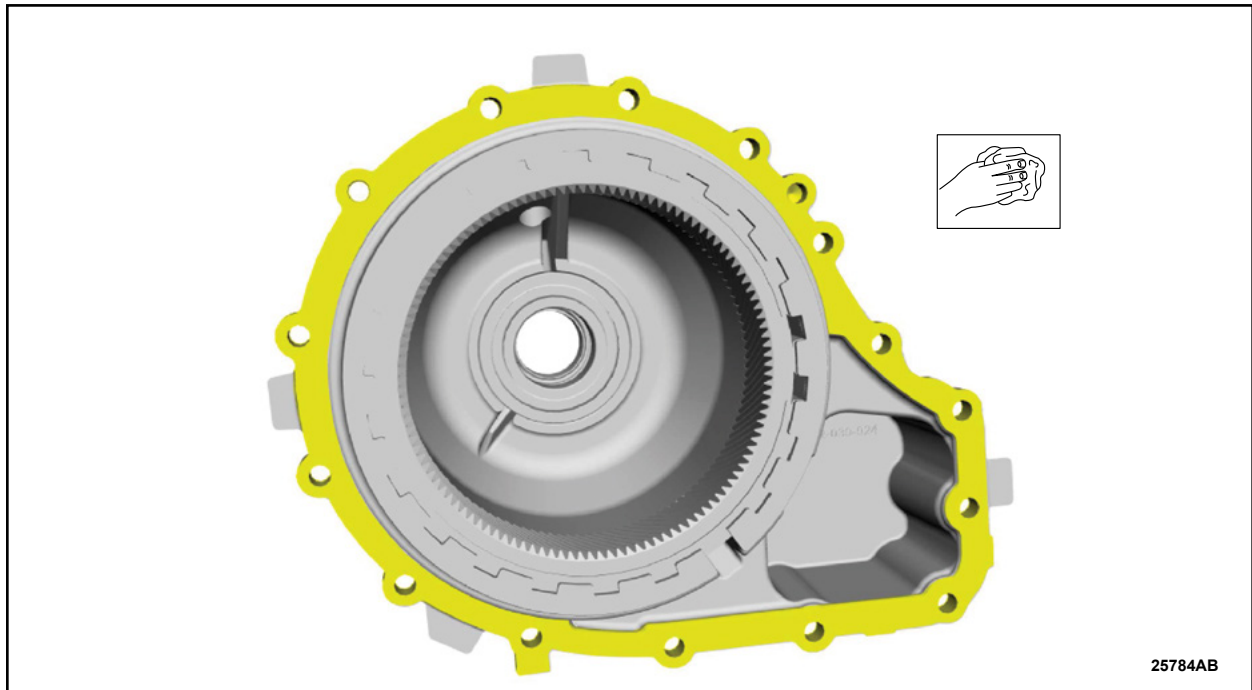
33. Clean and prepare the RTV sealing surfaces. Refer to the WSM procedures in Section 303-00 - RTV Sealing Surface Cleaning and Preparation. See Figures 29 and 30.

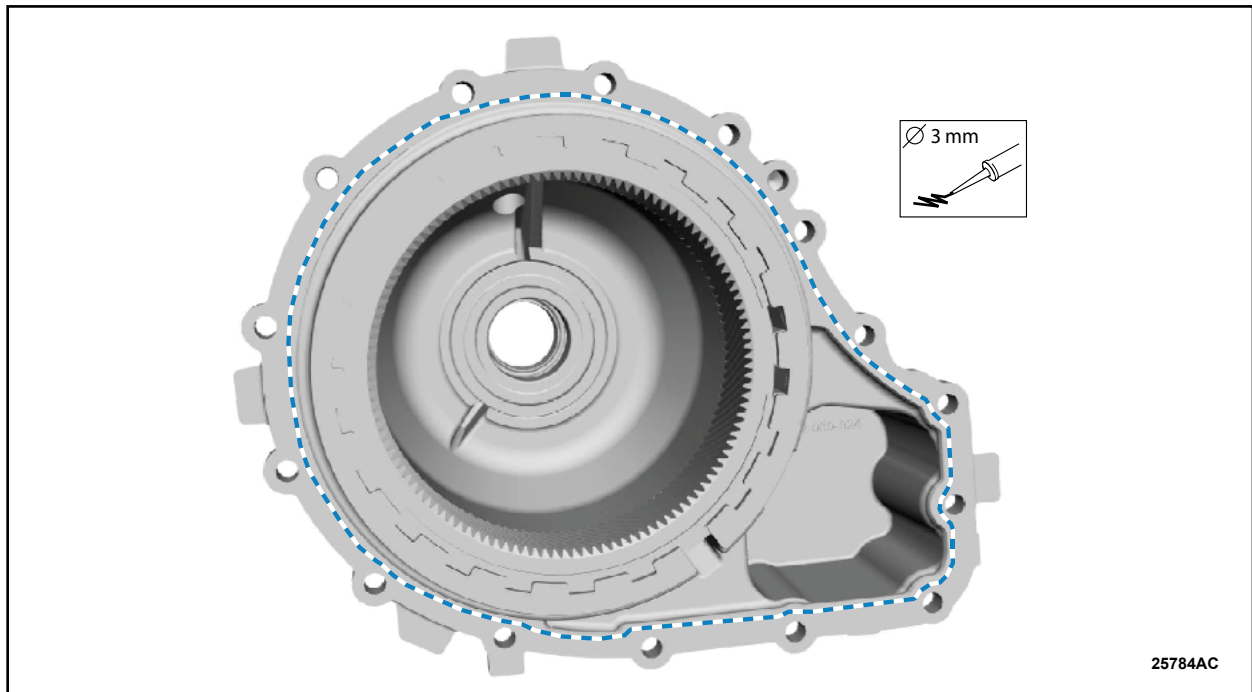
FIGURE 31

34. Apply a 0.12 in (3 mm) diameter bead of Motorcraft® Ultra Silicone Sealant to the differential case cover sealing surface. See Figure 31.

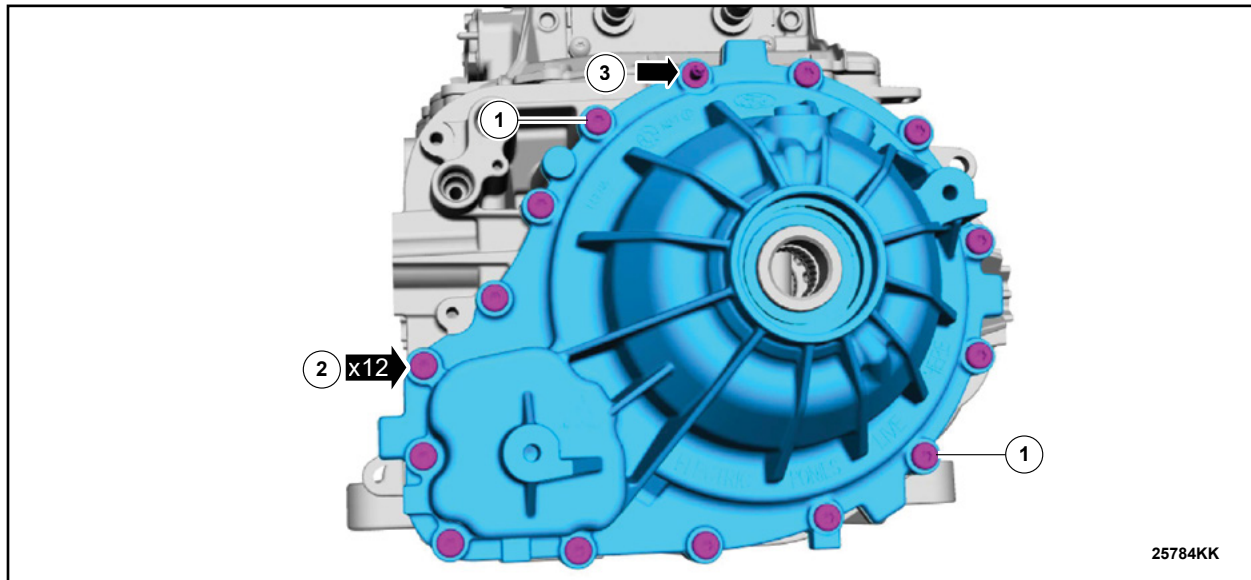
**FIGURE 32**

35. Perform the following: See Figure 32.

1. Install the differential case cover and the bolts. Using the bolts, seat the differential case cover.
2. Install the remaining differential case cover bolts. Tighten the differential case cover bolts.  
- Torque: 23 lb.ft (31 Nm).
3. Install the stud bolt.  
- Torque: 159 lb.in (18 Nm).

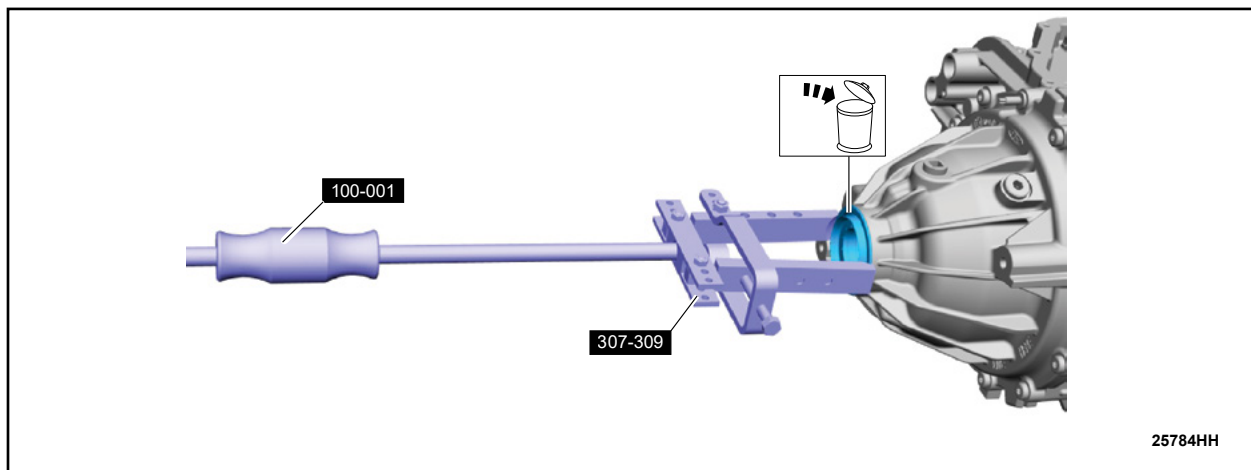
**FIGURE 33**

36. Using the special tools, remove and discard the LH rear halfshaft seal. See Figure 33.

- Use Special Service Tools: 100-001 (T50T-100-A) Slide Hammer, 307-309 Remover, Torque Converter Seal.

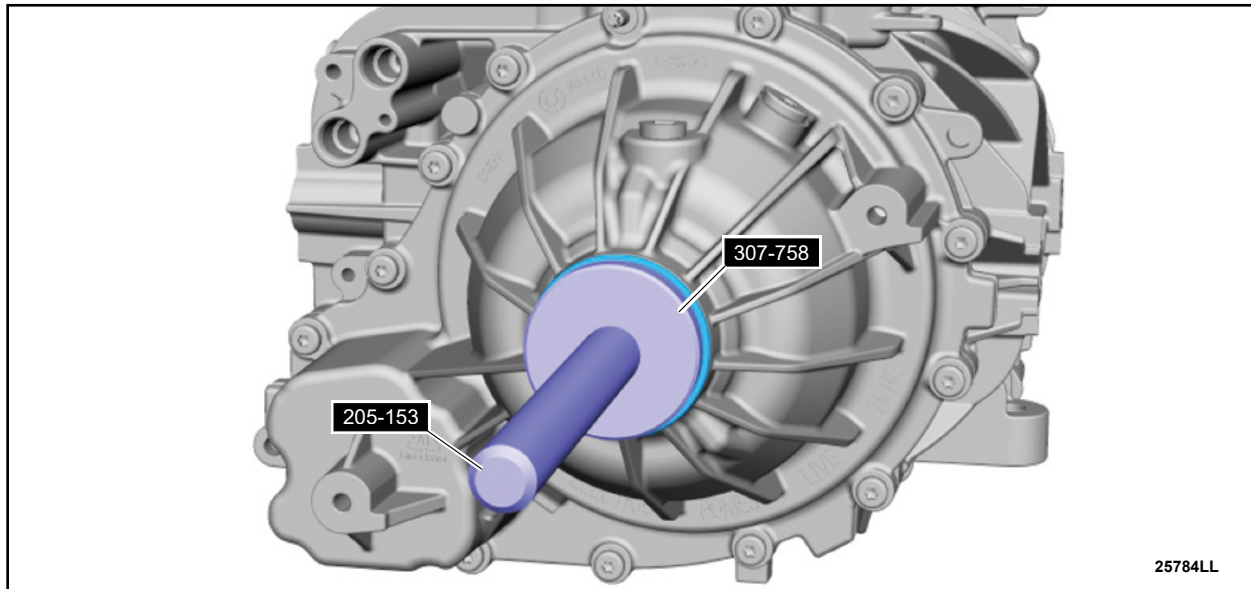
**FIGURE 34**

37. Using the special tools, install a *new* LH halfshaft seal. See Figure 34.

- Use Special Service Tool: 205-153 (T80T-4000-W) Handle, 307-758 Installer, Axle Seal - FWD.

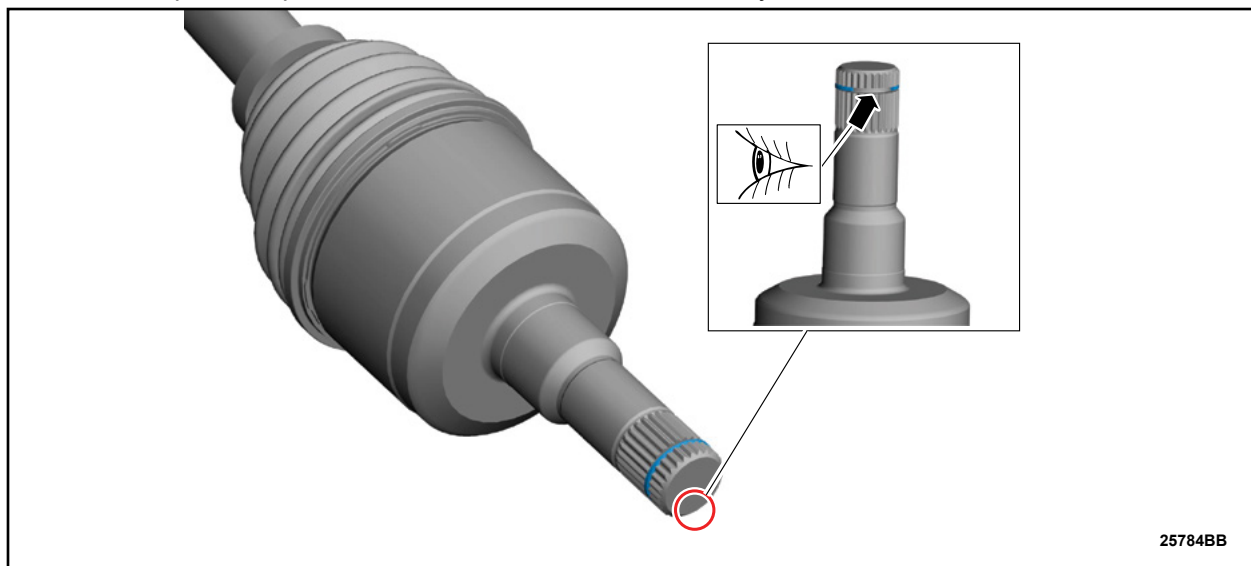
**FIGURE 35**

38. If reinstalling a LH halfshaft after inspection PASS, remove and discard, then install a *new* halfshaft retaining circlip. See Figure 35.

39. Make sure that the circlip opening is aligned and oriented to 6 o'clock position on both the LH/RH halfshafts before installing. See Figure 35.

**NOTE:** A circlip comes pre-installed on a *new* halfshaft assembly.

**NOTE:** Before reinstalling the halfshaft, make sure the *new* circlip has an opening that is aligned and oriented to 6 o'clock position. Refer to Figure 35.

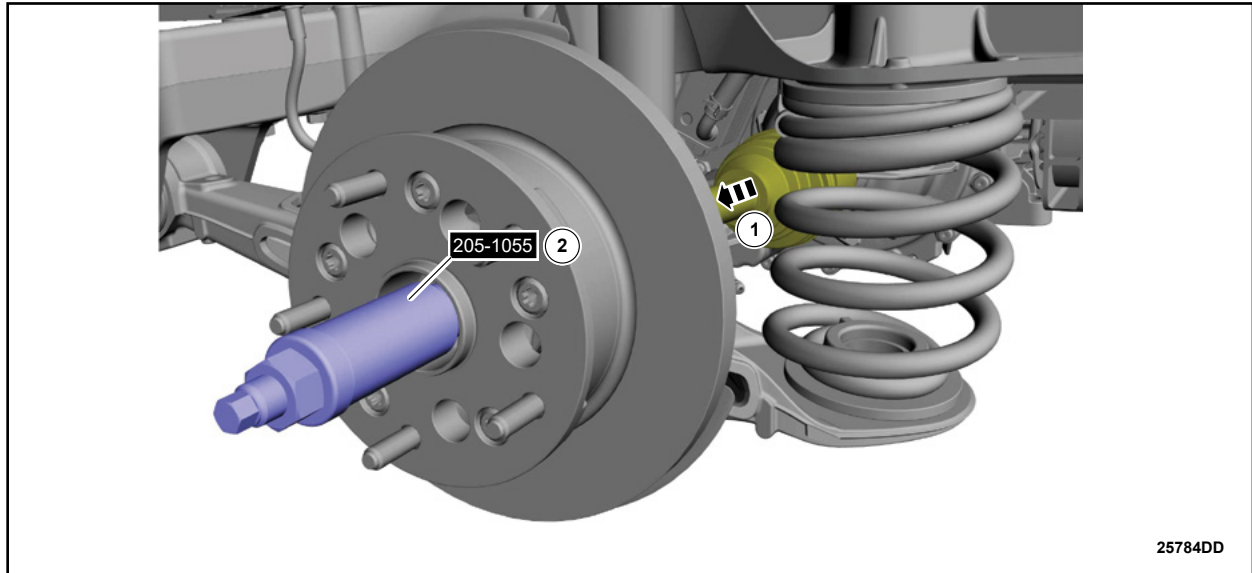
**FIGURE 36**

1. Insert halfshaft through the wheel bearing.
2. Using the special tool, pull the halfshaft into the wheel hub assembly. Tool shown or a commercially available equivalent can be used.

- Use Special Service Tool: 205-1055 Installer, Companion Flange.

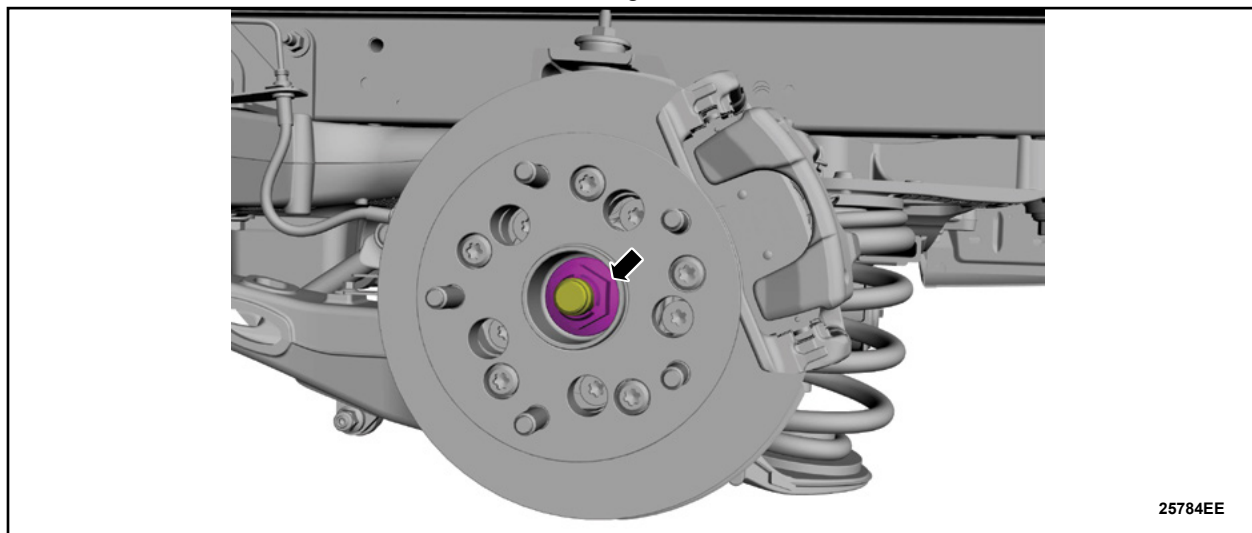
**FIGURE 37**

**NOTE:** Only tighten the nut finger tight at this stage.

41. As needed, install the *new* wheel hub nut. See Figure 37.

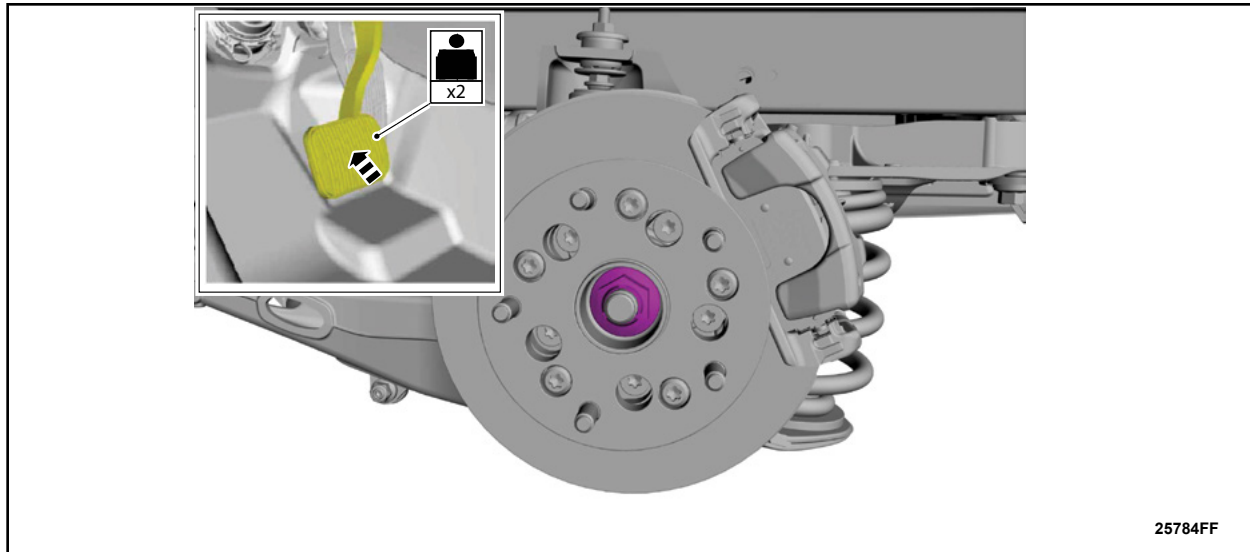
**FIGURE 38**

42. As needed, while an assistant applies the brake, tighten the wheel hub nut. See Figure 38.  
- Torque: 295 lb.ft (400 Nm).

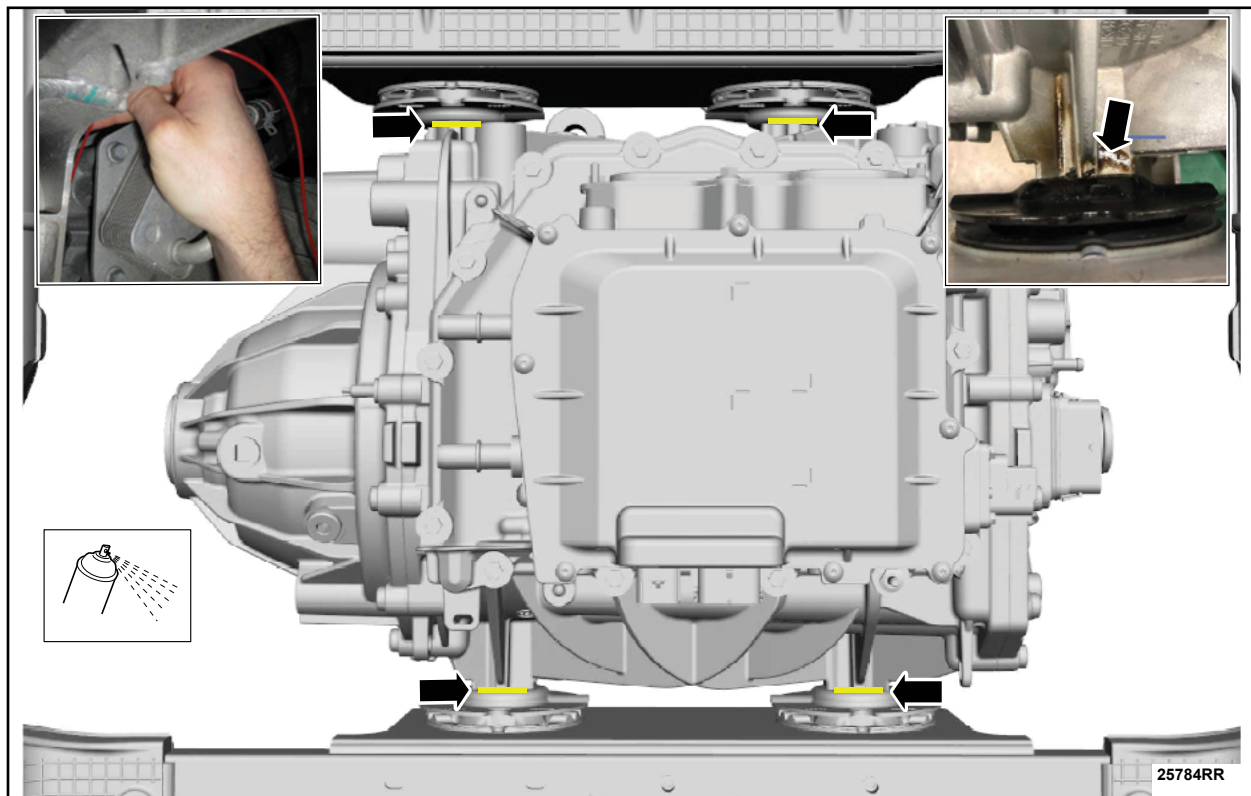
**FIGURE 39**

**NOTE:** Top of the rear electric drive assembly shown.

- See Dealer Bulletin parts list for products.
- **From the top** of the rear electric drive assembly.
- Confirm the mating surface location with an inspection mirror.
- Focus where the aluminum (grey) rear electric drive assembly touches the steel (black) mount plates (4 (four) locations).
- At the bolt interface, coat the **top** of the matting surface from the 11 o'clock position to the 1 o'clock position.
- Apply a generous coating so that it leaks down both sides of each mount.
- Perform for all 4 (four) mounts.

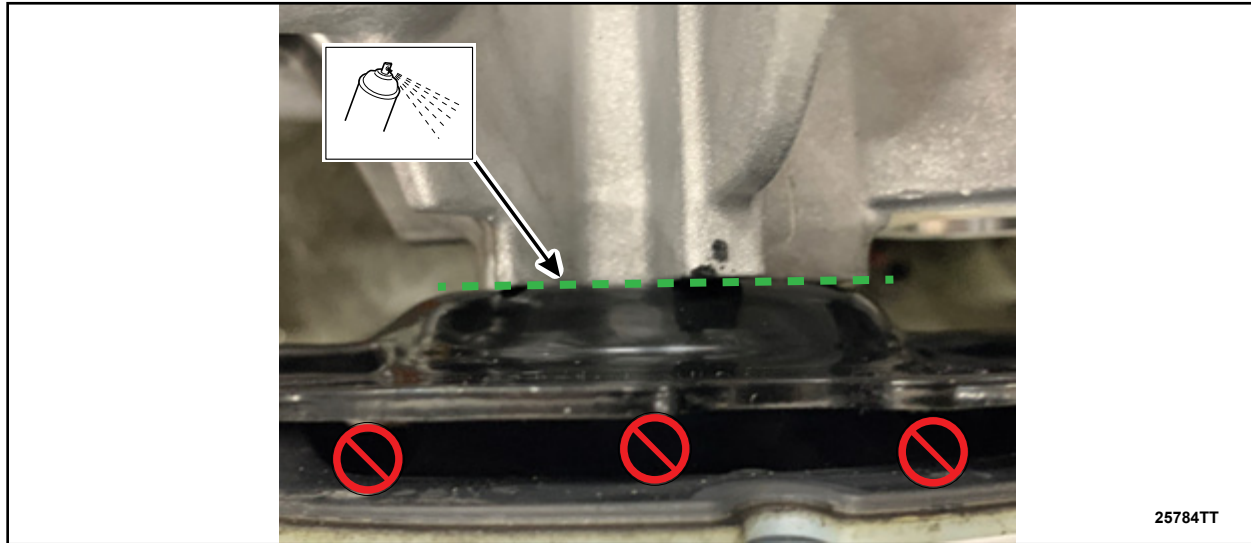
**FIGURE 40**

**NOTE:** Apply the chemical along the green dashed lines FROM THE TOP. See Figure 40.

**NOTE:** DO NOT apply any chemical onto the rubber mounts. See Figure 40.

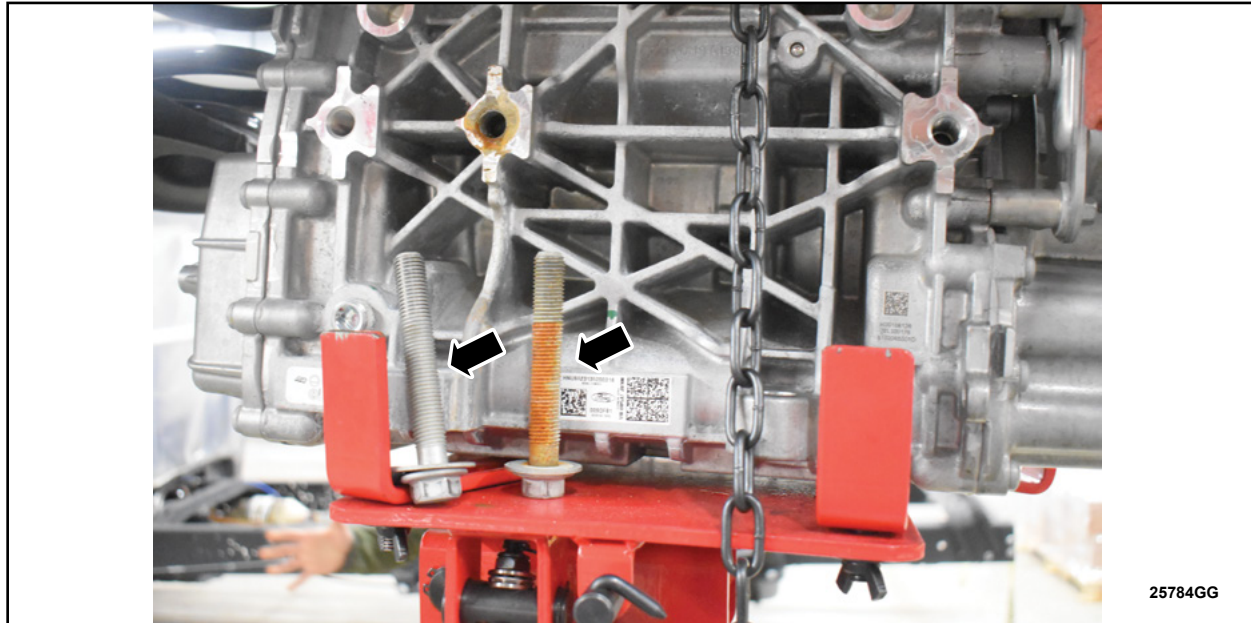
**FIGURE 42**

**NOTE:** Example of why the corrosion protection is needed after assembly.
