R26DY

IMPORTANT SAFETY RECALL

SUBJECT: R26DY: Electric Vehicles May Shut Down

R26DY – Electric Vehicles May Shut Down

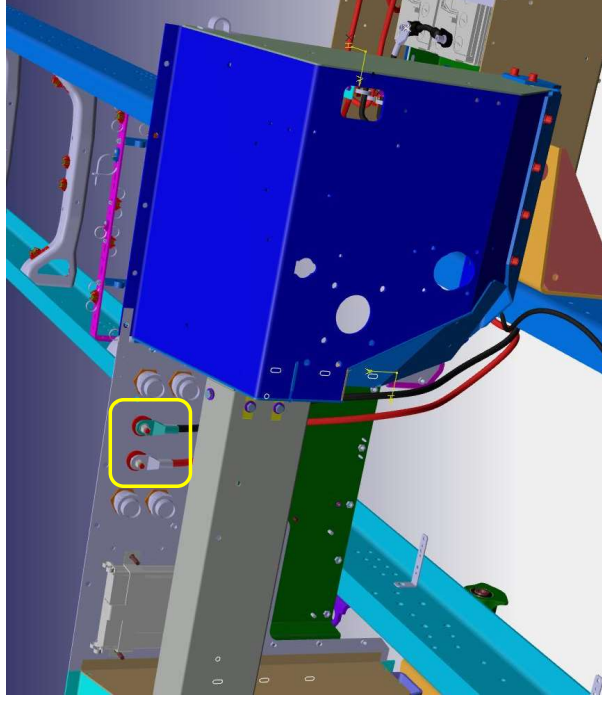
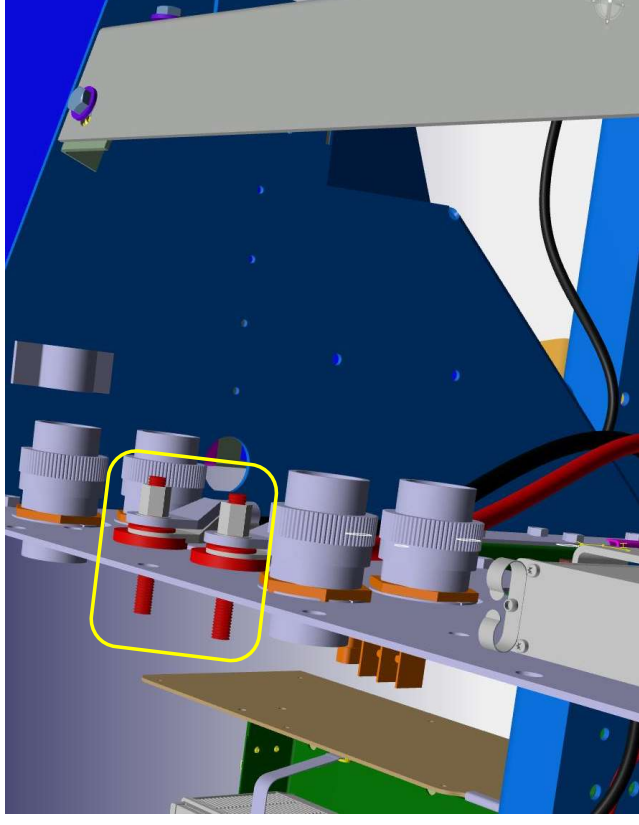
Issue: Critical safety systems rely on unswitched sources of 12 volt energy. There are a number of connection points that could become unsecure and create an unsafe condition.

1. Remove negative battery cable from 12v Battery bank and secure.
2. Replace both positive and negative DCM pass through studs. (See Figure 1 & 2)
3. Service locations highlighted in Figures 4 - 7. Any connections/components found to have any thermal stress MUST be replaced.
4. Clean/prep connection(s) per Figure 3, and torque per legend on Page 2.
