SUBJECT: SAFETY RECALL OF 2022~2025 MB TOURRIDER COACHES

Ref.: NHTSA recall reference # **25V-TBD**
DCNA Bulletin # **TI 91.10T25237A**

TITLE: Tourrider USA – stop (fixate stop) not mounted on backrest of ISRI driver’s seat

Retrofit solution for recall

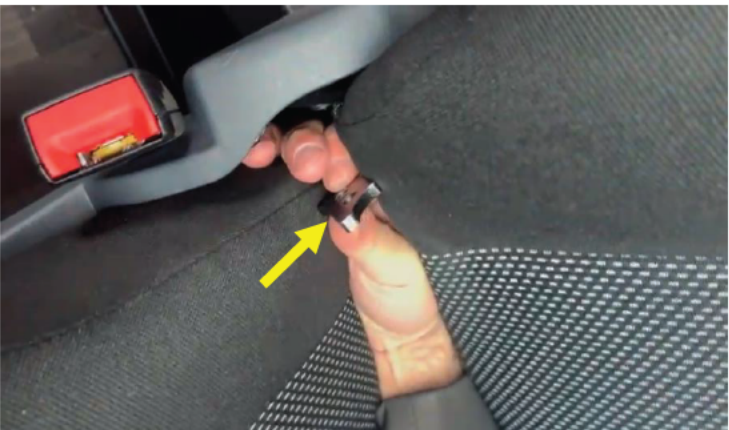
Fixate-Stop stop not installed on backrest of ISRI driver's seat delivery package

RETROFITTING

Torque: 22 NM ± 2Nm

Check whether the stop (fixate stop) is installed and retrofit if necessary.

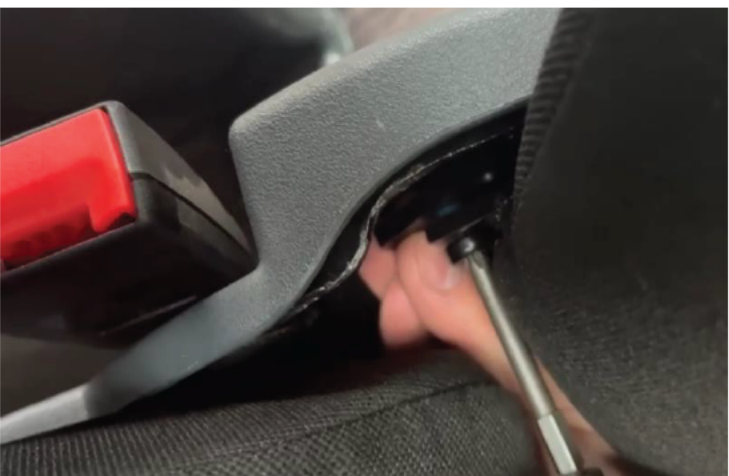
Pay attention to the correct orientation of the component!
