NHTSA Recall Number: 25V-373

IMPORTANT SAFETY RECALL

Headlight Marking

Headlight Marking Inspection and Sticker Installation Instructions for Self-Application

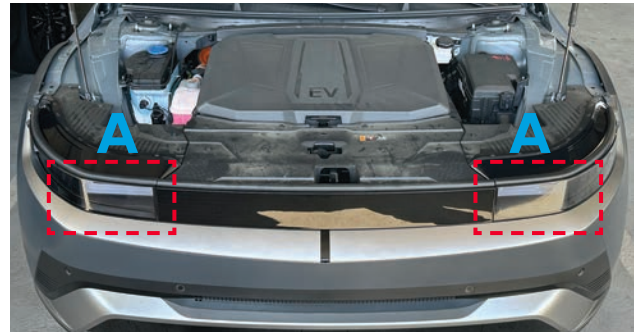
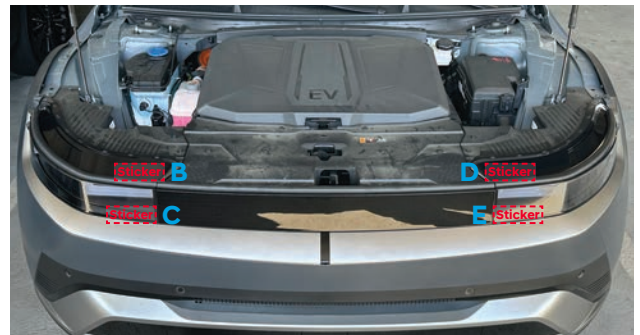
1. Locate the lower corner of the passenger-side headlight (marked "C" in the images on the right) and inspect the etched marking.

1. Open the hood.* Clean the top and corners of both headlights (**A**) using a clean microfiber cloth. Ensure both headlights are free of dust and debris.

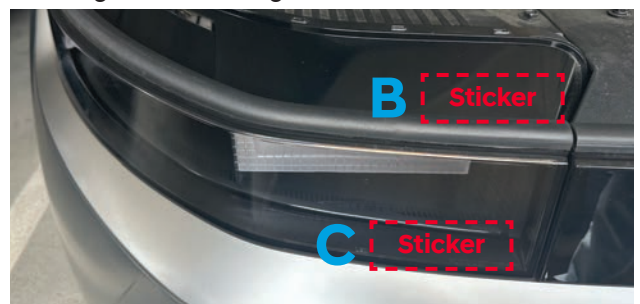
Passenger-side headlight

- **B:** Passenger-side headlight, top corner.
- **C:** Passenger-side headlight, lower corner (over the existing marking).
- **D:** Driver-side headlight, top corner.**
- **E:** Driver-side headlight, lower corner (over the existing marking).**

** The condition exists on the passenger-side headlight only. The driver-side stickers are for appearance and are optional.

Avoid touching the adhesive side of each sticker. Press firmly to remove air bubbles. Sticker should adhere smoothly and align with vehicle contours.

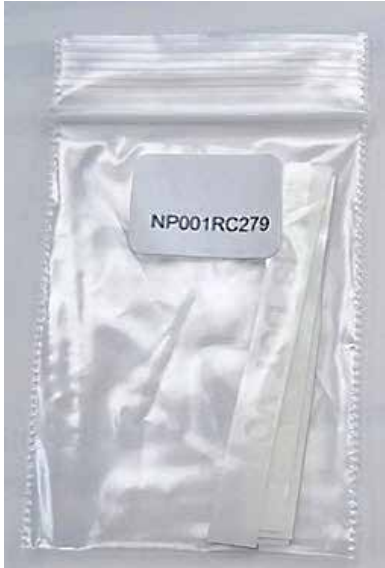
Each Kit has 4 stickers.
