Recall Instructions

R25DH: FMVSS 108 Noncompliance - High & Low Beam Reversed Operation

- Reversed headlamp operation between High & Low Beams due to improperly pinned circuit wires on the RH and LH headlamp jumper harness

- Replace jumper harness on RH and LH side headlamps

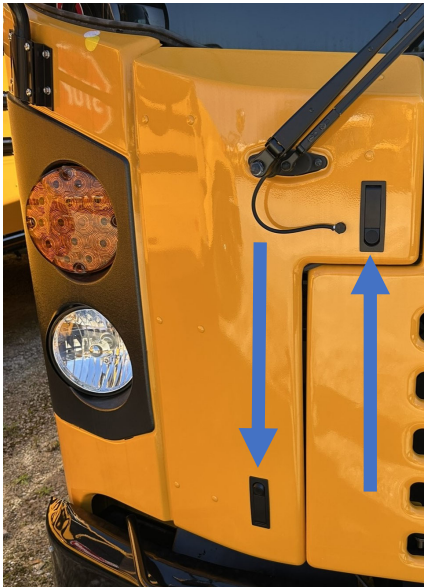
1. Open wiper access door to gain access to headlamp area on RH and LH sides.

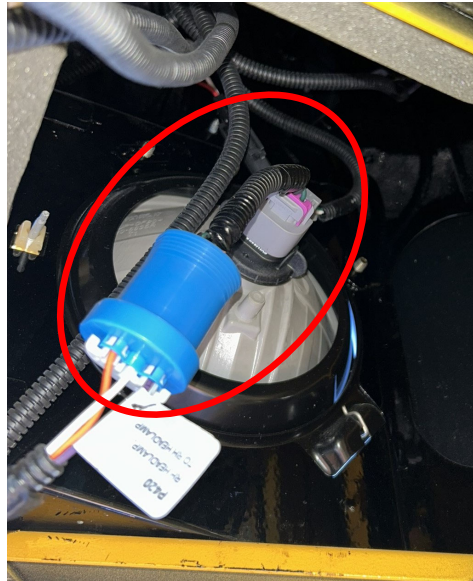
2. Locate headlamp jumper harness on headlamp.

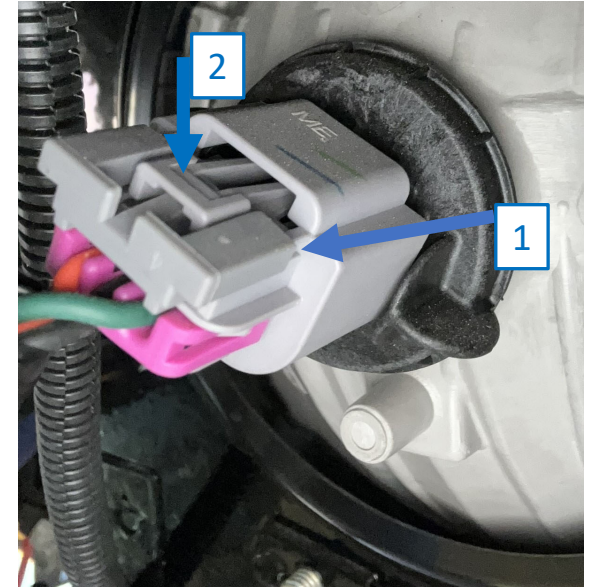
3. "1" Release lock by sliding back towards wiring and press "2" release tab to remove connector from headlamp.

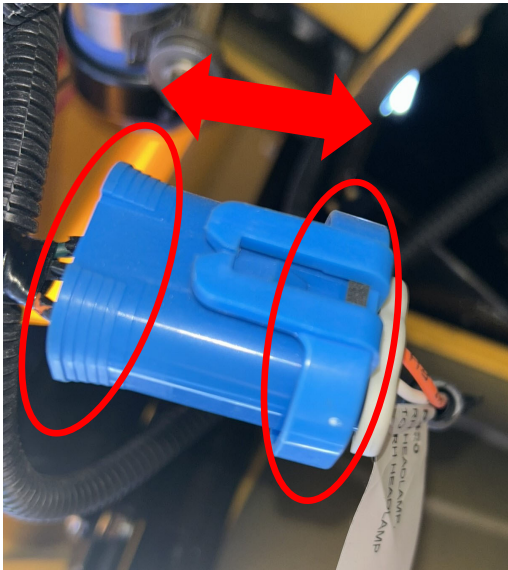
4. Disconnect jumper harness from body electrical harness by holding both connectors and pull apart. Discard removed jumper harness.

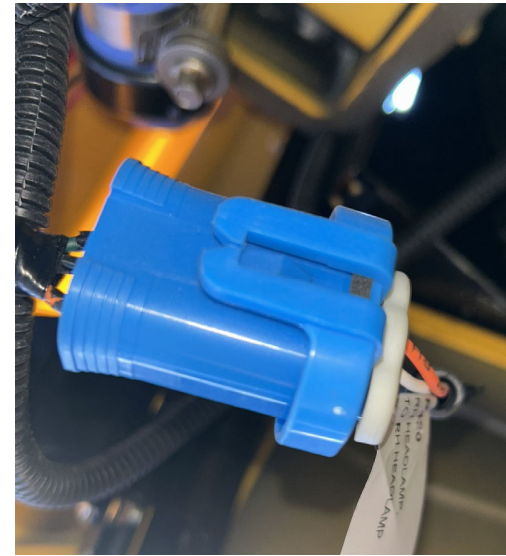
5. Install new jumper harness onto body electrical harness by pushing the connectors together.

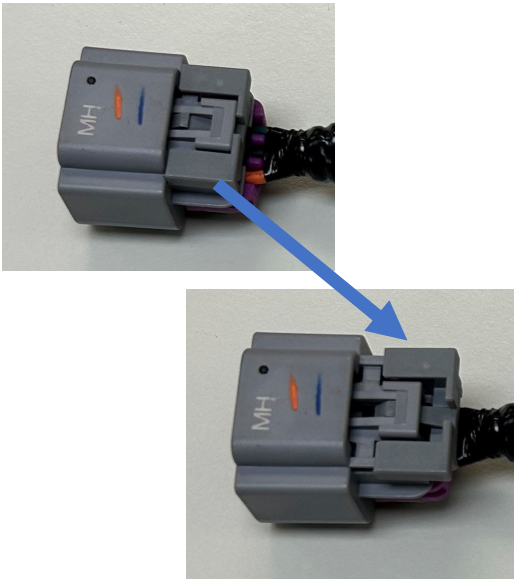
6. Make sure the lock is in unlock position and connect to headlamp.

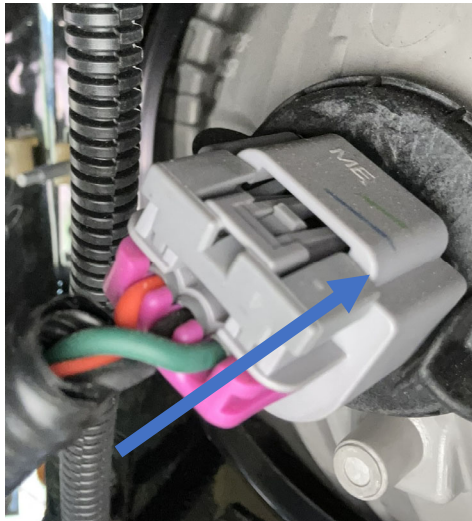
7. Slide the lock into locked position.

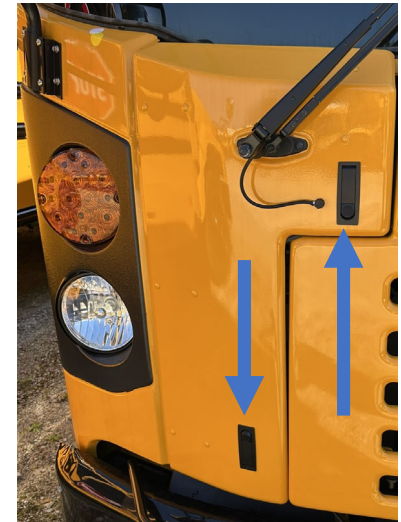
8. Close wiper door and secure the latches.

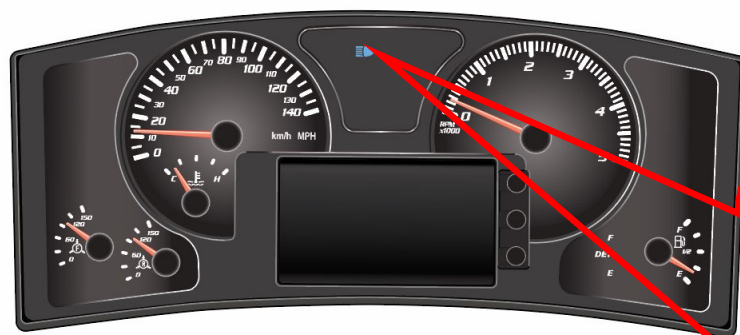
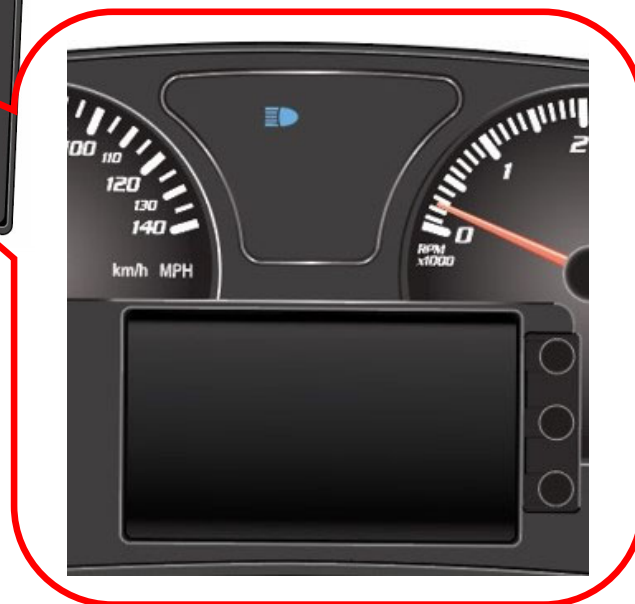
High/Low Beam

Repair Verification: Test High & Low Beam headlamp operation, verifying High Beam Indicator on dash is illuminated with High Beams "ON".
