## RECALL 25V005 / 2025-008 REMEDY INSTRUCTIONS

Make(s): SHASTA OASIS & SPIRIT Model(s): MANY, SEE BELOW Model Year(s): 2025	Repair Code: RC-030-01-00-004677 Allotted Time: .50 HRS. Inspection Code: RC-030-05-00-004676 Allotted Time: 17 HRS
	Concern: According to the recall 24E105 filed by InVision: "The center internal aluminum burner tube connecting the gas valve to the cook top burners can be fractured."	Photo(s) Required: N/A Prior Authorization Required: YES Part(s) Kit Number: F100697534 Part(s) Return: NO, FIELD DESTROY

**GAS LINE INSPECTION AND REPLACEMENT  
FOR FRONT BURNER**

**MODELS:  
Three Burner  
410-2030**

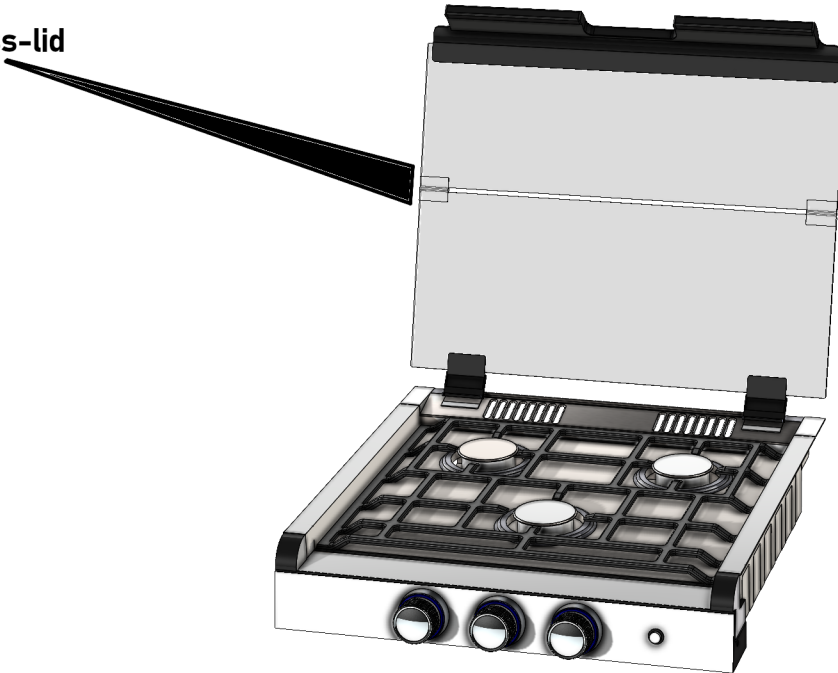
1. Lift glass-lid

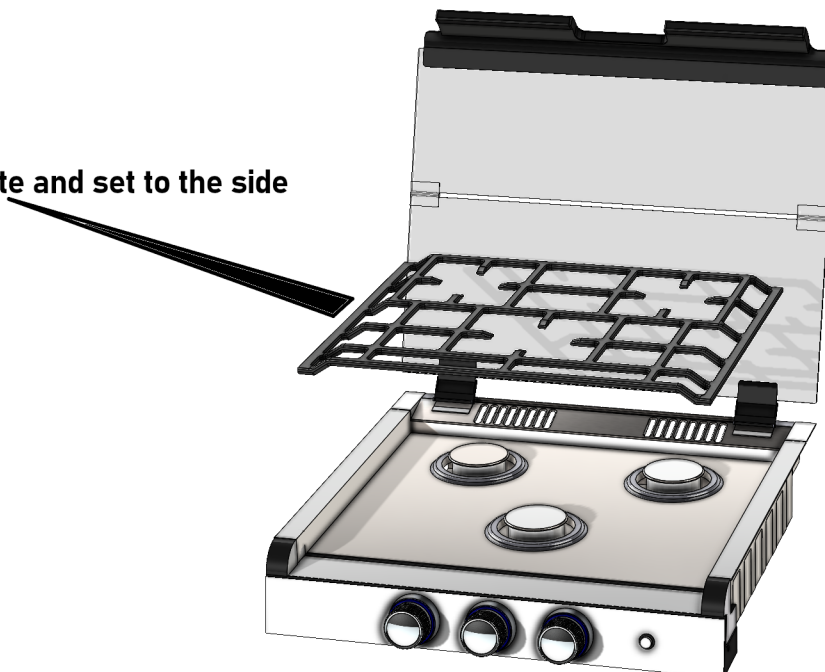
2. Lift grate and set to the side

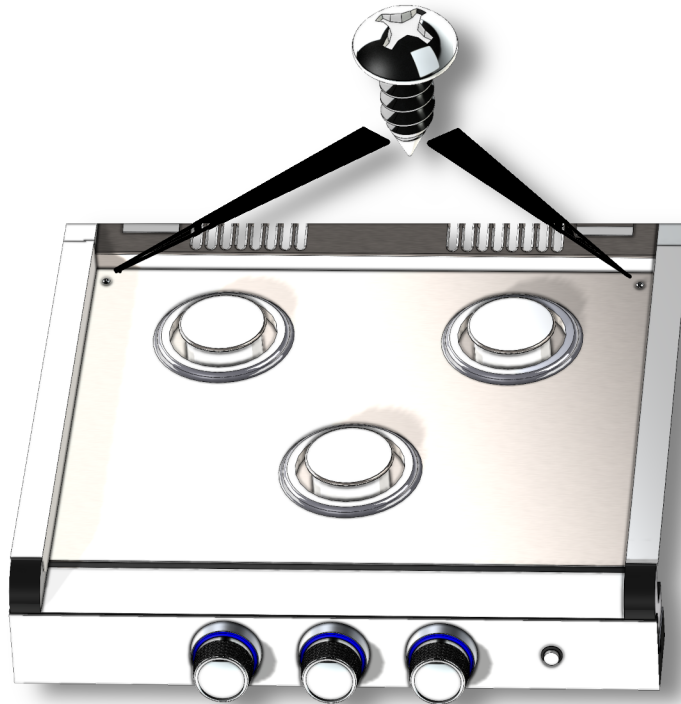
**3. Remove 2 screws from rear of pan**

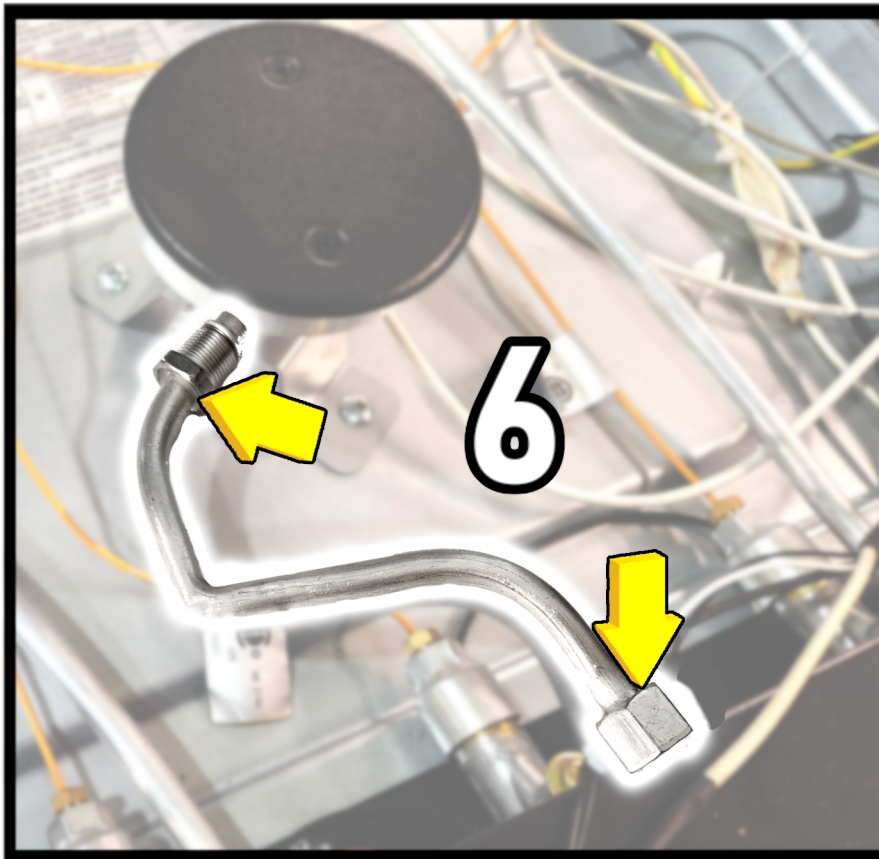
6. With a small brush, apply the soapy water to the areas indicated in the image to the left.

8. Visually inspect the areas for any bubbles forming which indicates a leak.

9. If no leaks are detected, record the serial number and re-assemble the unit; If a leak is detected move on to the next steps to replace the faulty gas line with a new one.

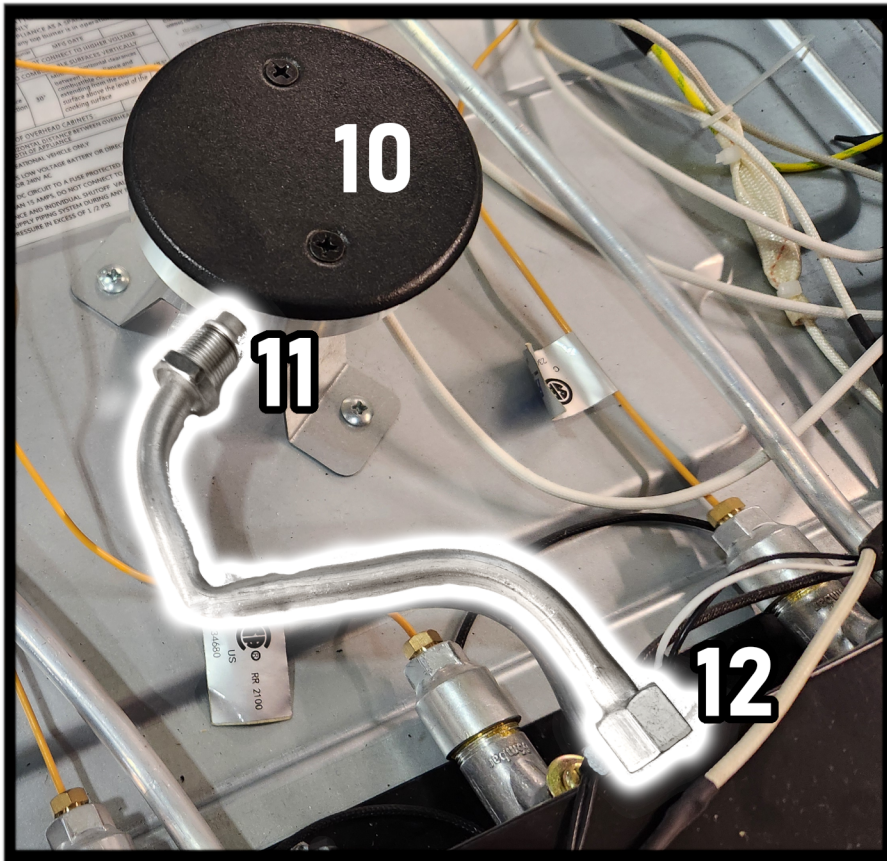
10. Brace burner with one hand so its position isn't altered .

11. With a 14mm wrench carefully turn the connector counter-clockwise.

12. With a 16mm wrench carefully turn the connector counter-clockwise.

13. Follow the procedure in reverse to install new gas line and reassemble cooktop.
