# RECALL 25V005 / 2025-008 REMEDY INSTRUCTIONS

| <br><b>FOREST RIVER</b> | Make(s): SHASTA OASIS & SPIRIT<br>Model(s): MANY, SEE BELOW<br>Model Year(s): 2025 | Repair Code: RC-030-01-00-004677<br>Allotted Time: .50 HRS.<br>Inspection Code: RC-030-05-00-004676<br>Allotted Time: 10 HRS |

## GAS COOKTOP

### GAS LINE REPLACEMENT FOR FRONT BURNER

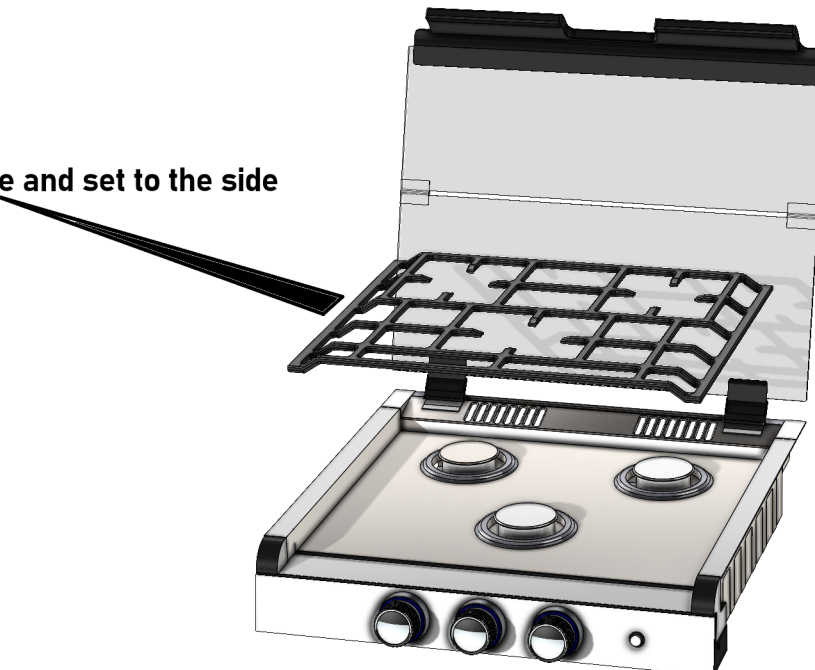
2. Lift grate and set to the side

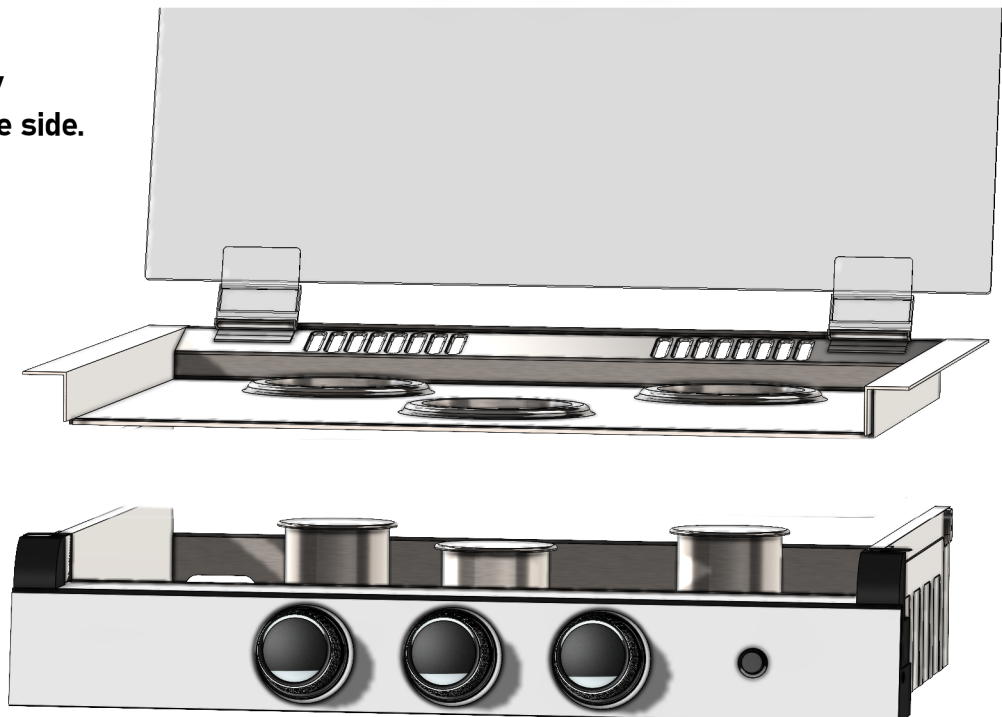
4. Lift pan/glass-top away from base and set to the side.

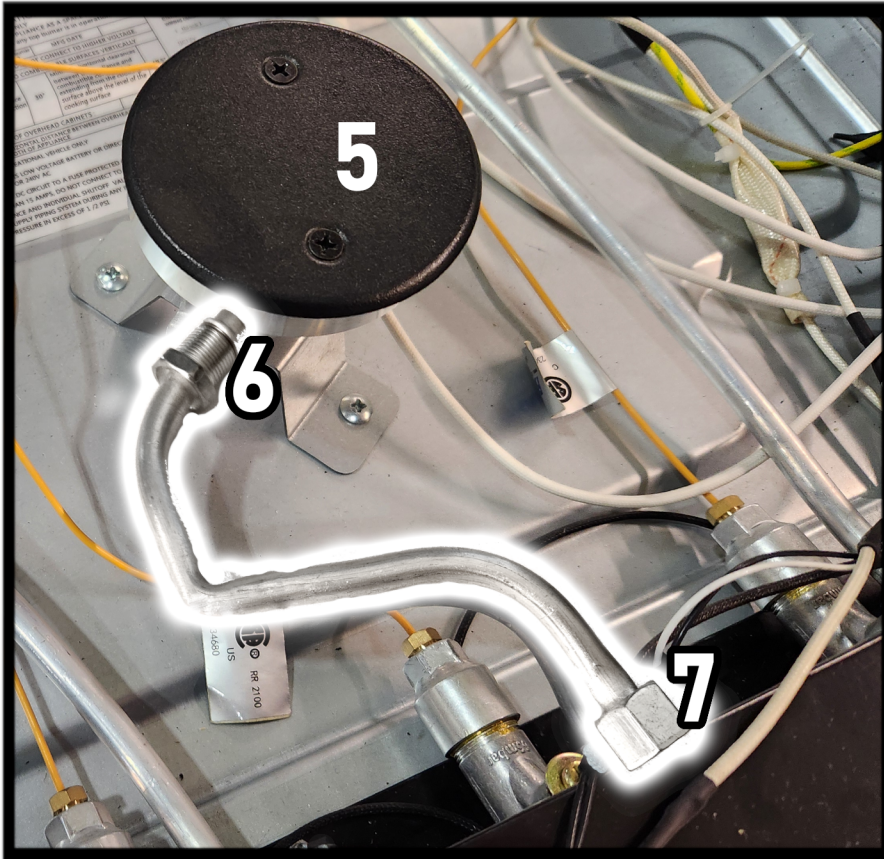
5. Brace burner with one hand so its position isn't altered .

6. With a 14mm wrench carefully turn the connector counter-clockwise.

7. With a 16mm wrench carefully turn the connector counter-clockwise.

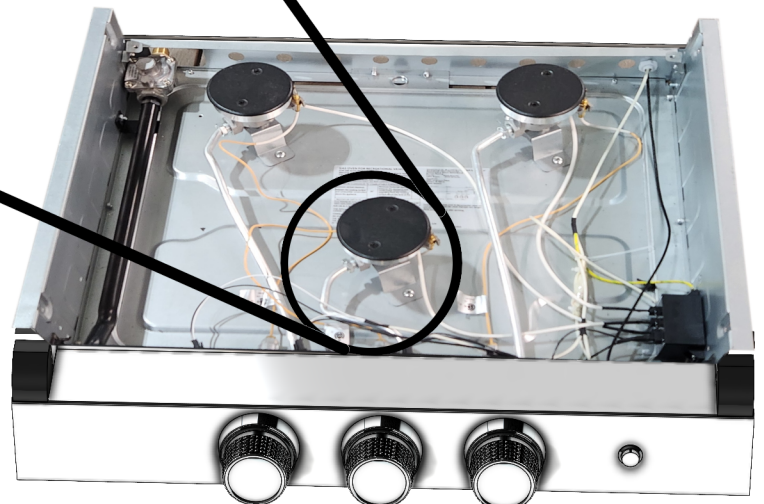
8. Follow the procedure in reverse to install new gas line and reassemble cooktop.
