**NHTSA Safety Recall 25V-007**

**SUBJECT: Campaign # 194 – Spare Tire Carrier May Detach**

# Spare Tire Carrier

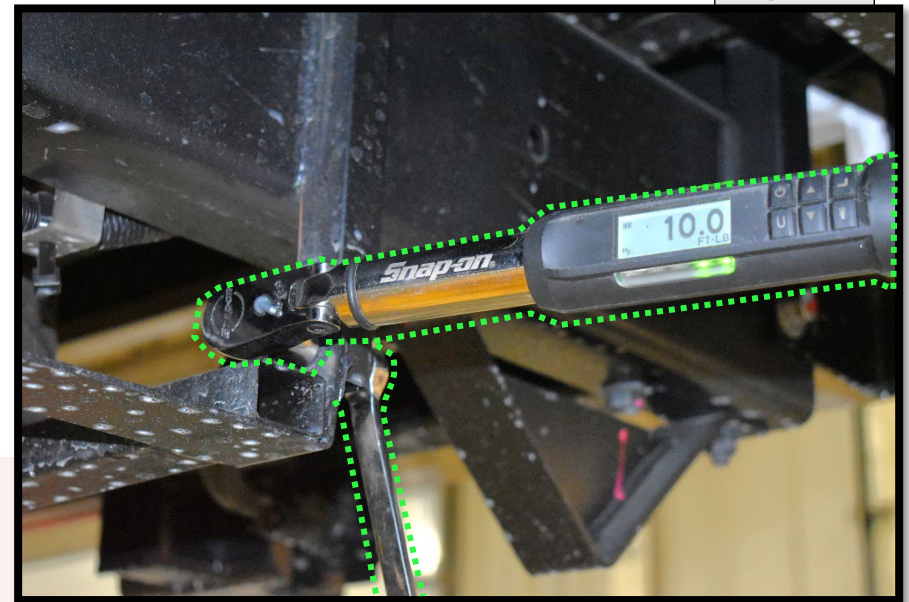
Figure 3

1. Use a torque wrench capable of 10ft/lbs. and a 9/16" socket and place on the nut of the bolt. (See Figure 3)
2. Use a 9/16" backup wrench to hold the head of the bolt to secure it from moving as you torque the nut to the required torque specification 10ft/lbs. (See Figure 3)
3. Repeat the process for the second bolt.
4. Once bolts are torqued correctly, use a torque marker or torque paint to mark the bolt and the surface of the bracket the bolt is on. This will indicate that the bolt was torqued to the proper specification. (See Figure 4 – Orange Marks)
