RAM Remedy available for

- 2016 and 2018-2019 (D2) Ram 3500 Pickup
- 2016 and 2018-2020 (DJ) Ram 2500 Pickup
- 2016 and 2018-2019 (DS) Ram 1500 Pickup
- 2016 (DF) Ram 3500 GVWR less than 10,000 lbs Cab Chassis

SYMPTOM DESCRIPTION

Replace Right Side (Passenger Side) CAB.

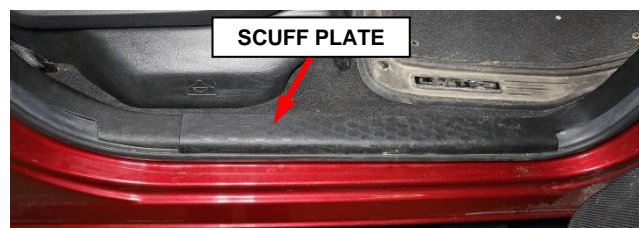
Figure 5 – Door Sill Scuff Plates

10. Release the front and rear door sill scuff plates on either side of the B pillar lower trim panel to allow for removal of the B-pillar lower trim panel (Figure 5).

49. Install the seat belt turning loop cover (Figure 7).
50. Position the B-pillar lower trim panel and engage the retaining clips fully (Figure 6).
51. Position the front and rear door sill scuff plates and engage the retainers (Figure 5).

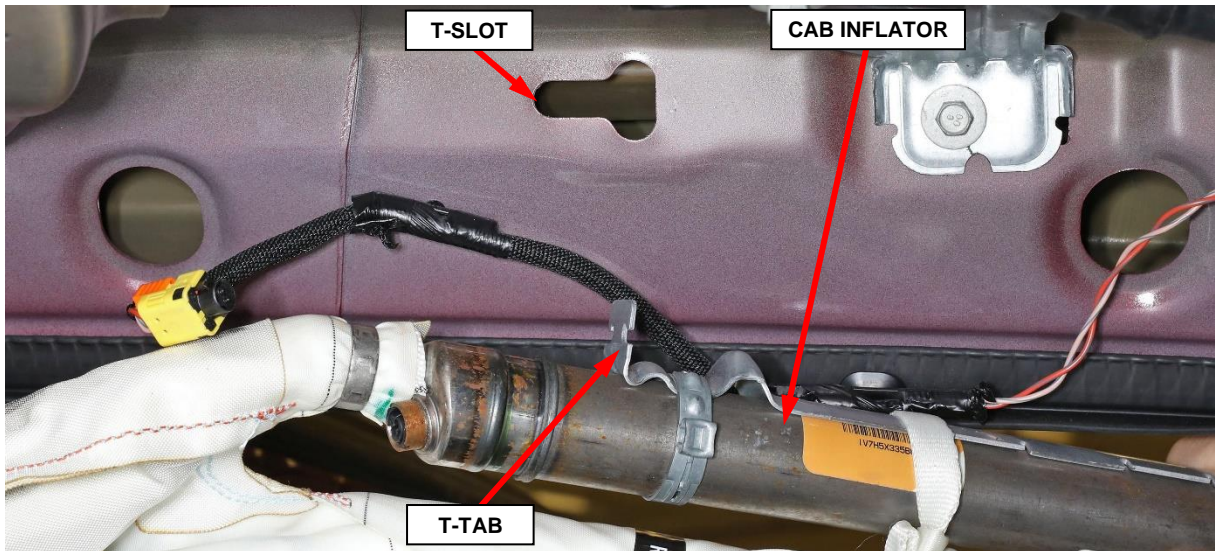
Figure 38 – CAB Inflator T-Tab and Inner Roof Rail T-Slot

32. Slide the inflator rearward far enough to disengage the T-tab at the front of the inflator bracket from the keyed T-slot in the inner roof rail over the rear door opening (Figure 38).
