RAM Remedy available for

SAFETY RECALL

Curtain Airbag Inflator

Reference: 09C / NHTSA 25V-010

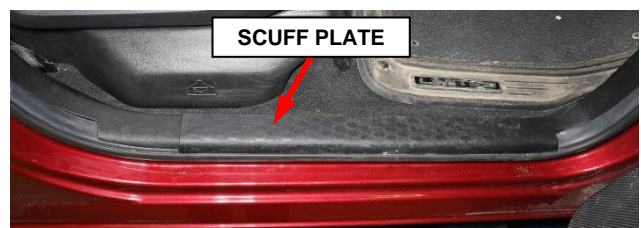
Figure 5 – Door Sill Scuff Plates

10. Release the front and rear door sill scuff plates on either side of the B pillar lower trim panel to allow for removal of the B-pillar lower trim panel (Figure 5).

49. Install the seat belt turning loop cover (Figure 7).
50. Position the B-pillar lower trim panel and engage the retaining clips fully (Figure 6).
51. Position the front and rear door sill scuff plates and engage the retainers (Figure 5).

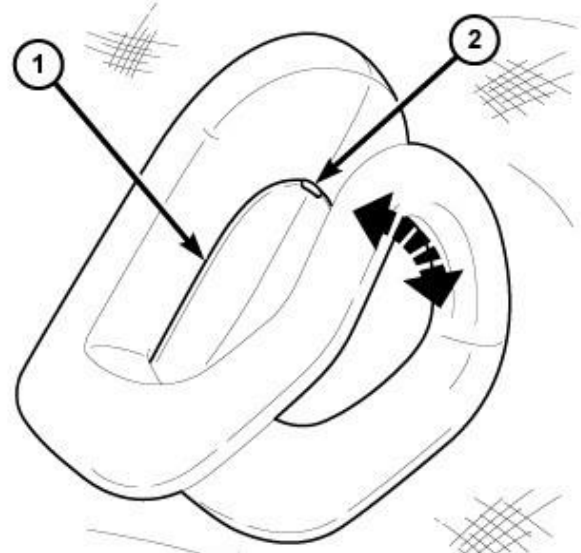
Figure 9 – Coat Hook

16. Using a small flat bladed tool, open the coat hook screw cover (2) then remove the screw and coat hook (Figure 9).

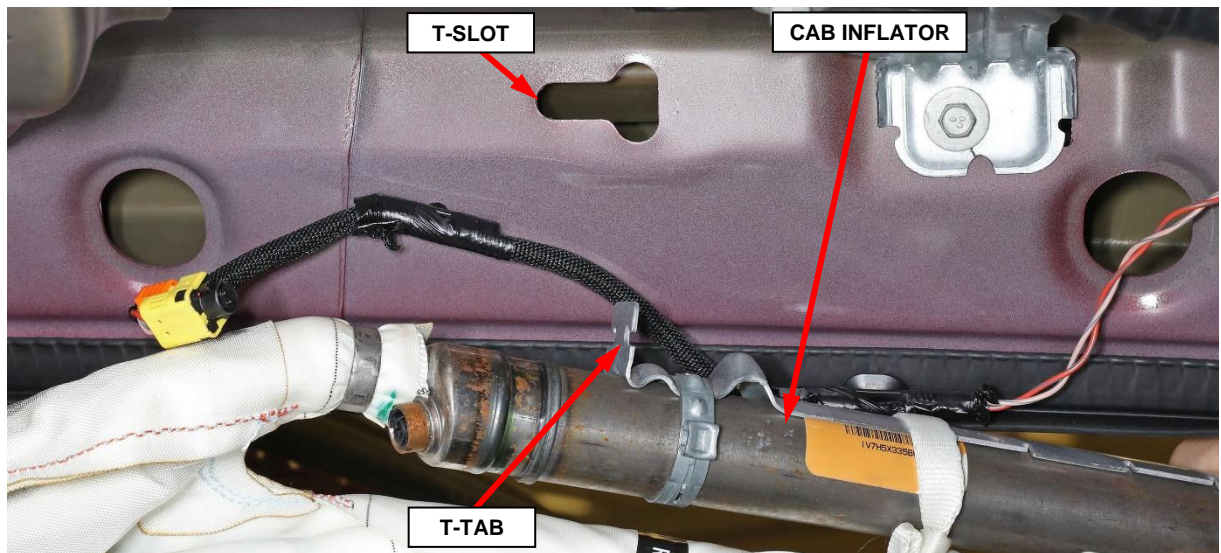
Figure 18 – CAB Inflator T-Tab and Inner Roof Rail T-Slot

30. Slide the inflator rearward far enough to disengage the T-tab at the front of the inflator bracket from the keyed T-slot in the inner roof rail over the rear door opening (Figure 18).

34. Insert the T-tab at the front of the inflator bracket into the keyed T-slot in the inner roof rail over the rear door opening and slide the inflator forward to engage it (Figure 18).

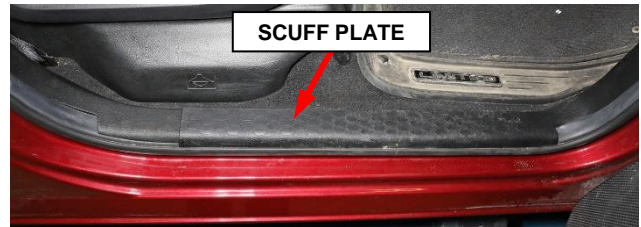
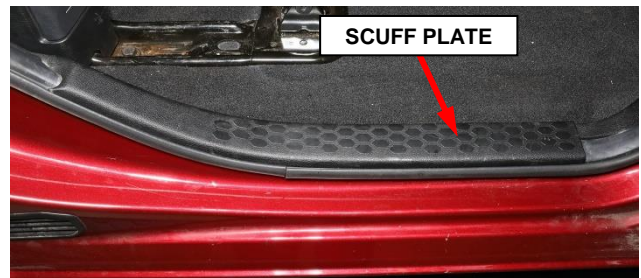
Figure 24 – Door Sill Scuff Plates

9. Release the front and rear door sill scuff plates on either side of the B pillar lower trim panel to allow for removal of the B-pillar lower trim panel (Figure 24).

NOTE: Ensure that all C-pillar fasteners are installed/engaged properly.
60. Install the B-pillar upper trim panel (1) and engage the retaining clips fully (Figure 27).
61. Install the grab handle bolts and tighten to 5 N·m (44 in. lbs.). Close the fastener covers (2) (Figure 27).
62. Remove and **DISCARD** the bolt retainer and the bolt from the seat belt turning loop, save the spacer washer for reuse (Figure 40).
63. Using a **NEW** bolt and reusing the spacer washer, install the turning loop then tighten the bolt to 40 N·m (30 ft. lbs.) (Figure 26).
64. Install the seat belt turning loop cover (Figure 26).
65. Position the B-pillar lower trim panel and engage the retaining clips fully (Figure 25).
66. Position the front and rear door sill scuff plates and engage the retainers (Figure 24).

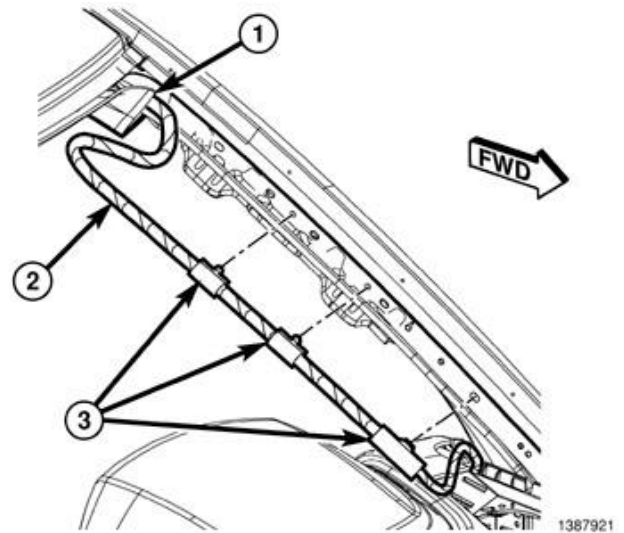
Figure 35 – Headliner Harness

- 25. As necessary, release the headliner wiring harness clips (3) from the A-pillar to allow enough wiring harness slack for lowering the headliner (Figure 35).
- 26. Release the door seals from the door openings to allow for lowering of the headliner.
