**SAFETY RECALL**  
 NORTH AMERICA  
**Curtain Airbag Inflator**

Reference: 05C / NHTSA 25V-010

FCA US LLC

- 2016 and 2018-2019 (D2) Ram 3500 Pickup
- 2016 and 2018-2020 (DJ) Ram 2500 Pickup
- 2016 and 2018-2019 (DS) Ram 1500 Pickup
- 2016 (DF) Ram 3500 GVWR less than 10,000 lbs Cab Chassis

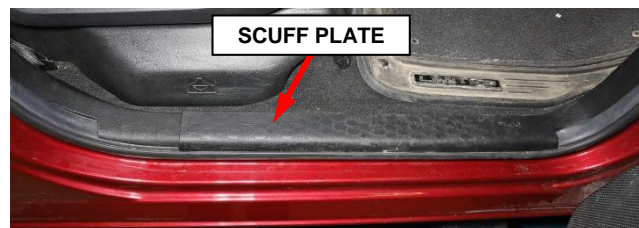
**Figure 5 – Door Sill Scuff Plates**

10. Release the front and rear door sill scuff plates on either side of the B pillar lower trim panel to allow for removal of the B-pillar lower trim panel (Figure 5).

49. Install the seat belt turning loop cover (Figure 7).
50. Position the B-pillar lower trim panel and engage the retaining clips fully (Figure 6).
51. Position the front and rear door sill scuff plates and engage the retainers (Figure 5).

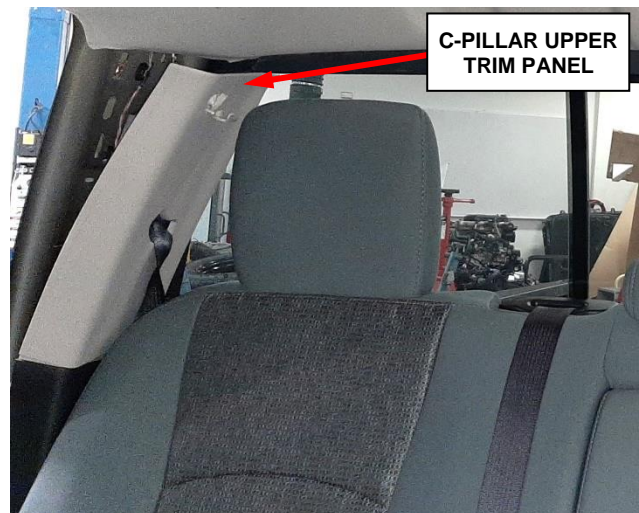
**Figure 11 – C-Pillar Trim Panels**

18. Release the retaining clips and tilt the top of the C-pillar upper trim panel inward (Figure 11).

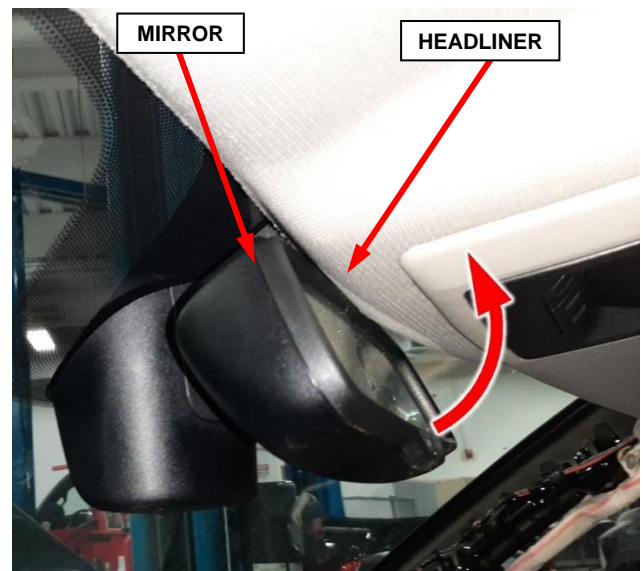
**Figure 15 – Rearview Mirror**

22. Release the door seals from the door openings to allow for lowering of the headliner.
23. Tilt the rear view mirror up to allow clearance for lowering the headliner (Figure 15).

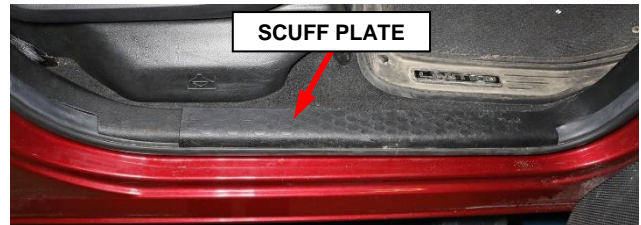
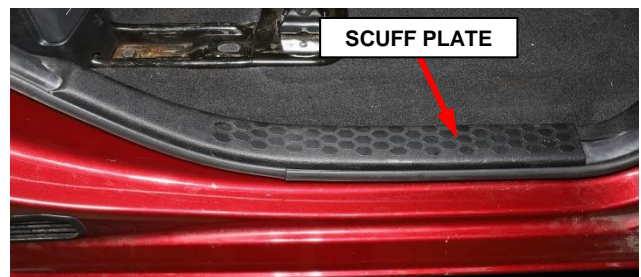
**Figure 24 – Door Sill Scuff Plates**

9. Release the front and rear door sill scuff plates on either side of the B pillar lower trim panel to allow for removal of the B-pillar lower trim panel (Figure 24).

60. Install the B-pillar upper trim panel (1) and engage the retaining clips fully (Figure 27).
61. Install the grab handle bolts and tighten to 5 N·m (44 in. lbs.). Close the fastener covers (2) (Figure 27).
62. Remove and **DISCARD** the bolt retainer and the bolt from the seat belt turning loop, save the spacer washer for reuse (Figure 40).
63. Using a **NEW** bolt and reusing the spacer washer, install the turning loop then tighten the bolt to 40 N·m (30 ft. lbs.) (Figure 26).
64. Install the seat belt turning loop cover (Figure 26).
65. Position the B-pillar lower trim panel and engage the retaining clips fully (Figure 25).
66. Position the front and rear door sill scuff plates and engage the retainers (Figure 24).

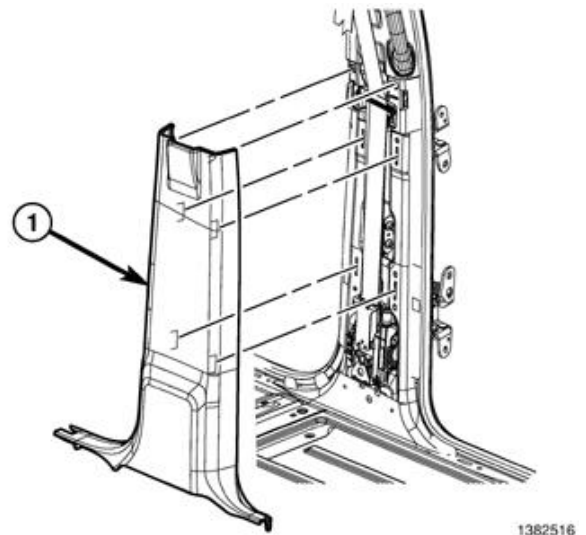
**Figure 25 – B-Pillar Lower Trim Panel**

10. Release the retaining clips and remove the B-pillar lower trim panel to allow for removal of the B-pillar upper trim panel (Figure 25).

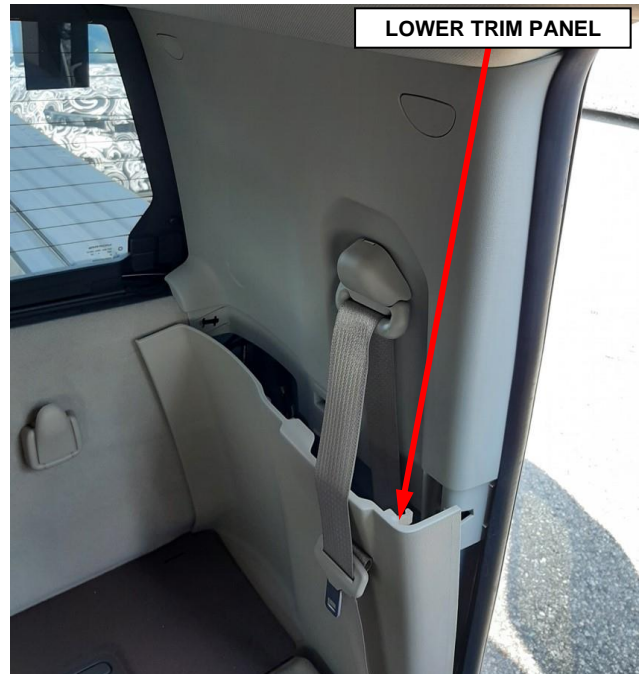
**Figure 28 – C-Pillar Lower Trim Panel**

- 16. Release the upper retaining clips of the lower C-pillar trim panel to allow for removal of the upper C pillar trim panel (Figure 28).

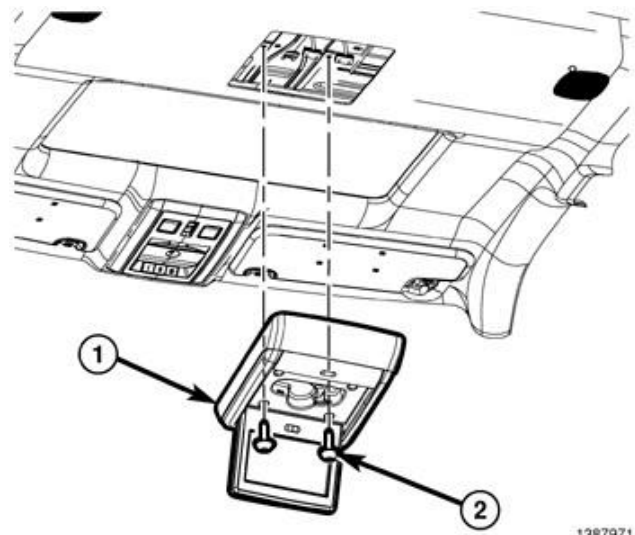
**Figure 32 – Rear Seat DVD Monitor**

22. If equipped with DVD monitor, remove the screws (2) and separate the monitor (1) from the roof (Figure 32).

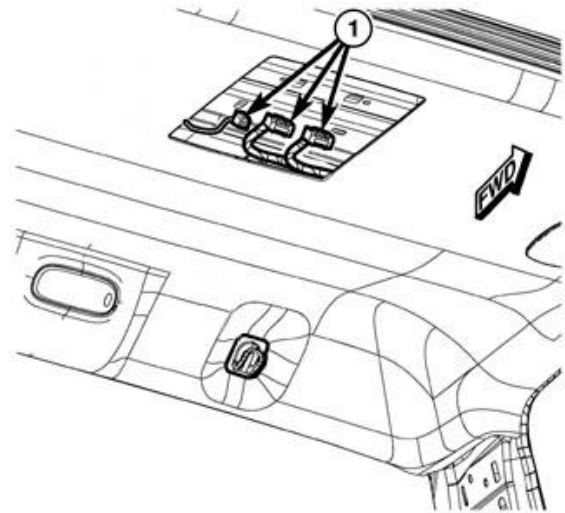
**Figure 33 – DVD Monitor Electrical Connectors**

23. If equipped with DVD monitor, disconnect the electrical connectors (1) (Figure 33).

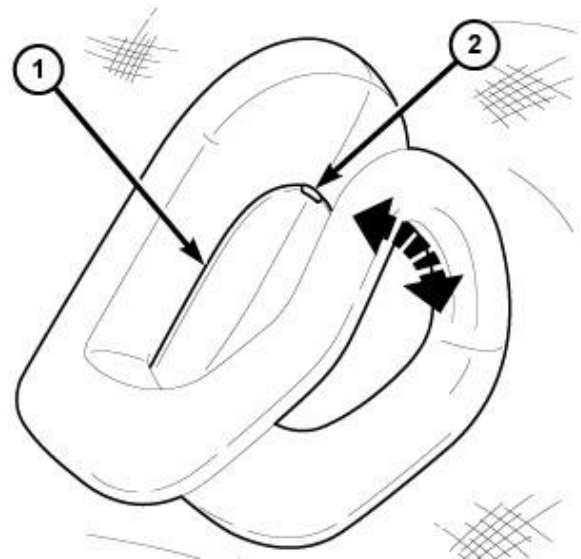
**Figure 34 – Coat Hook**

24. Using a small flat bladed tool, open the coat hook screw cover (2) then remove the screw and coat hook (Figure 34).

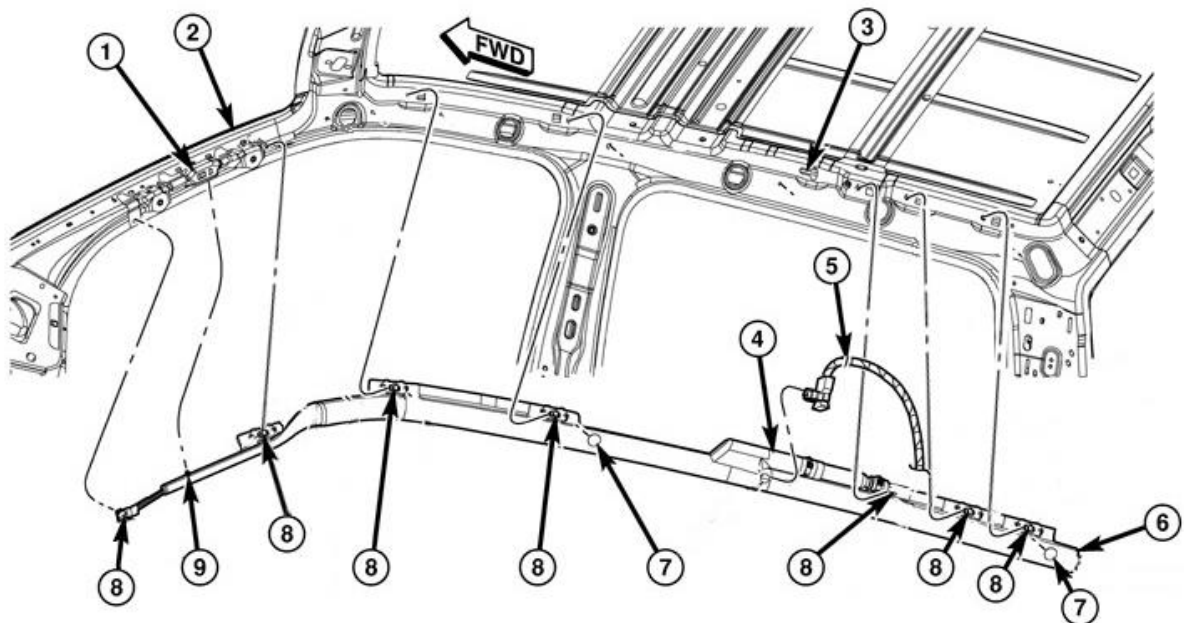
**Figure 37 – Side Curtain Airbag**

33. Remove the CAB (6) from the vehicle as a unit and **DISCARD** following local ordinances and recommended procedures for handling and disposal of Non-Deployed Supplemental Restraints (Figure 37). Provided packaging is not authorized for the transport of the recalled CAB Module. Parts will need to be either deployed on-site or transported in alternative approved containers.

34. Check to be certain that the spring nuts are properly installed in the inner roof rail and that they are in good condition.
35. Position the **NEW** CAB (6) into the vehicle as a unit (Figure 37).
