January 17, 2025

Version 1

Safety Recall: 2024 ZDX Passenger-Side Front Stabilizer Bracket Bolt Inspection

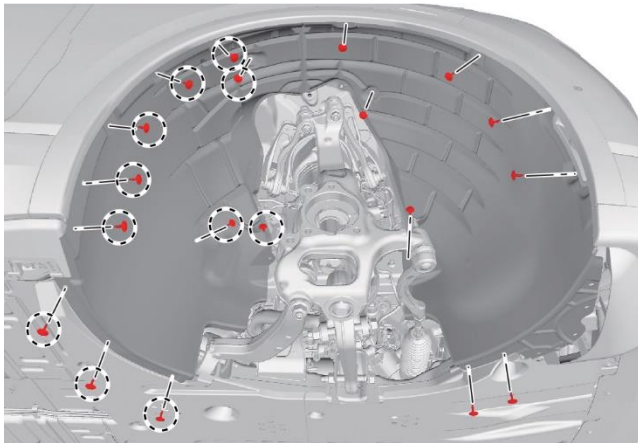
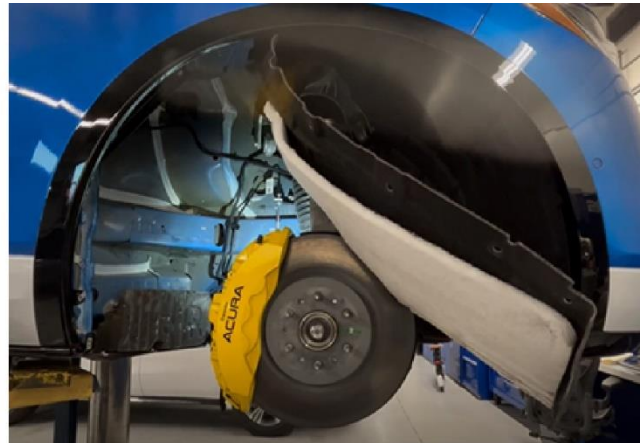
1. Remove the front right tire and wheel assembly.
 - [Tire and Wheel Removal and Installation](#)
2. Remove the mounting bolts (circled) for the rear half of the wheelhouse liner, then move the rear half of the wheelhouse liner to allow access to the front stabilizer bar mounting bolts.

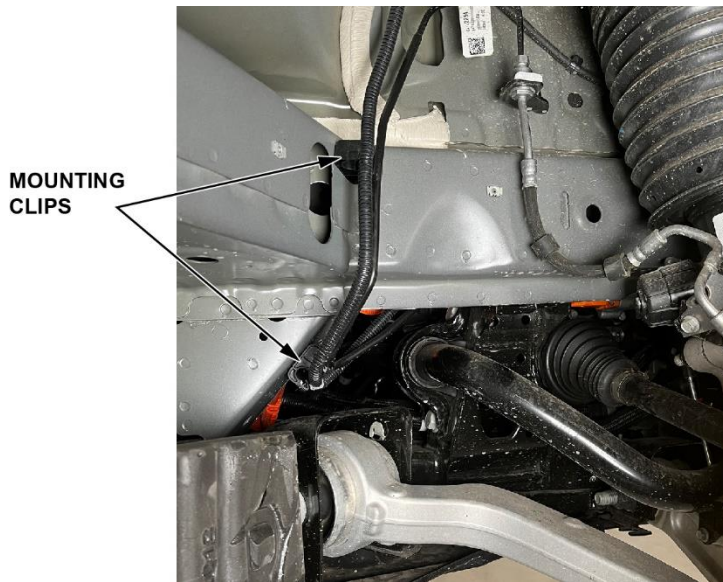
3. Release the harness and brake line from the two mounting clips.

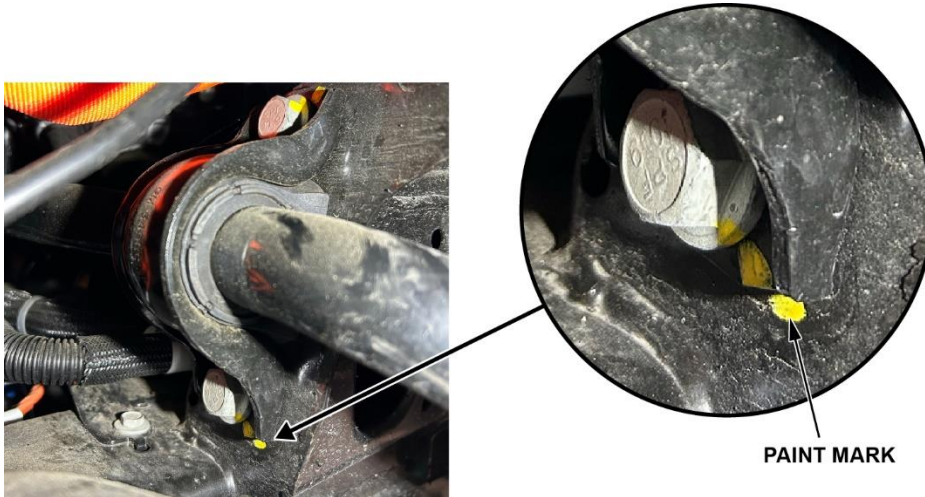
4. Make a reference mark on both bolts and the stabilizer bar bracket with a paint pen.
NOTE: If any bolts are missing, refer to the appropriate Required Action in Step 5.

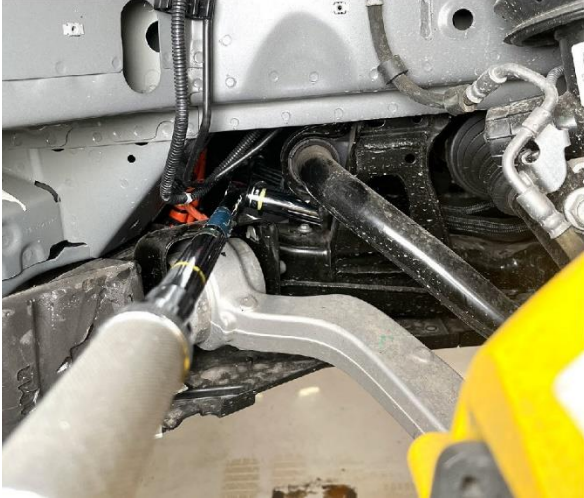
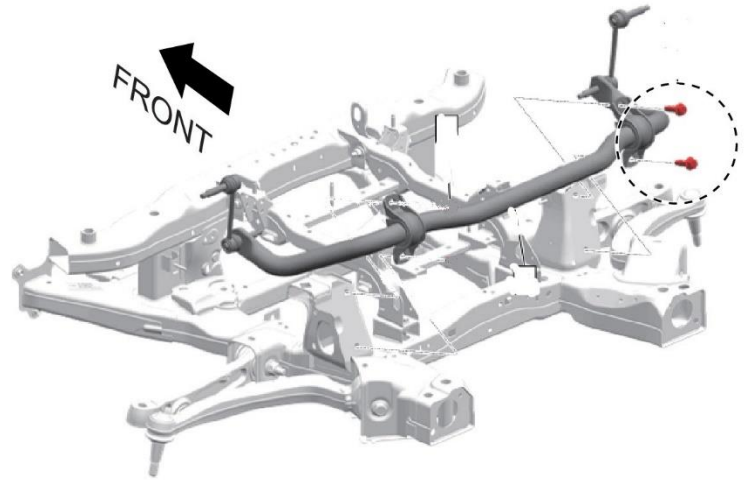
5. Torque both right-side front stabilizer bar bracket bolts to **10 N·m (7 lb-ft)**, then check the paint marks to see if the bolts have moved:

Bolt Status	Required Action
Neither of the two bolts have moved.	Torque the two passenger-side front stabilizer bar bracket bolts to 100 N·m (74 lb-ft) .
One bolt moved, or is missing.	Replace the loose or missing bolt with a new bolt, then torque the two passenger-side front stabilizer bar bracket bolts to 100 N·m (74 lb-ft) .
Both bolts have moved.	Replace both bolts with new bolts, then torque the two passenger-side front stabilizer bar bracket bolts to 100 N·m (74 lb-ft) .
Both bolts are missing.	Inspect the EV battery cable, the drive motor battery charger inlet hose, the drive motor power distribution control module hose, and the stabilizer bar for any damage. Replace any damaged components. Replace both bolts with new bolts, then torque the two passenger-side front stabilizer bar bracket bolts to 100 N·m (74 lb-ft) .

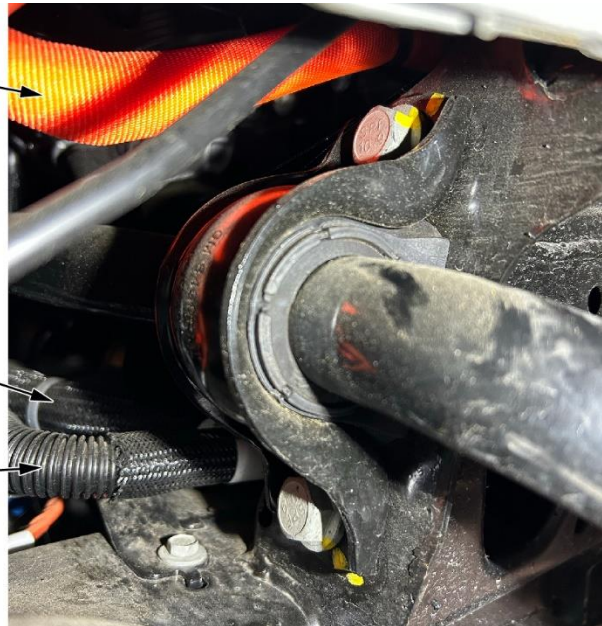
During assembly, the passenger-side front stabilizer bar bracket bolts may have been improperly fastened. If the bracket bolt(s) loosens and separates from the vehicle frame, the stabilizer bar and/or bracket can damage the high voltage cables and/or EV battery coolant lines.

EV BATTERY CABLE

DRIVE MOTOR BATTERY CHARGER INLET HOSE

DRIVE MOTOR POWER DISTRIBUTION CONTROL MODULE HOSE

Inspect the passenger side front stabilizer bolts, inspect for damage if bolts are missing, replace any damaged parts, replace missing bolts, tighten bolts to proper torque specification.
