February 25, 2025

Version 2

## Safety Recall: 2025 MDX Center Information Display

Year	Model	Trim Level	VIN Range
2025	MDX	Advance, Advance A-Spec, Advance Type S	Check the iN VIN status for eligibility.

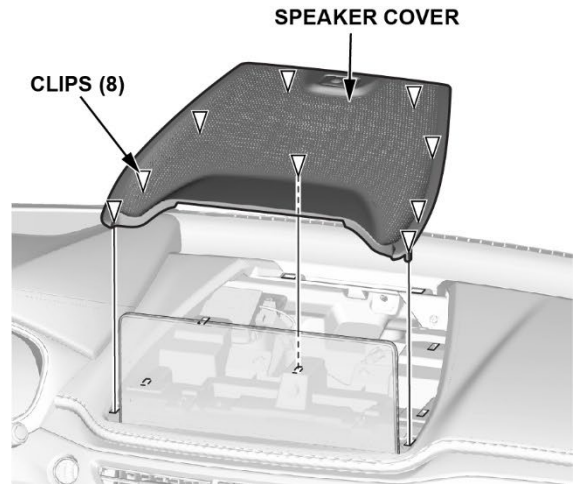
1. Disconnect the [12 Volt Battery Terminal](#).
2. Using a trim tool, carefully remove the center speaker cover.

NOTE: Take care not to scratch or damage the dash and speaker cover when inserting the trim tool.

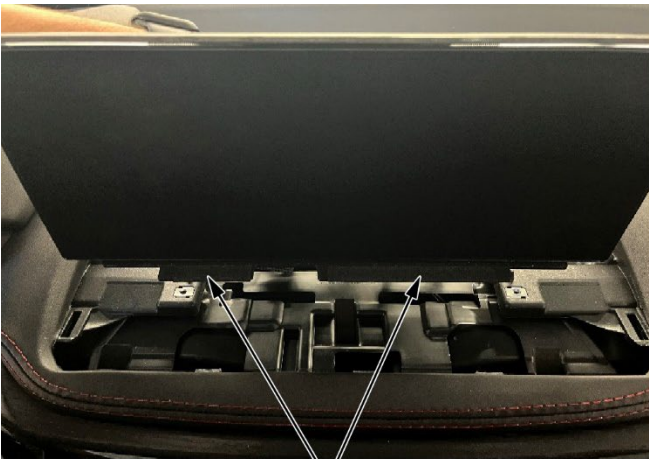
TABS

6. First, pivot the screen forward to release the lower tabs from the dash, then slide the screen back to remove.

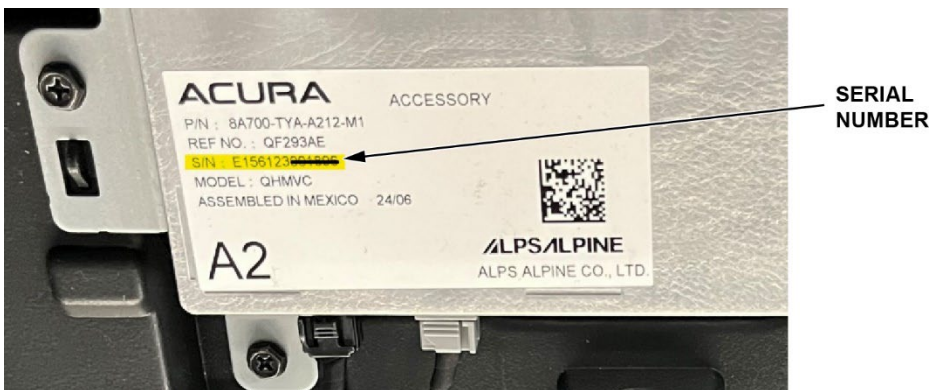
- Safety glasses and protective gloves recommended.
  - To prevent reusing a defective screen, it is necessary to render the screen useless.
1. Document the defective screen serial number on the repair order.

2. Cover the defective screen using a shop towel and shatter the screen.
3. Properly dispose the defective screen in accordance with federal, state and/or local regulations.
