January 28, 2025

Version 1

Safety Recall: 2025 MDX Center Information Display

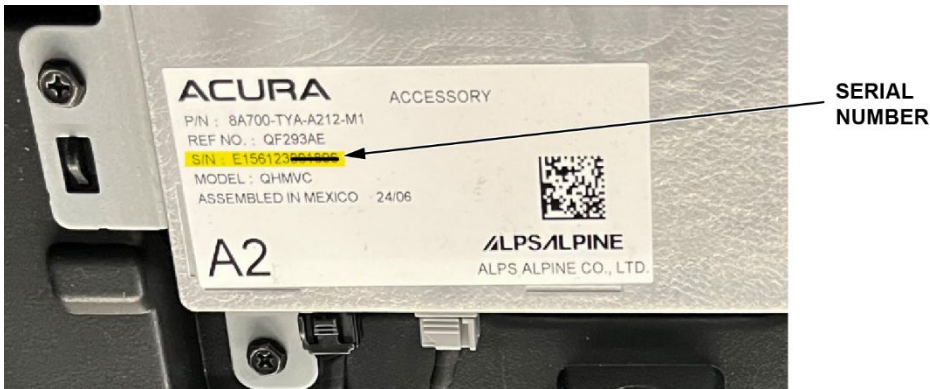
- Safety glasses and protective gloves recommended.
 - To prevent reusing a defective screen, it is necessary to render the screen useless.
1. Document the defective screen serial number on the repair order.

2. Cover the defective screen using a shop towel and shatter the screen.
3. Properly dispose the defective screen in accordance with federal, state and/or local regulations.
