# TECHNICAL INSTRUCTIONS

SAFETY RECALL 25TA02

DRIVER AIRBAG MAY NOT DEPLOY

CERTAIN MODEL YEAR 2023 COROLLA, COROLLA CROSS, COROLLA CROSS HV, HIGHLANDER, HIGHLANDER HV AND TACOMA

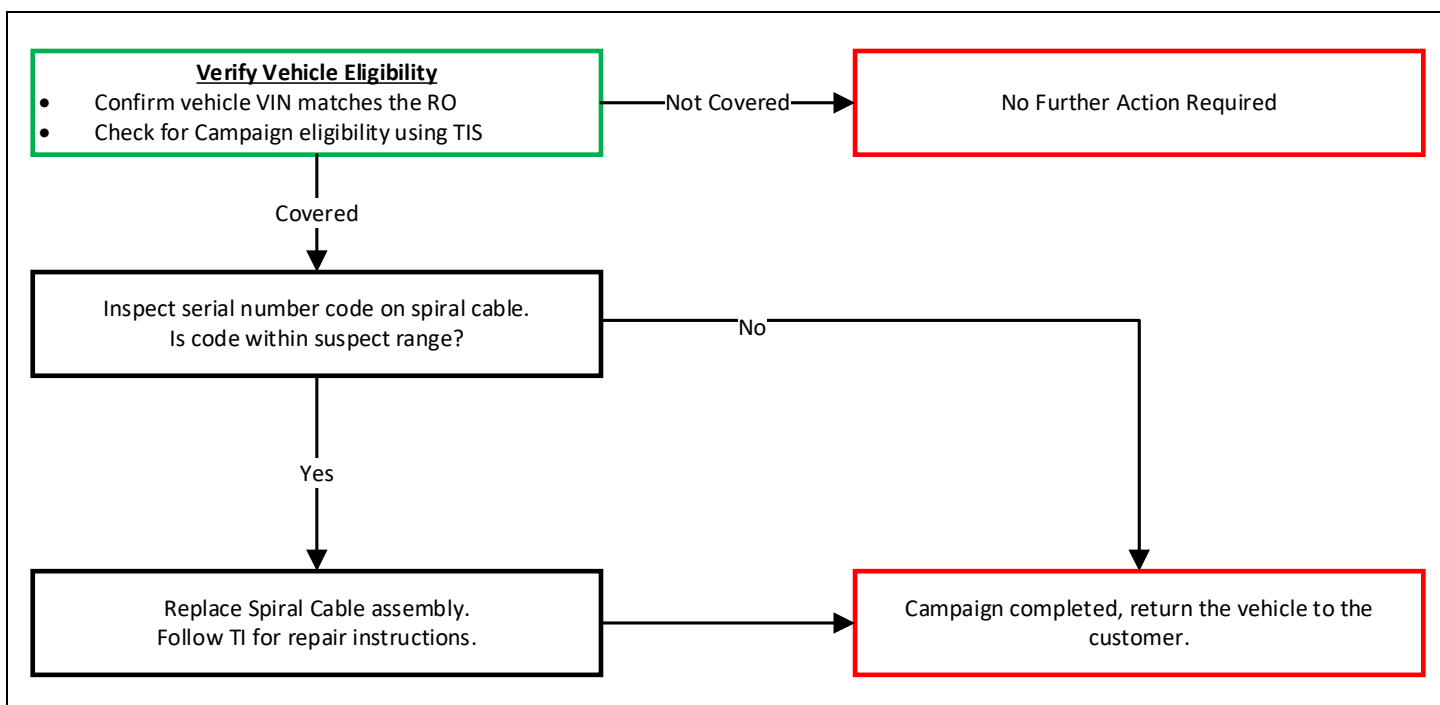
## I. OPERATION FLOW CHART

The flow chart is for reference only. DO NOT use it in place of the full technical instructions. Follow ALL steps as outlined in the full technical instructions to confirm the campaign is completed correctly.

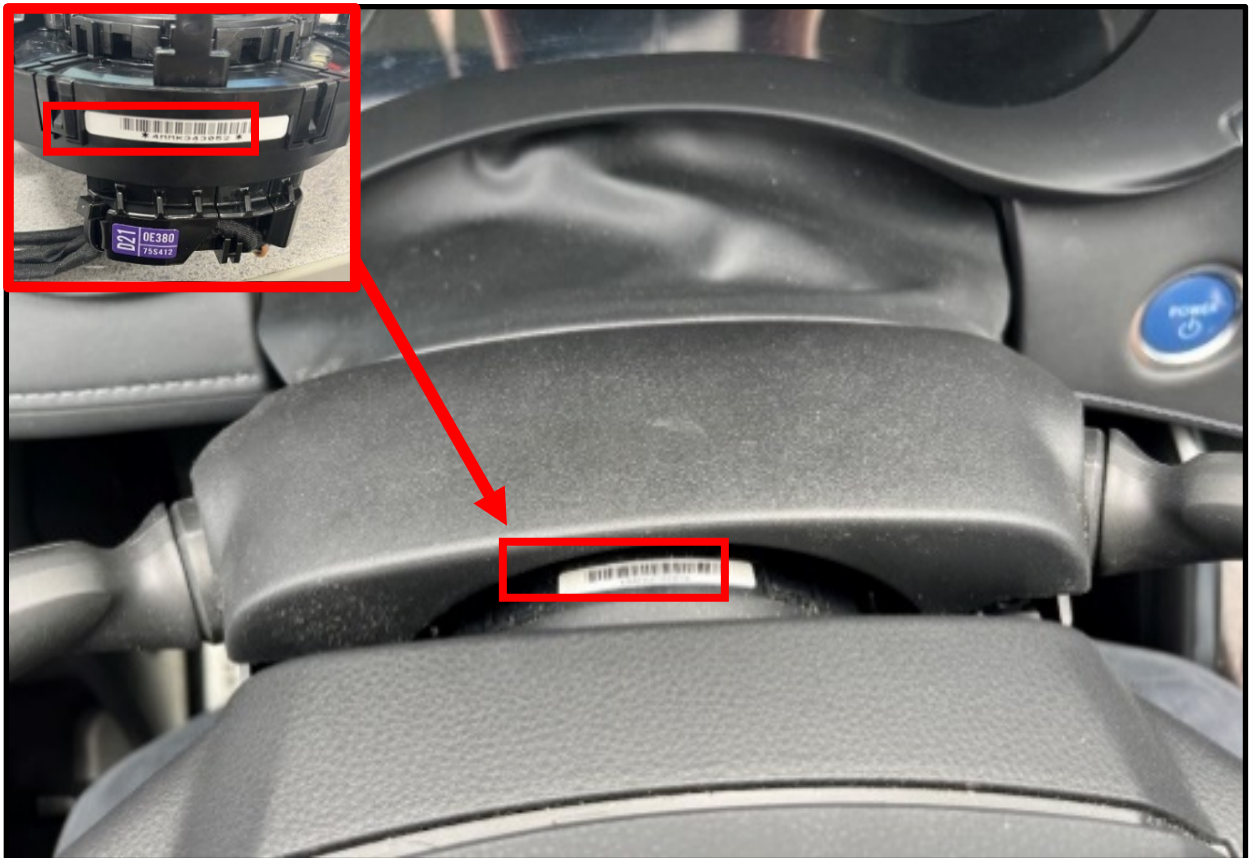
1. Remove upper steering column cover to access spiral cable serial number.  
*Steering – Steering Column – Steering Column Assembly – Removal*

Follow the steps in the Repair Manual to remove the upper steering column cover. **DO NOT REMOVE THE LOWER STEERING COLUMN COVER TO ACCESS THE SERIAL NUMBER.**

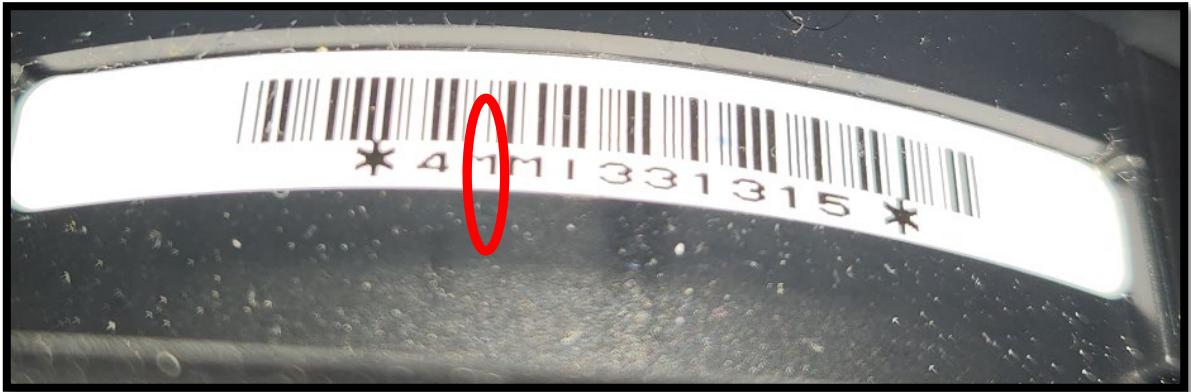
Example of serial number with “l”.

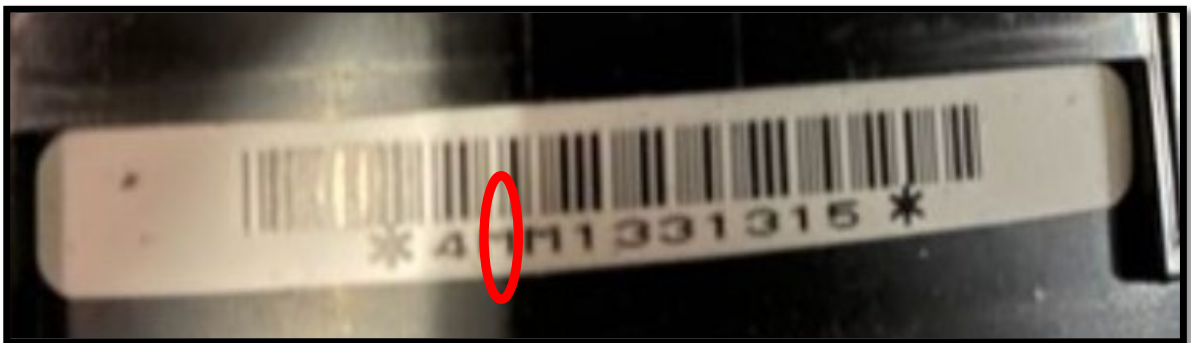
Example of serial number with “1”.
