March 13, 2025

Version 2

Safety Recall: 2025 Pilot 3rd Row Seat Belt Not Routed Correctly

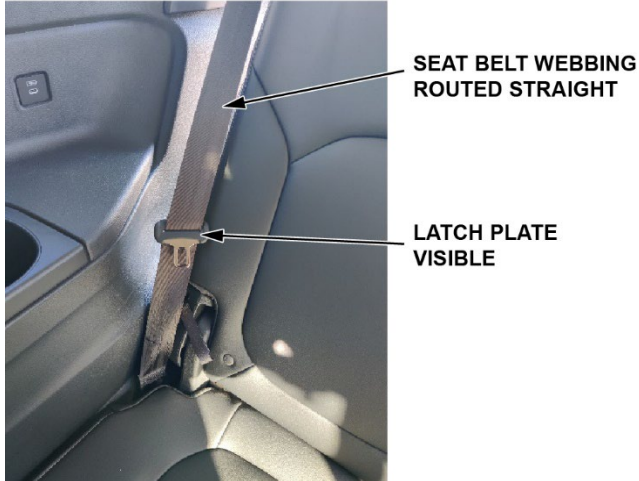
CORRECT

1. Inspect the 3rd row right passenger seat belt, see if the latch plate and seat belt webbing are visible and not trapped behind the rear side liner.
 - If the latch plate and the seat belt webbing are visible, no further action is needed. Ensure proper seat belt functionality.
 - If the latch plate is **not** visible and/or webbing is **not** properly routed, proceed to the REPAIR PROCEDURE.

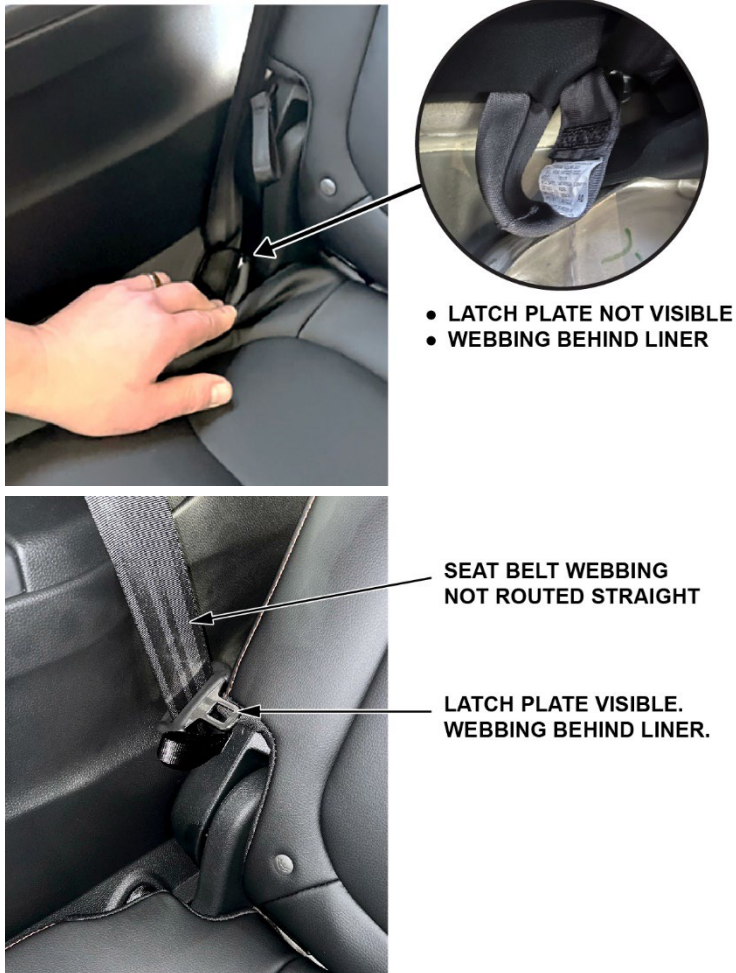
INCORRECT

The passenger side 3rd row seat belt may have been improperly routed, trapping and hiding the seat belt latch plate and seat belt webbing behind the rear side liner panel.

- Inspect the location of 3rd row right passenger seat belt latch plate and seat belt webbing, and ensure proper seat belt functionality
- Reroute the 3rd row right passenger seat belt latch plate and/or seat belt webbing, if necessary

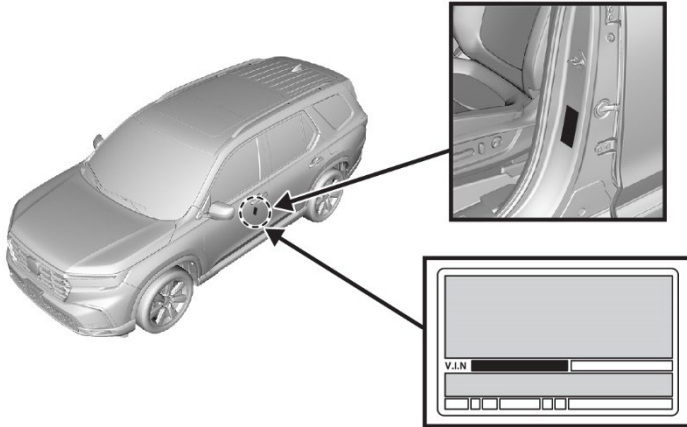
1. Prior to starting the repair procedure, take a photo of the door VIN sticker.
NOTE: A photo of the VIN sticker **will be** needed for warranty submission.

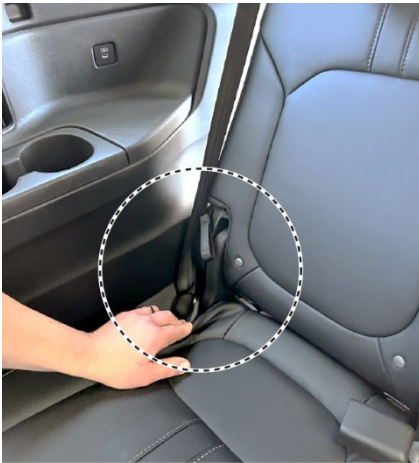
2. Take a photo of the 3rd row right passenger latch plate and seat belt webbing routing.

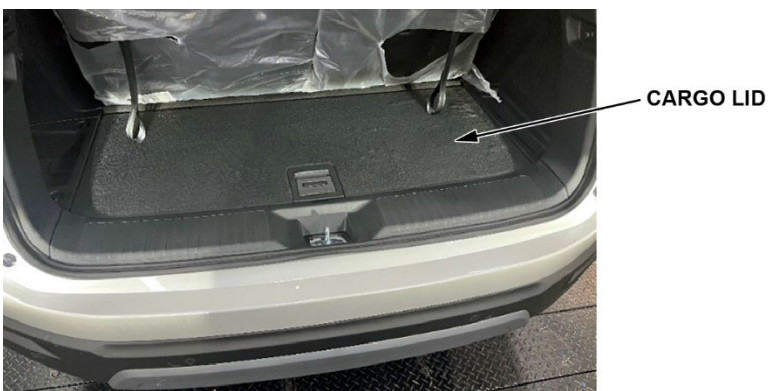
3. Remove the cargo lid.

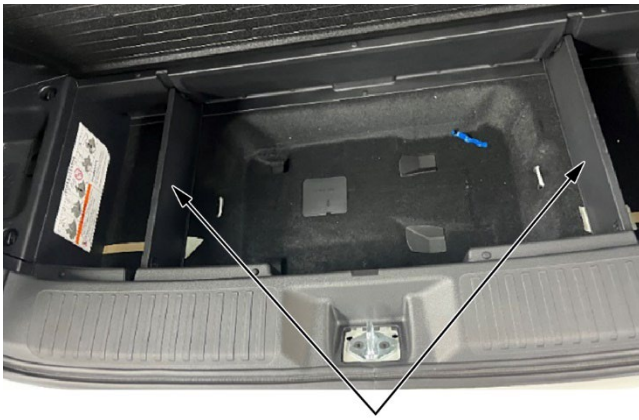
CARGO DIVIDERS

4. Remove the two cargo dividers.

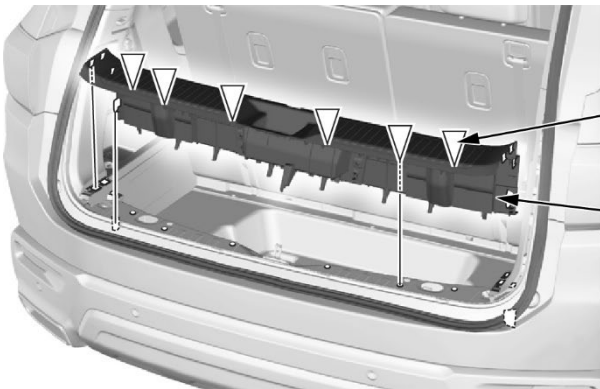
**LOWER TAILGATE
STEP GARNISH**

5. Release the six clips to remove the lower tailgate step garnish.

CLIPS (6)

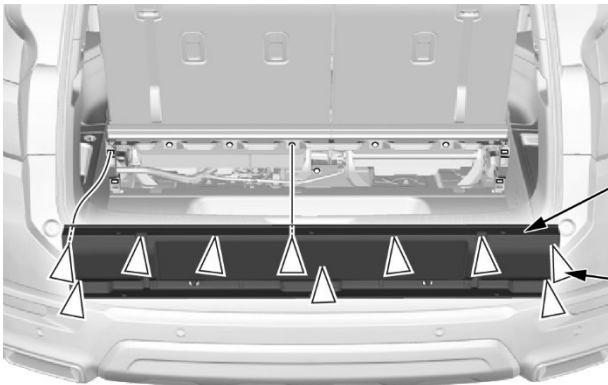
**FORWARD
GARNISH**

6. Pull on the forward garnish to release the clips and tabs, then remove the forward garnish.

CLIPS (10)

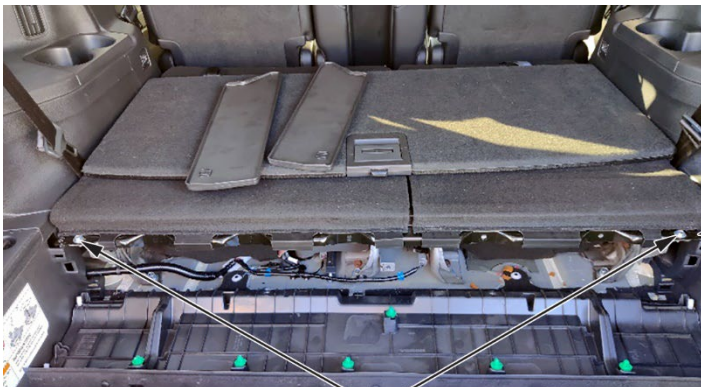
SEAT BAR

7. Remove the two bolts that secure the metal seat bar, then remove the seat bar.

BOLTS

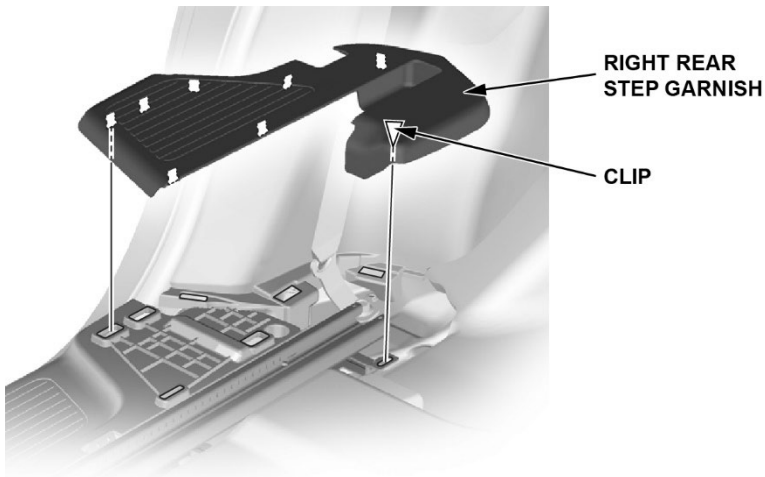
8. Remove the right rear step garnish.

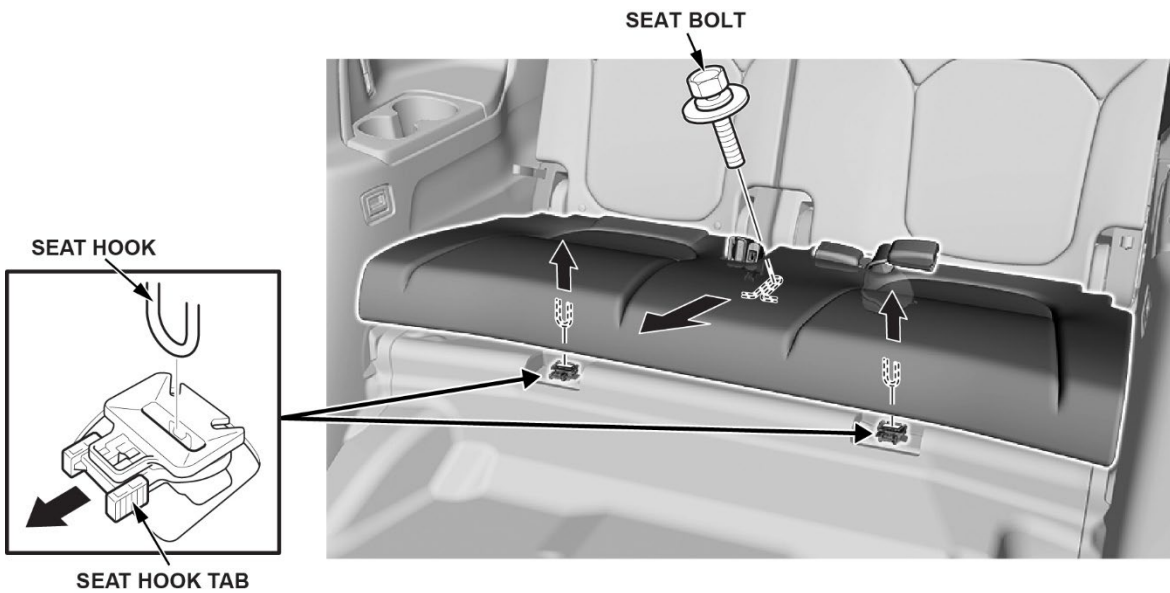
9. Push down on the 3rd row seat cushion while pulling on the seat hook tab to release the seat hook. Remove the center seat bolt, then slide the seat cushion forward to remove.

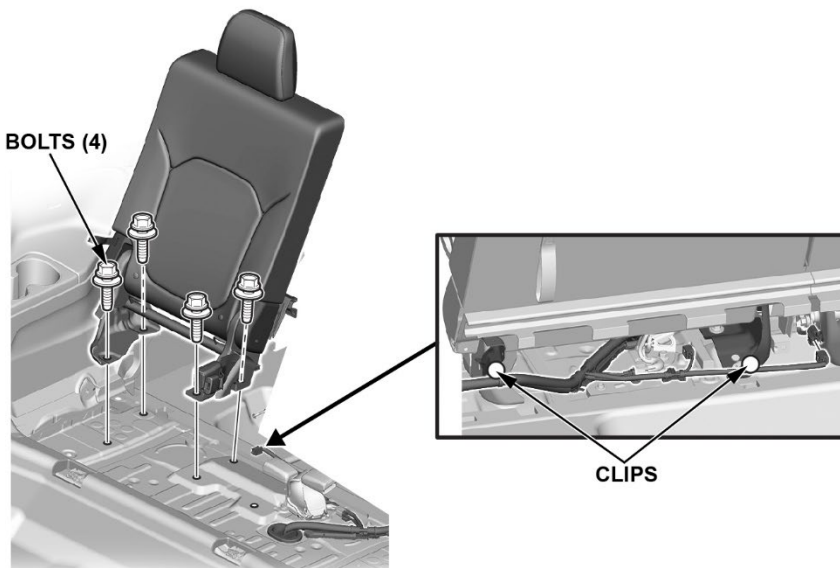
10. Remove the four mounting bolts from the 3rd row right passenger seat only, then remove the harness clips and disconnect the harness connector.

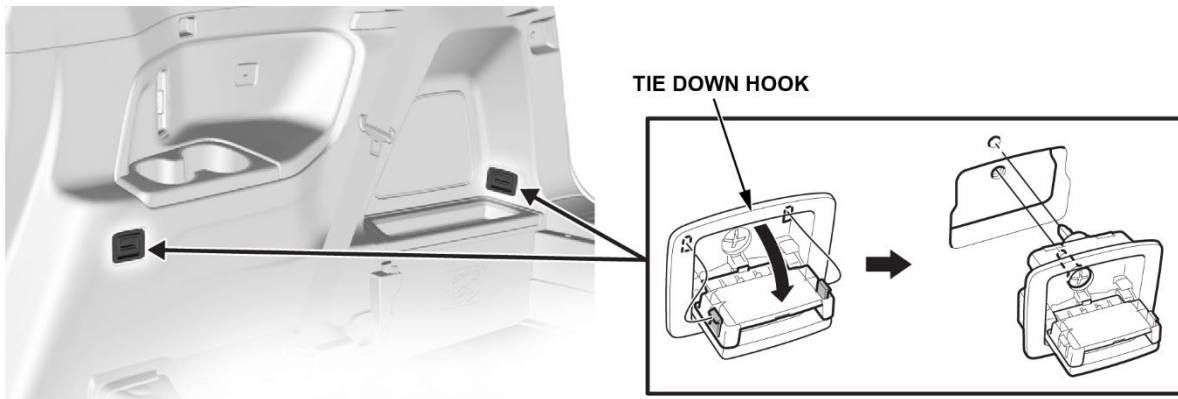
11. Remove the two right tie down hooks.

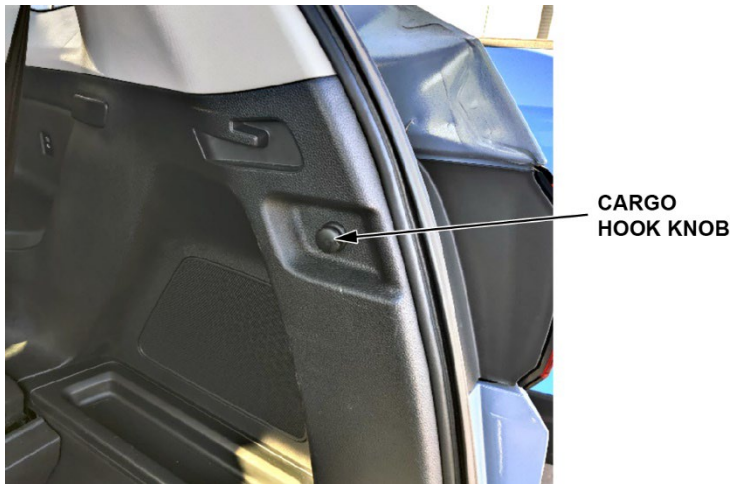
12. Remove the cargo hook knob.

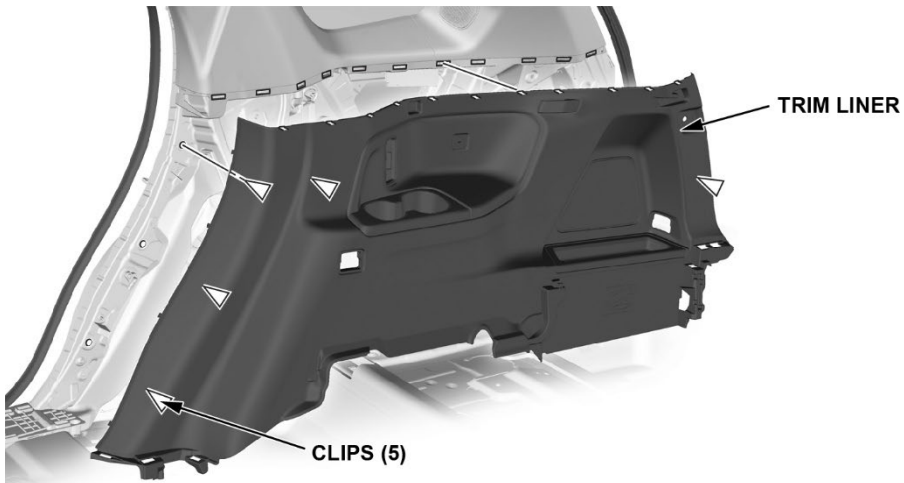
13. Remove the right rear trim liner coupler and clips.

NOTE: Disconnect the connector to the USB port if equipped.

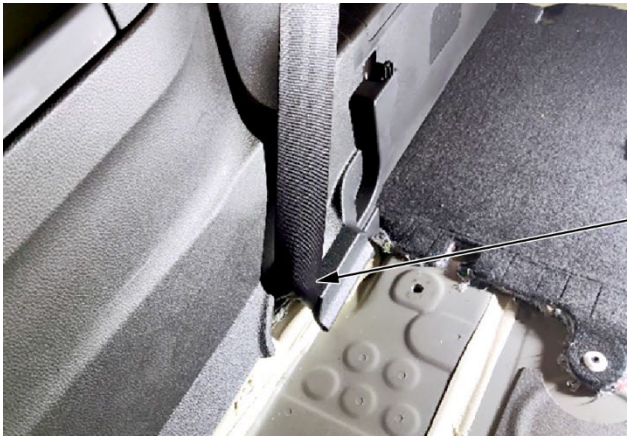
TRAPPED SEAT BELT LATCH PLATE

14. Reroute the trapped latch plate or seat belt webbing from behind the rear side liner.

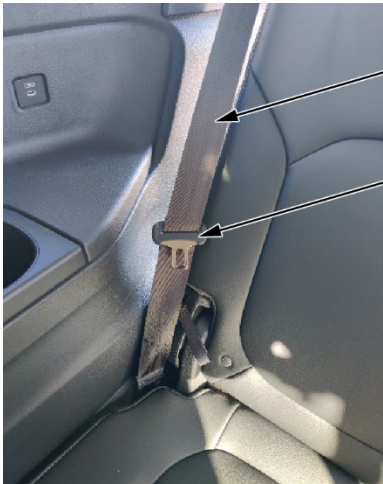
15. Ensure that the latch plate is visible and seat belt webbing is routed straight. Ensure proper seat belt functionality with the seatbelt assembly.

SEAT BELT WEBBING ROUTED STRAIGHT

LATCH PLATE

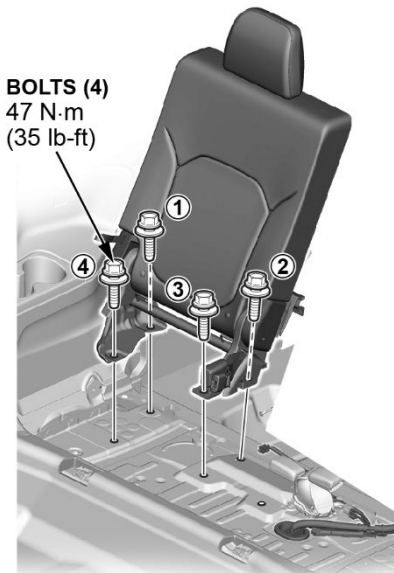
17. Install the 3rd row right passenger seat mounting bolts, tighten the bolts by hand first. Torque the bolts to the specified torque **47 N·m (35 lb-ft)** in the numbered sequence shown.

BOLTS (4)
47 N·m
(35 lb-ft)
