SAFETY RECALL

ID No. AB2Q0
Ref. No. RCB-001-25
Release Date 02-10-2025

AB2Q0 RIGHT FRONT AIR BRAKE HOSE

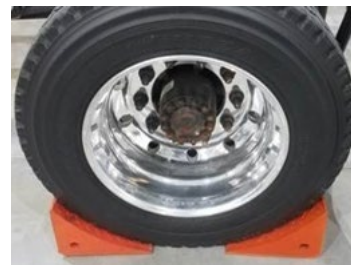
4. Chock all the wheels.

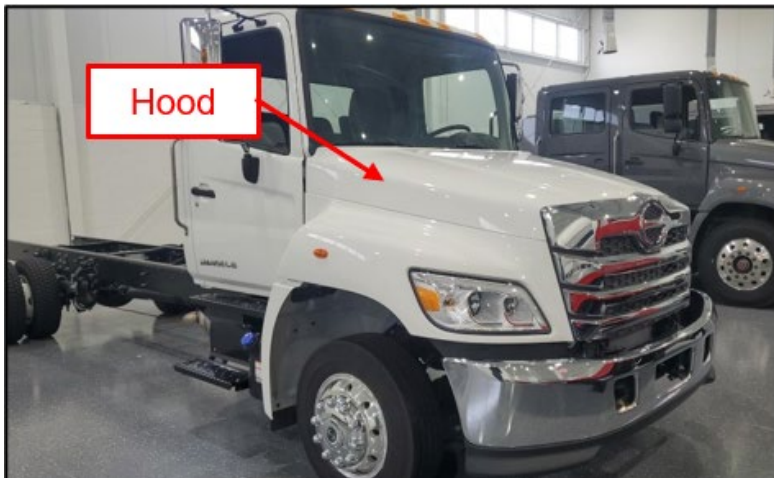
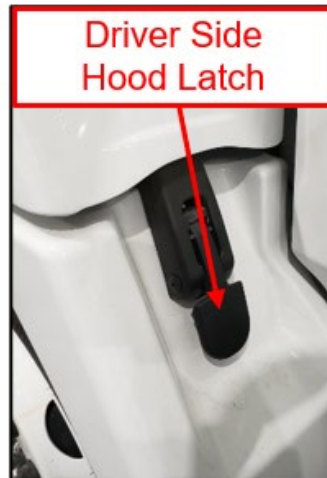
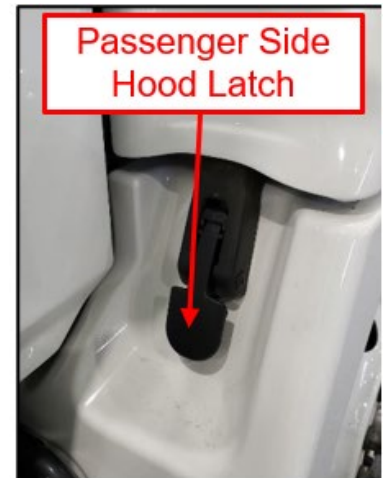
1. To complete this procedure review and confirm the following:
 - The air brake tube is correctly routed along the passenger side frame rail and No. 3 cross member.
 - All zip ties are tightened to secure the air brake tube in the designated locations.
 - All nuts have been tightened to the specified torque.
 - The 2 air brake tube connections are secure, and no air leaks are present.
 - The hood has been lowered and both left and right hood latches are latched in the locked position.
