TECHNICAL INSTRUCTIONS
FOR
SAFETY RECALL 25TA03
INCREASED RISK OF INJURY DUE TO SEAT BELT DAMAGE
CERTAIN 2025MY CAMRY HV

The second-row center seatbelt of the subject vehicles may have been damaged during manufacturing. This may cause the seatbelt to not meet certain strength requirements. If an occupant is belted in the second-row center seat with a damaged seatbelt, it may increase the risk of injury during certain crashes.

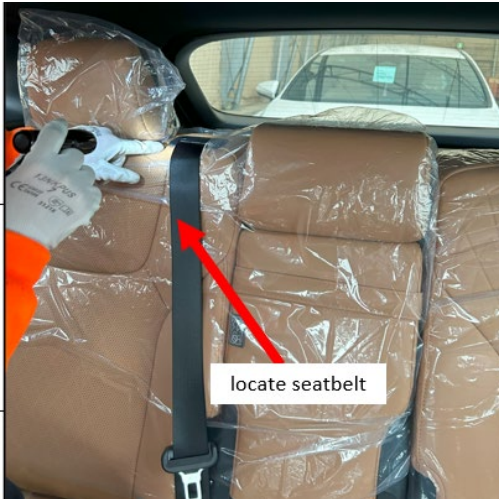
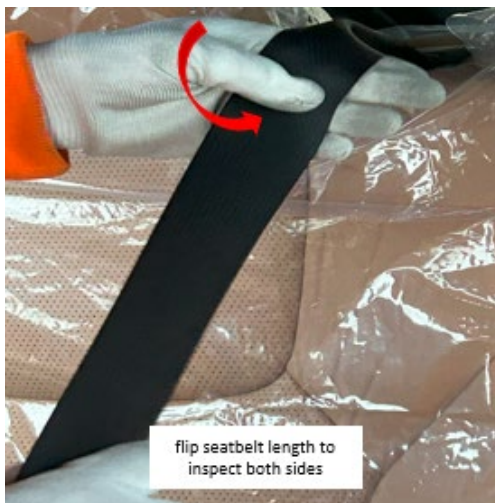
VI. INSPECT THE REAR CENTER SEAT BELT

- A. Locate the rear center seat belt
- B. Inspect the rear center seat belt webbing for damage
 - Begin from bottom at seat cushion near the anchor bracket
 - Continue to inspect belt webbing up to the top of the seat cushion
 - Slowly pull seat belt out of retractor, continuing to visually inspect front side
 - Using an ungloved fingertip, feel across the belt's surface for any abnormalities in the surface texture.
 - Repeat on the back side as you feed the belt back into the retractor
- C. If any suspect seatbelts are identified, record inspection results and capture photos of the condition. Provide the photos to the QC inbox before ordering any parts for part approval. Once Approved for the repair and parts are received, move to Step VII.
 - If No damage to the seat belt is found, the vehicle can be returned to the customer.
