DATE	TOPIC
2/07/2025	Added part detail for repair and part judgement criteria

TECHNICAL INSTRUCTIONS
FOR
SAFETY RECALL 25LA03
INCREASED RISK OF INJURY DUE TO SEAT BELT DAMAGE
CERTAIN 2024-25MY RX and 2025MY NX

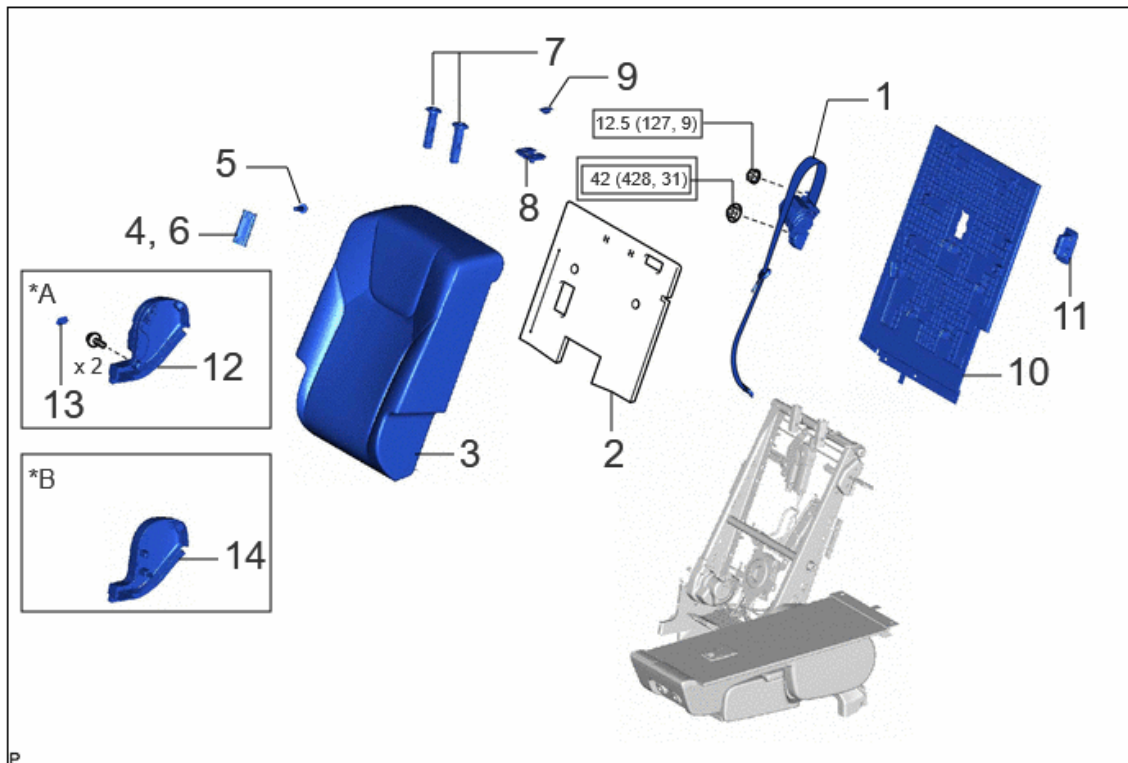
Rear Center Seat Belt Assembly

The second-row center seatbelt of the subject vehicles may have been damaged during manufacturing. This may cause the seatbelt to not meet certain strength requirements. If an occupant is belted in the second-row center seat with a damaged seatbelt, it may increase the risk of injury during certain crashes.

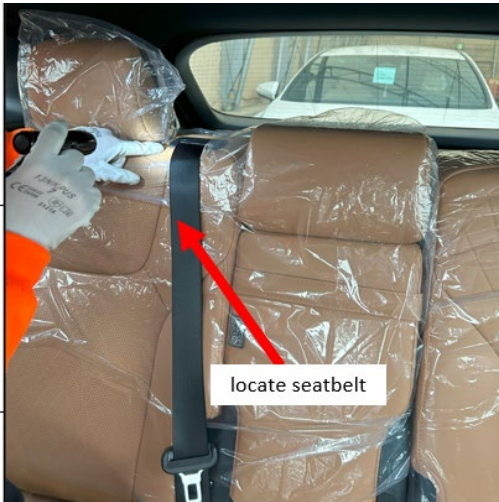
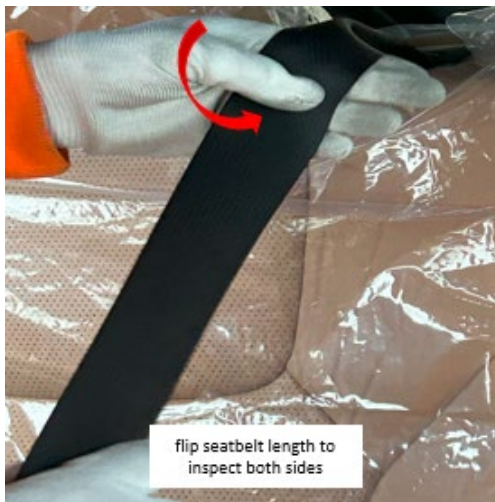
VI. INSPECT THE REAR SEAT BELT

- A. Locate the rear center seat belt
- B. Inspect the rear center seat belt webbing for damage
 - Begin from bottom at seat cushion near anchor bracket
 - Continue to inspect belt webbing up to the top of the seat cushion
 - Slowly pull seat belt out of retractor, continuing to visually inspect front side
 - Using an ungloved fingertip, feel across the belt's surface for any abnormalities in the surface texture.
 - Repeat on the back side as you feed the belt back into the retractor
- C. If any suspect seatbelts are identified, record inspection results and capture photos of the condition. Provide the photos to the QC inbox before ordering any parts for part approval. Once Approved for the repair and parts are received, move to Step VII.
 - If No damage to the seat belt is found, the vehicle can be returned to the customer.

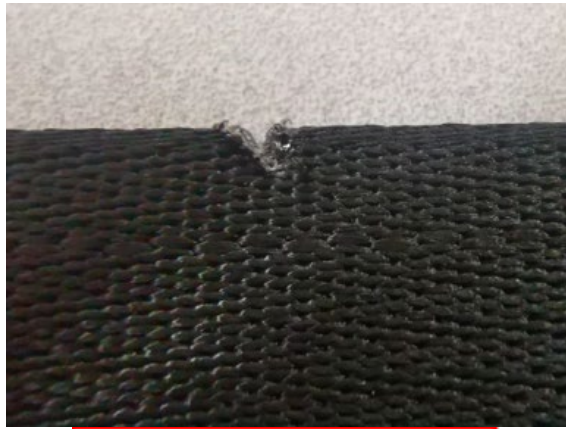
Nick Mark = NG

VII. PERFORMING THE REMEDY

2. Install the **NEW** Rear Center Seat Belt Assembly

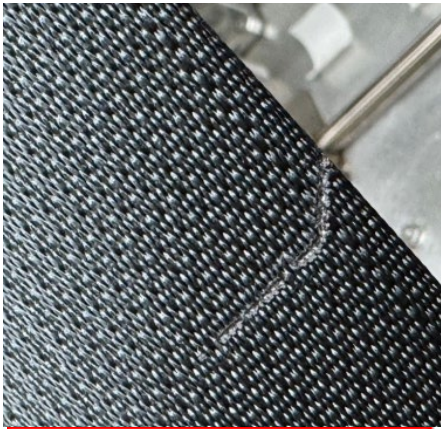
Burn Mark = NG

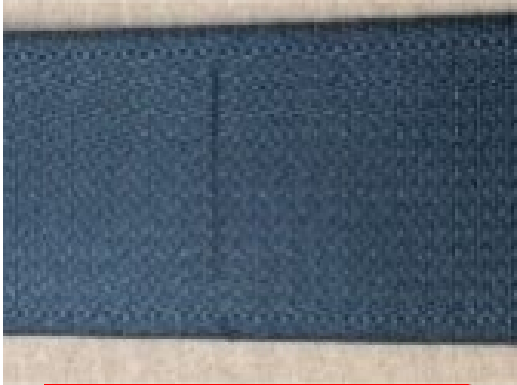
Burn Mark = NG

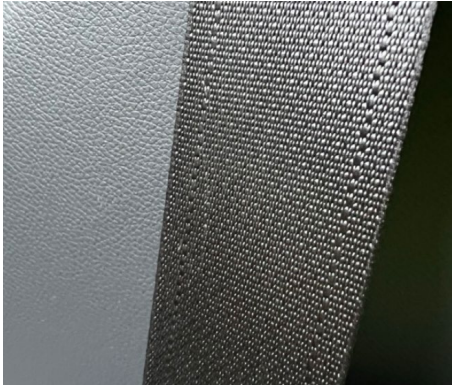
OK
