**TECHNICAL INSTRUCTIONS**  
**FOR**  
**SAFETY RECALL 25TA03**  
**INCREASED RISK OF INJURY DUE TO SEAT BELT DAMAGE**  
**CERTAIN 2025MY CAMRY HV**

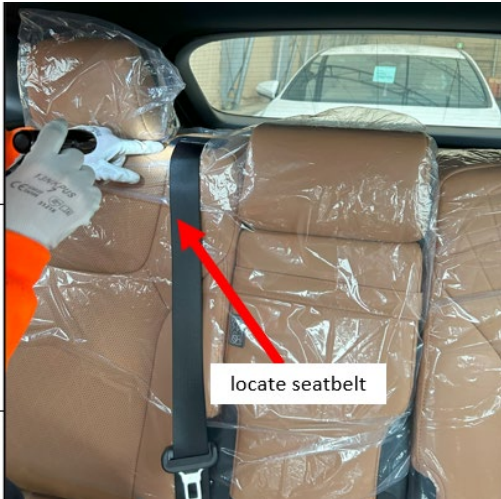
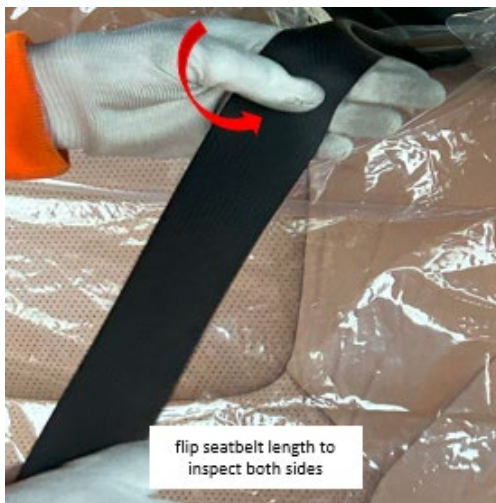
## VI. INSPECT THE REAR CENTER SEAT BELT

- A. Locate the rear center seat belt
- B. Inspect the rear center seat belt webbing for damage
  - Begin from bottom at seat cushion near the anchor bracket
  - Continue to inspect belt webbing up to the top of the seat cushion
  - Slowly pull seat belt out of retractor, continuing to visually inspect front side
  - Using an ungloved fingertip, feel across the belt's surface for any abnormalities in the surface texture.
  - Repeat on the back side as you feed the belt back into the retractor
- C. If damage is found, record inspection result and take photos of the condition. Provide the photos to the parts department for parts release. Once Approved for repair, move to Step VII.
  - If No damage to the seat belt is found, the vehicle can be returned to the customer.

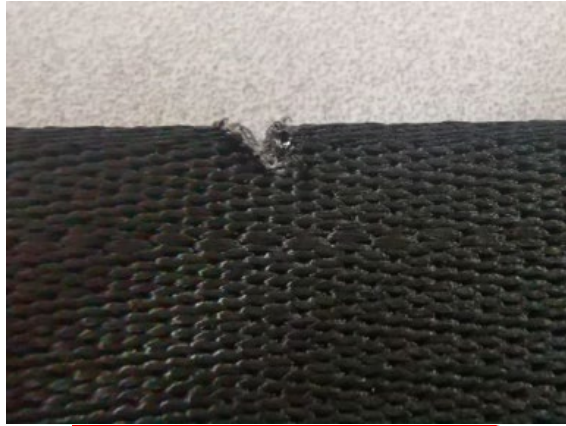
Nick Mark = NG

## VII. REAR CENTER SEAT BELT ASSEMBLY REPLACEMENT

### 1. Remove the Rear Center Seat Belt Assembly

### 2. Install the *NEW* Rear Center Seat Belt Assembly

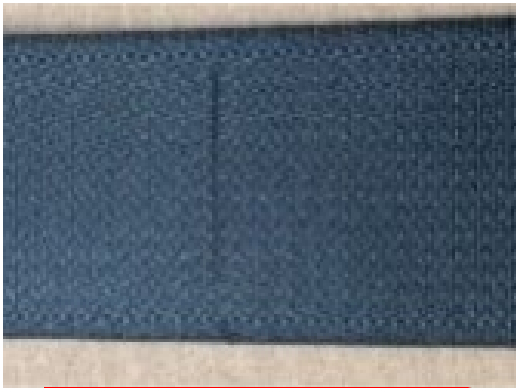
Burn Mark = NG
