**TECHNICAL INSTRUCTIONS**

**SAFETY RECALL 25TA05**

**Third Row Seat Back Performance**

**Certain 2021- 2025 Model Year Sienna**

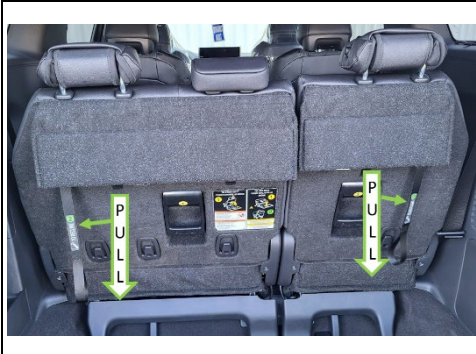
### 1. Fold LH and RH 3rd row seat flat.

If Seat backs are upright:  
Pull strap and let seat fall forward

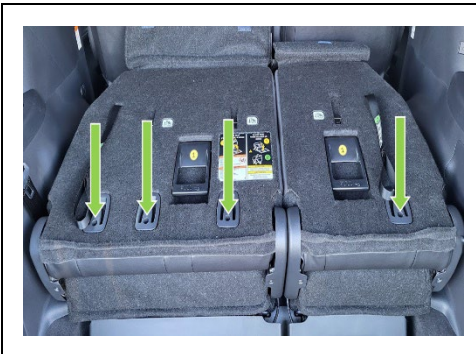
### 3. Remove seat cover bezel (x4)

Using Phillips screwdriver, loosen seat cover bezels and set aside

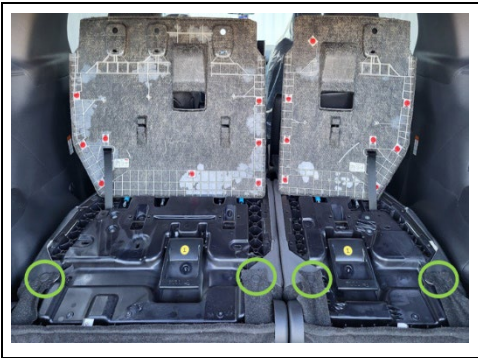
**5. Remove clips.**

Using a clip removal tool, remove the 4 black trim push clips holding the fabric in place

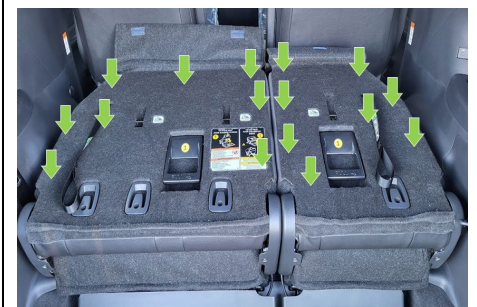
c. Align back board and push to secure all clips.
