TITLE: 2024 Z500 ABS & SE ABS, NINJA® 500, ABS, SE ABS, KRT Edition, SE 40th Anniversary Edition, Replace Clutch Release Shaft

RECALL

Subject

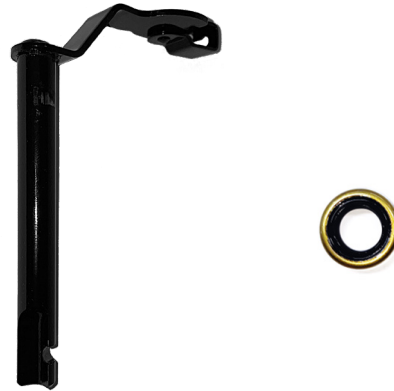
Kit, Clutch, MC25-04 P/N 99999-0975

Contents	Qty
Release, Comp, Clutch	1
Seal, Oil	1

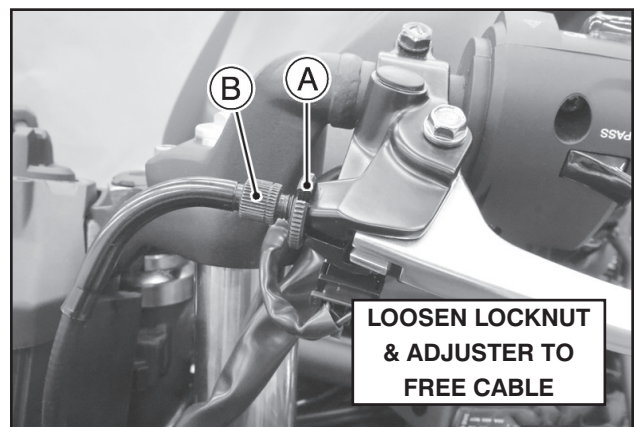
- Loosen the locknut [A] at the clutch lever, and screw in the adjuster [B].
- Line up the slots in the clutch lever, locknut and adjuster, and then free the cable from the lever.

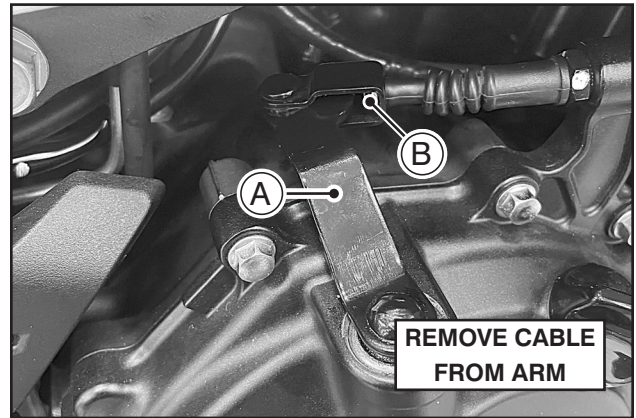
- Free the clutch inner cable tip [B] from the clutch release shaft arm [A].

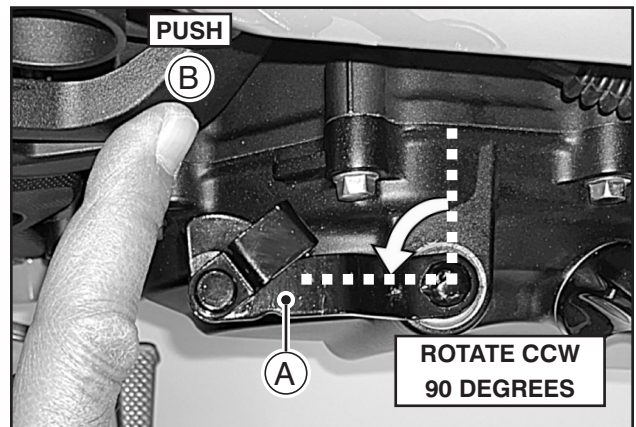
- Push cover [B] inward to provide clearance for release shaft arm [A].
- Rotate release shaft arm [A] counterclockwise (approximately 90 degrees) until it points to the rear of the vehicle.

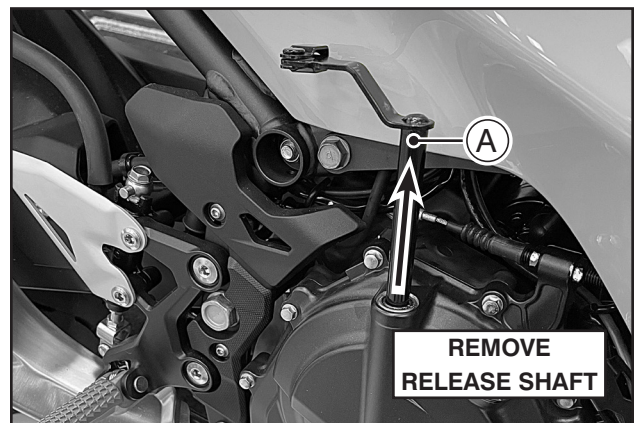
- Pull the release shaft [A] straight up out of the clutch cover.

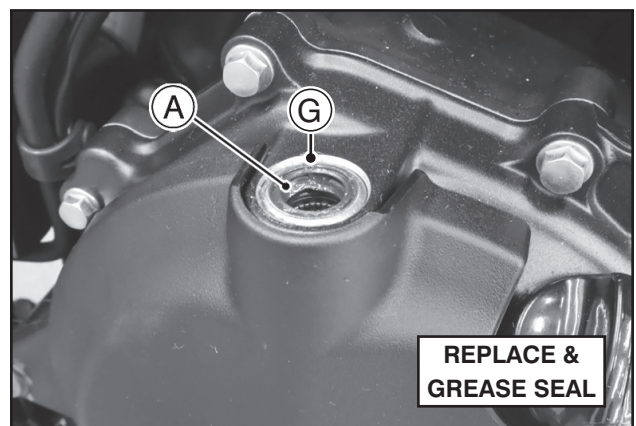
- Remove and discard the oil seal [A].
- Apply grease [G] to the new oil seal lips.
- Press the oil seal [A] until fully seated.

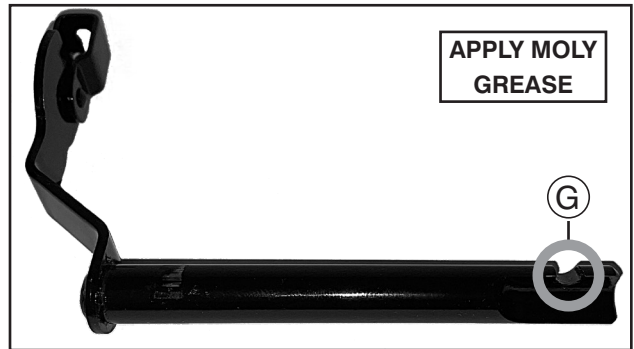
- Apply molybdenum disulfide grease to the pusher-holding portion [G] on the release shaft.

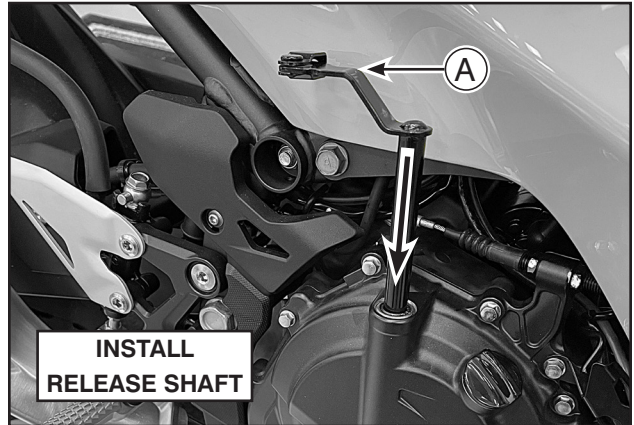
When inserting the release shaft, be careful not to dislodge the oil seal spring.

- Point the release shaft arm [A] towards the rear of the vehicle.
- Push down to install the release shaft straight into the upper hole of the clutch cover taking care not to damage the oil seal and oil seal spring.

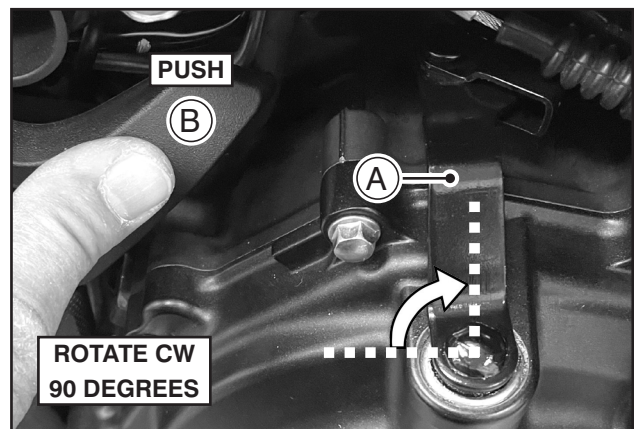
- Push cover [B] inward to provide clearance for release shaft arm [A].
- Rotate release shaft arm [A] clockwise until it stops.

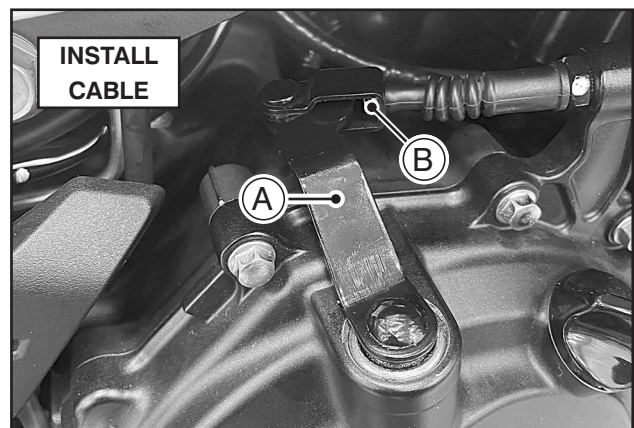
- Install the clutch inner cable tip [B] in the clutch release shaft arm [A].

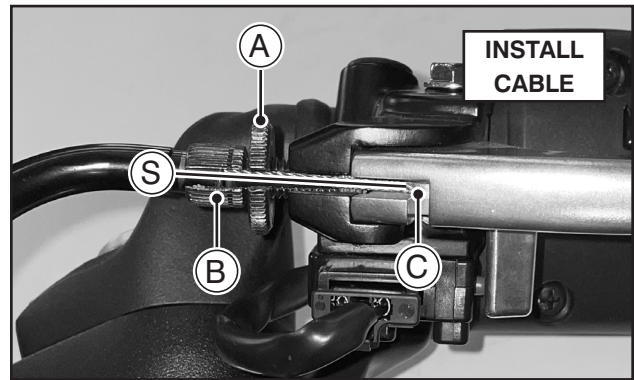
- Line up the slots [S] in the clutch lever, locknut [A] and adjuster [B], and then install cable end [C] into the lever.

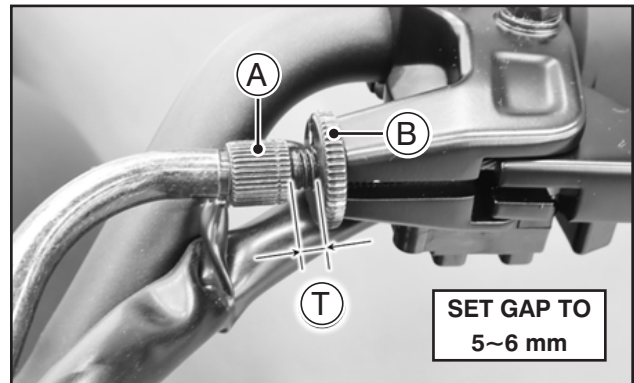
- Turn the adjuster [A] so that 5 – 6 mm (0.20 – 0.24 in.) [T] of threads are visible.
- Hand tighten the locknut [B] at the clutch lever.

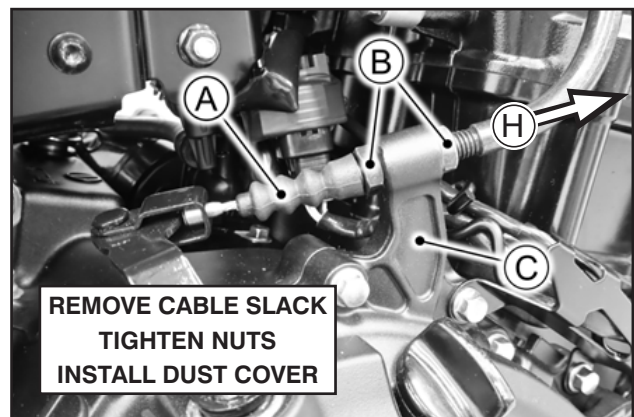
- Slide the dust cover [A] at the clutch cable lower end out of place.
- Loosen both adjusting nuts [B] at the clutch cover as far as they will go.
- Pull the clutch cable housing [H] tight and tighten the adjusting nuts [B] against the clutch cover [C].
- Slip the dust cover back onto place.

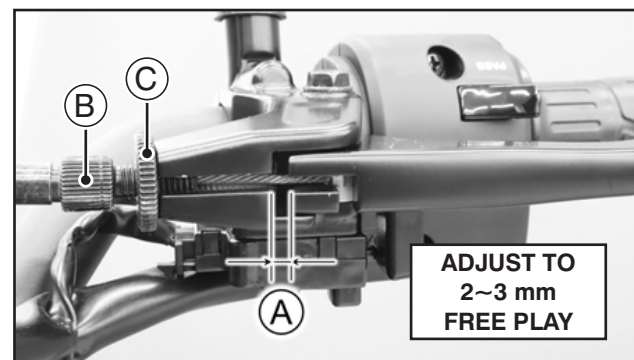
- Pull the clutch lever just enough to take up the free play [A].
- Measure the gap between the lever and the lever holder.
Clutch Lever Free Play
Standard: 2 – 3 mm (0.08 – 0.12 in.)
- Turn the adjuster [B] at the clutch lever until the free play is correct.
- Tighten locknut [C].

Too much cable play can prevent clutch disengagement and cause an accident resulting in serious injury or death. When adjusting the clutch or replacing the cable, be sure the upper end of the clutch outer cable is fully seated in its fitting, or it could slip into place later, creating enough cable play to prevent clutch disengagement.

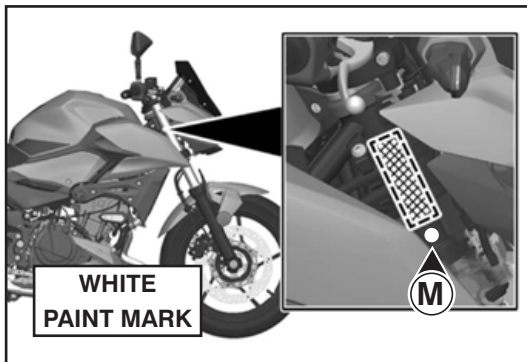
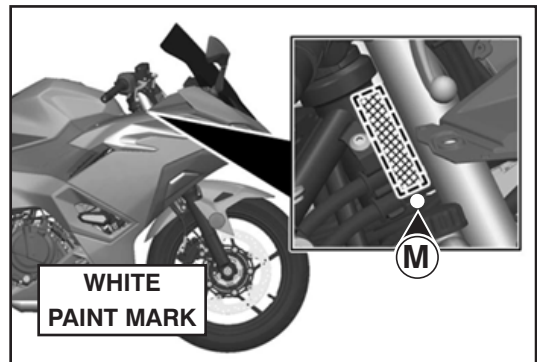
Make a white paint mark [M] to the left of the first digit of the frame number as shown.
