VOLUNTARY RECALL CAMPAIGN

VOLUNTARY SAFETY RECALL CAMPAIGN 2025 SENTRA; DRIVER SEAT TRACK INSPECTION

CAMPAIGN ID #: PMA45
APPLIED VEHICLES: 2025 Sentra (B18)

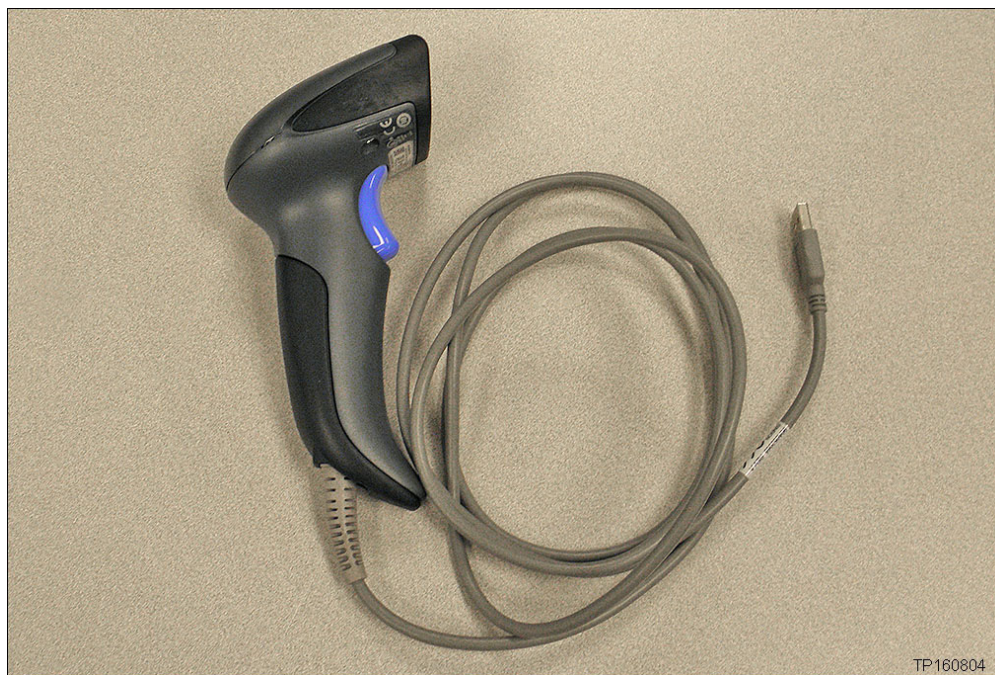
Figure 1

Quick Scan Tool (J-52352)

- Each dealer has been previously shipped one Quick Scan Tool (J-52352).

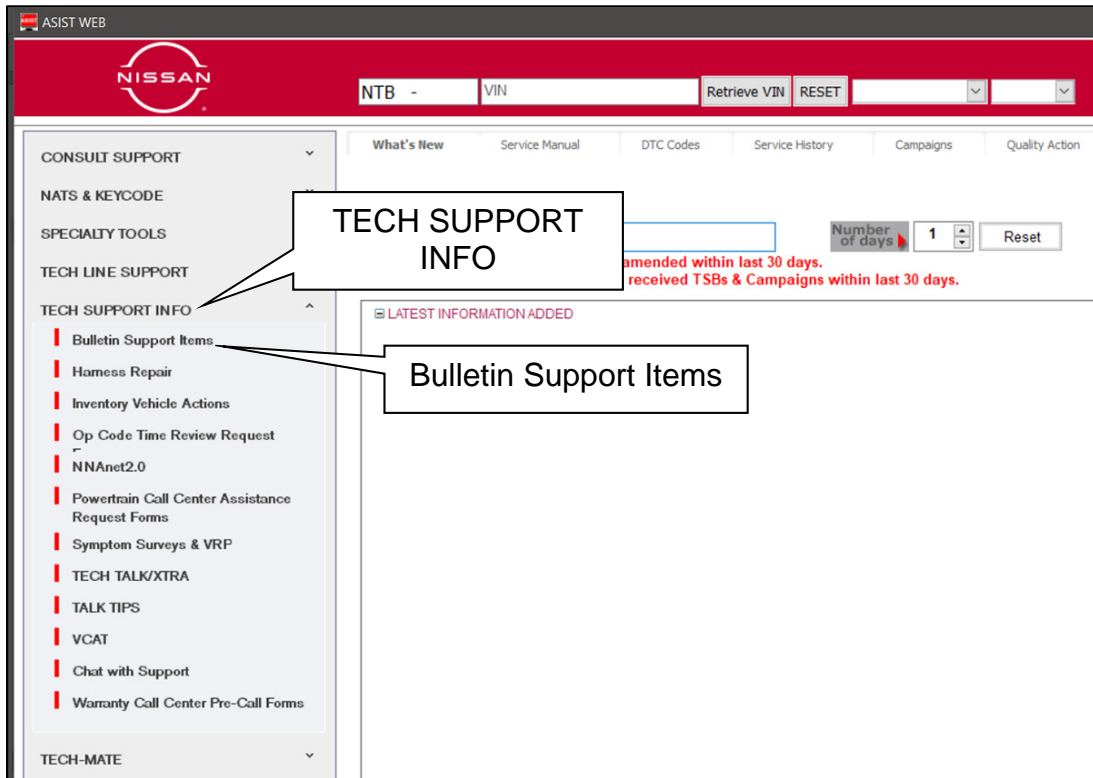
Figure 3

3. On the left side of ASIST main menu, select **TECH SUPPORT INFO**, and then **Bulletin Support Items**.

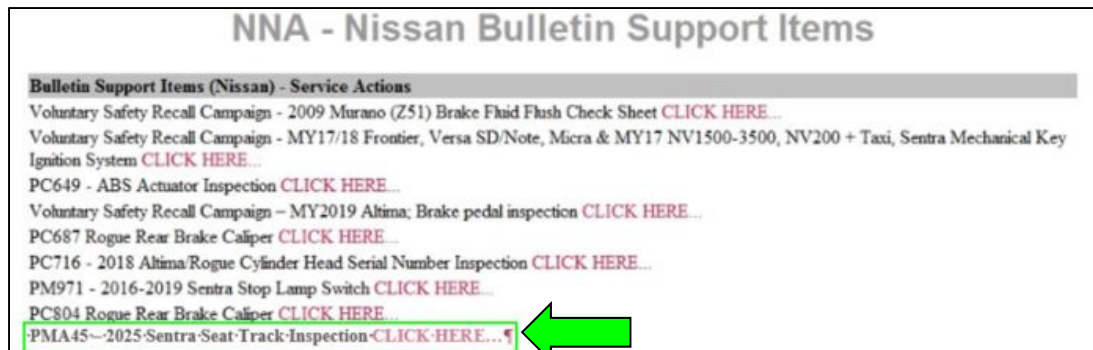
Figure 4

4. Select "**CLICK HERE...**" next to **PMA45 – 2025 Sentra Seat Track Inspection**.

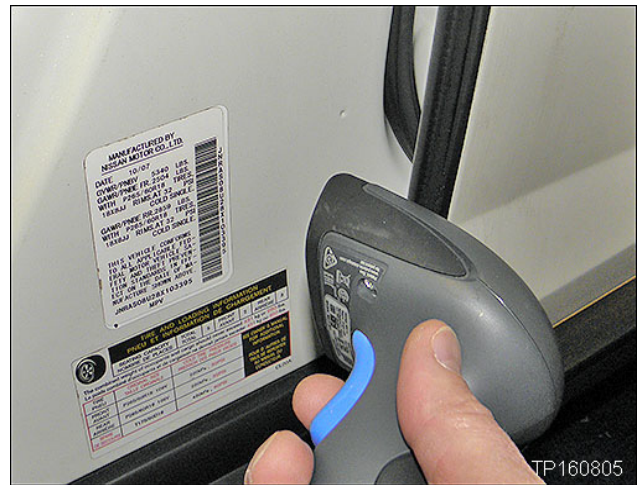
Figure 6

6. Using the Quick Scan Tool, scan the bar code on the VIN Certification Label located at the base of the B-pillar.

- Make sure the VIN Certification Label is clean.
- Hold the Quick Scan Tool approximately six (6) inches away from the label.
- Hold the trigger down until the Quick Scan Tool is finished scanning the label (an audible “beep” sound will be heard).
- Some VIN Certification Labels may not scan quickly.
- Once the VIN automatically populates in the form, verify all 17 characters are correct.
- If needed, the VIN can be entered manually.

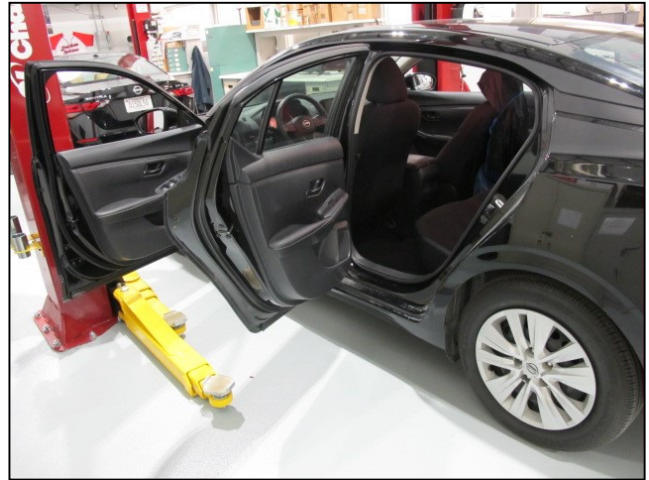
Figure 8

7. Open the front driver (LH) side door and the rear driver (LH) side door.

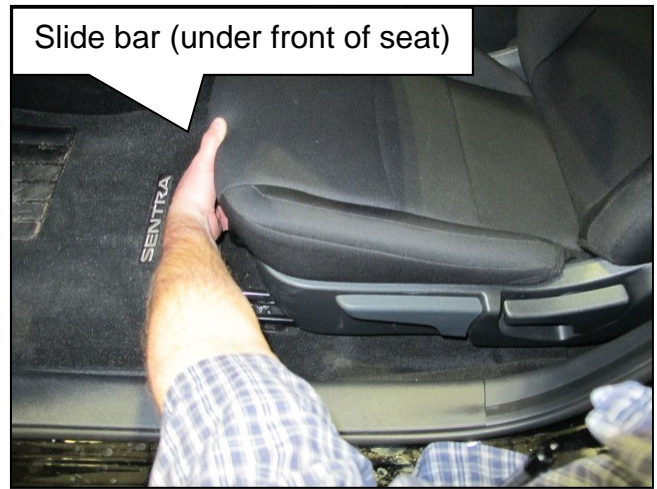
Figure 10

9. Using the slide bar under the front of the driver's seat (Figure 10), position the driver's seat so the rear outer seat bolt is visible (Figure 11).

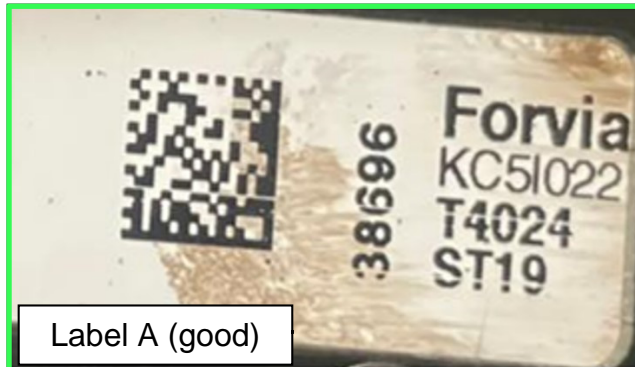
13. Inspect the traceability label and compare it to Figure 16 (Label A) and Figure 17 (Label B) below.

- Does the traceability label look like Label A (Figure 16) or Label B (Figure 17)?
 - **Label A** – The driver's seat track is GOOD. Reinstall the driver's outer (LH) seat track finisher. No further repair is required. Proceed to **CLAIMS INFORMATION** on the last page and submit a claim for Driver Seat Track Inspection.
 - **Label B (Has 3 digit code)** – Continue to step 14 on page 11 and perform **Second Inspection**.

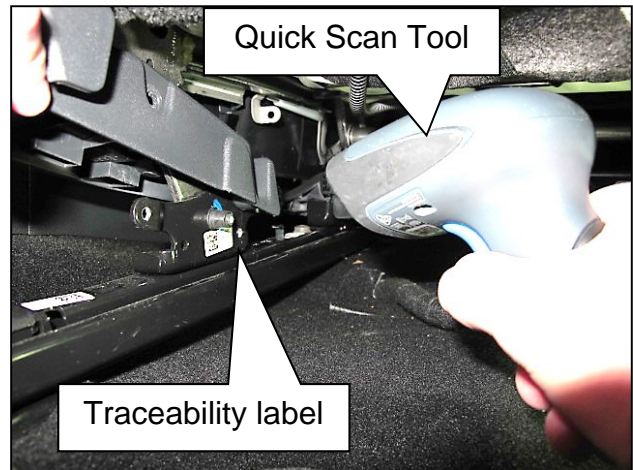
Figure 18

- Using the Quick Scan Tool, scan the traceability label QR code serial number (Figure 18).

HINT: If the QR code on the seat track traceability label does not scan or the label is missing, skip to step 17 on page 13 to email Field Quality Assurance (FQA).

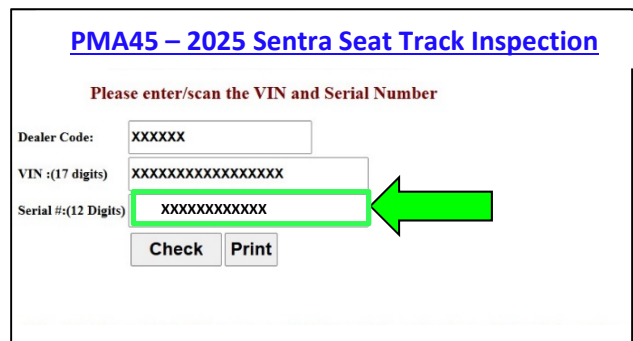
Figure 19

- Once the QR code serial number populates in the form, verify all 12 characters are present (Figure 19).

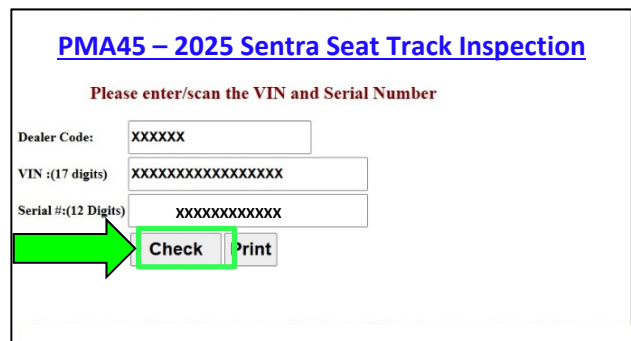
Figure 20

- Select **Check** (Figure 20).
