NGDVTSB034 Wiper Arm Alignment and Torque		Revision	-
Release Date:	April 2025	Bulletin Type:	Safety Recall
Rework Time:	.7 Hrs/Vehicle (1 Person Hrs)	PLRS Number:	P108039.A0999
Parts Returned:	None Required	Tread Component	Visibility

Description: A nut that secures the windshield wiper arm to the wiper motor shaft may not have been properly torqued. An improperly torqued windshield wiper arm nut may loosen and result in the wiper arm failing to operate properly when the wiper system is activated to clear a windshield.

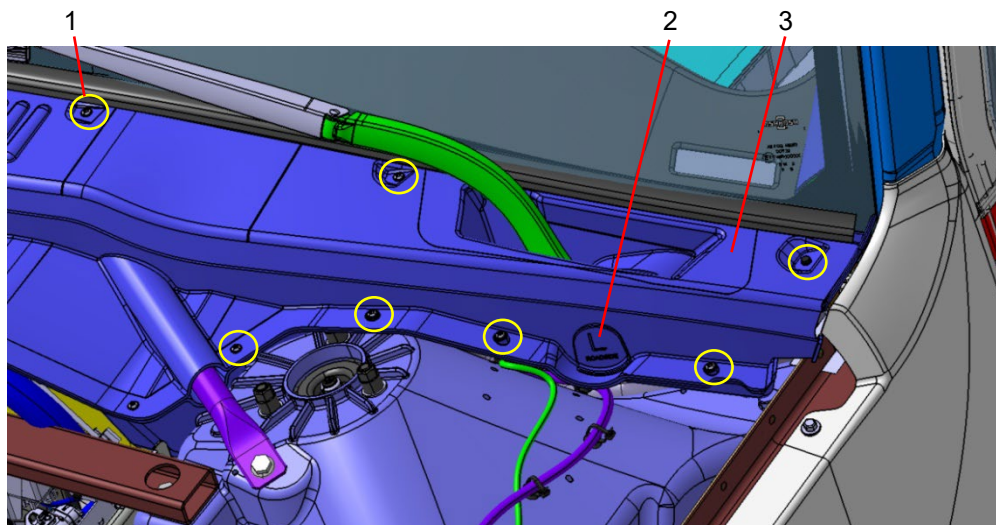
- 1) Ensure vehicle is parked on a flat, level, solid surface.
- 2) Turn engine "Off" and engage parking brake.
- 3) Open and support the hood.
- 4) Remove the upper cowl left-hand wiper arm access plug (Item 2) from the upper cowl (Item 3).
- 5) Remove seven screws (Item 1) from the upper cowl (Item 3).

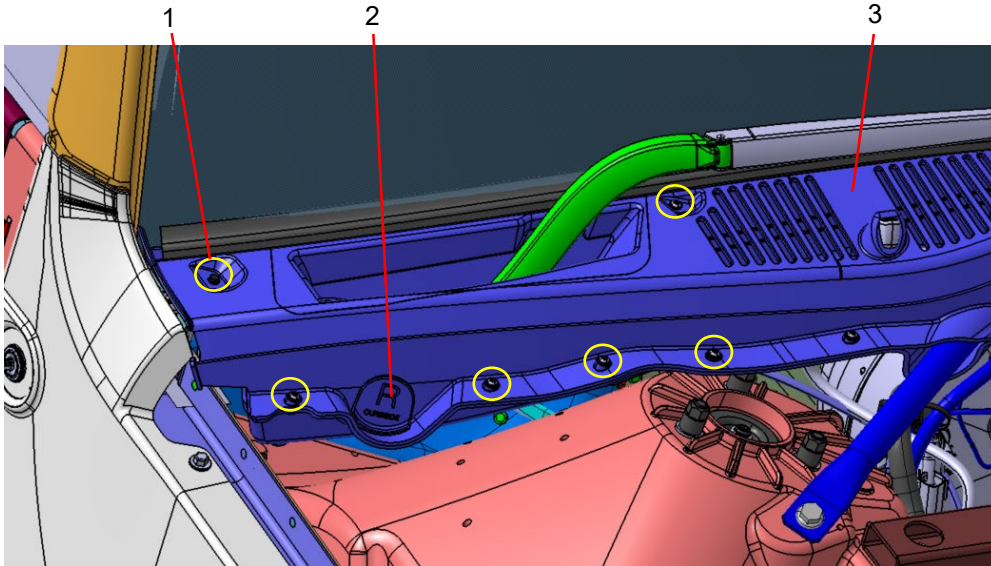
- 6) Remove the upper cowl right-hand wiper arm access plug (Item 2) from the upper cowl (Item 3).
- 7) Remove six screws (Item 1) from the upper cowl (Item 3).

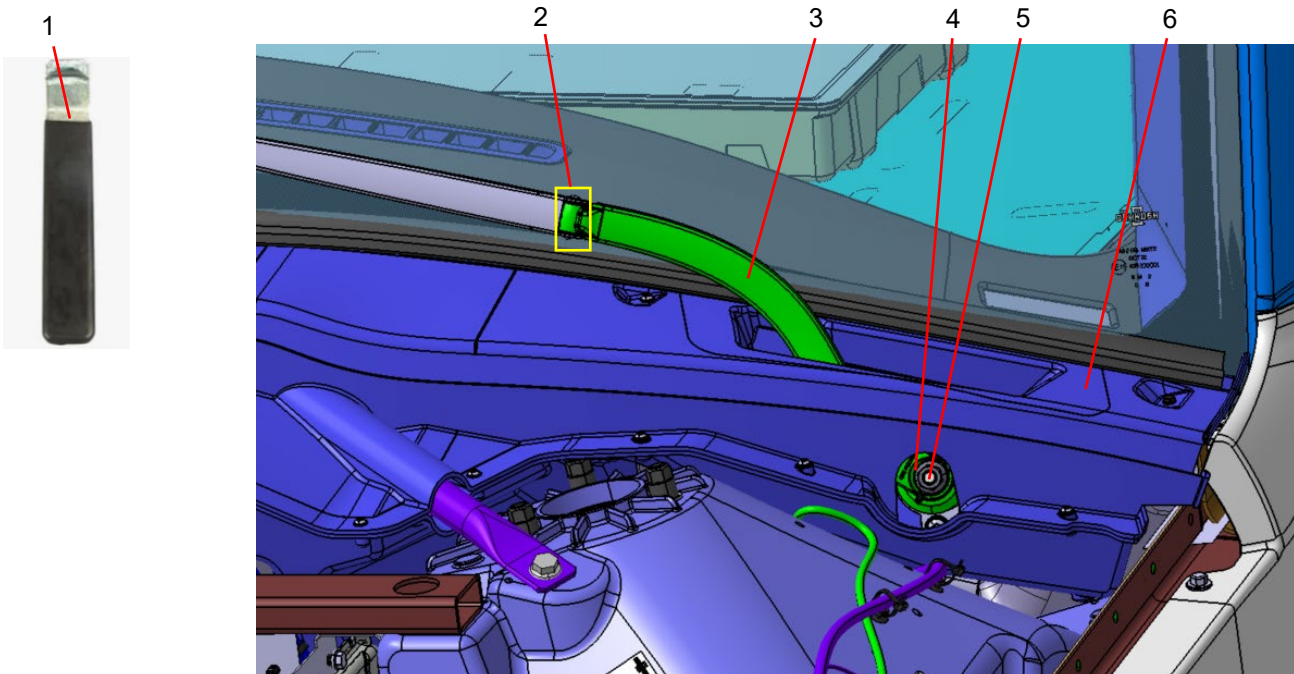
- 8) Remove locknut (Item 4) from the wiper arm (Item 3) and wiper motor stud (Item 5). Discard locknut.
- 9) Pivot wiper arm (Item 3) at the pivot point (Item 2) outward to a 90° position, and with the use of a wiper arm removal tool (Item 1), maneuver and remove the wiper arm (Item 3) from the wiper arm motor stud (Item 5) and out of the upper cowl (Item 6).

NOTE: Ensure the wiper arm does not snap back at the pivot point during removal or damage to the windshield may occur.

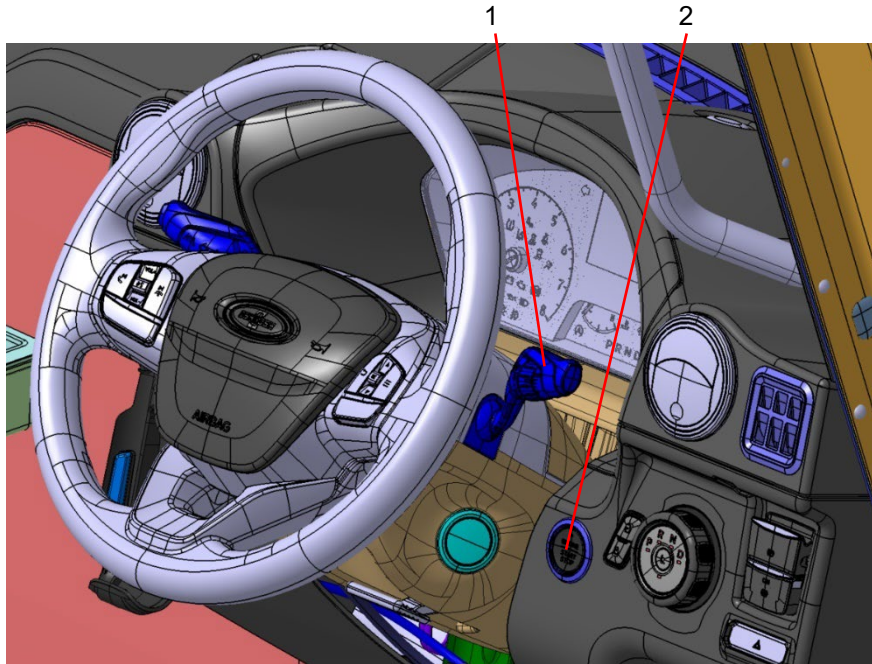
- 10) Repeat Steps 8–9 for the right-hand side wiper arm removal.
- 11) Once both wiper arms are removed, turn on the vehicle by pressing the start/stop button (Item 2) one time.
- 12) Cycle the wipers by pulling down one time on the wiper control switch (Item 1) to position the wiper motors in the “HOME” position.
- 13) Once wiper motors have been placed in the “HOME” position, turn off the vehicle by pressing the start/stop button (Item 2) one time.

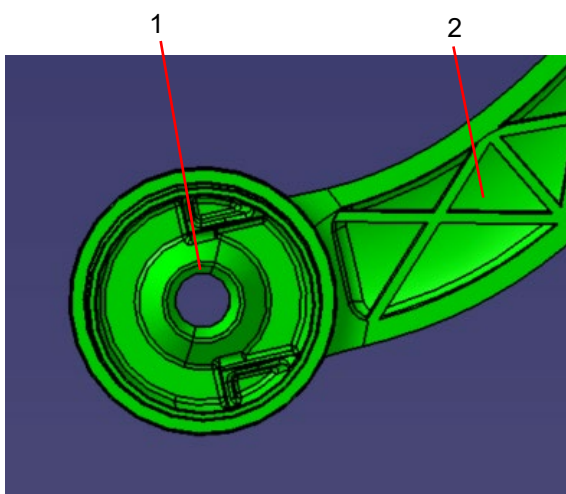
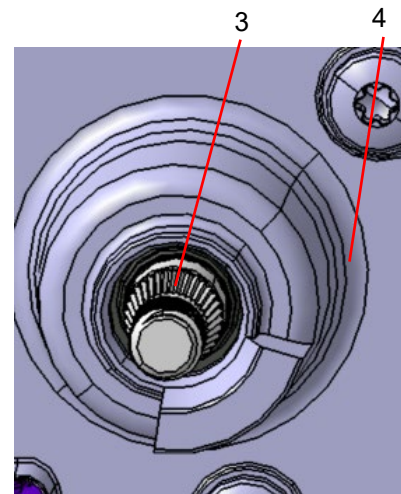
- 14) Inspect the internal splines (Item 1) on both wiper arms (Item 2).
- 15) Inspect the external splines (Item 3) on both wiper arm motors (Item 4).
- 16) If either the wiper arms (Item 2) or wiper arm motors (Item 4) show signs of the splines being stripped, replace the component.
- 17) If no visible signs of damage are noticed, continue with the service procedure.

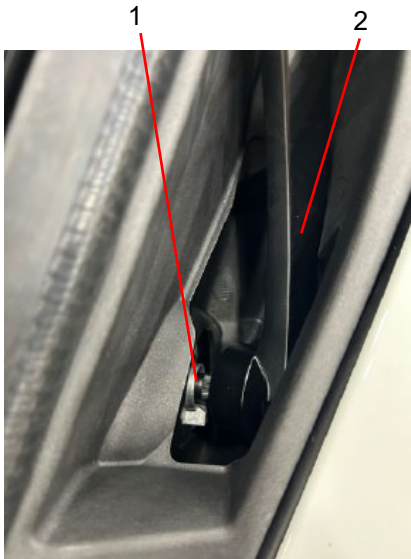
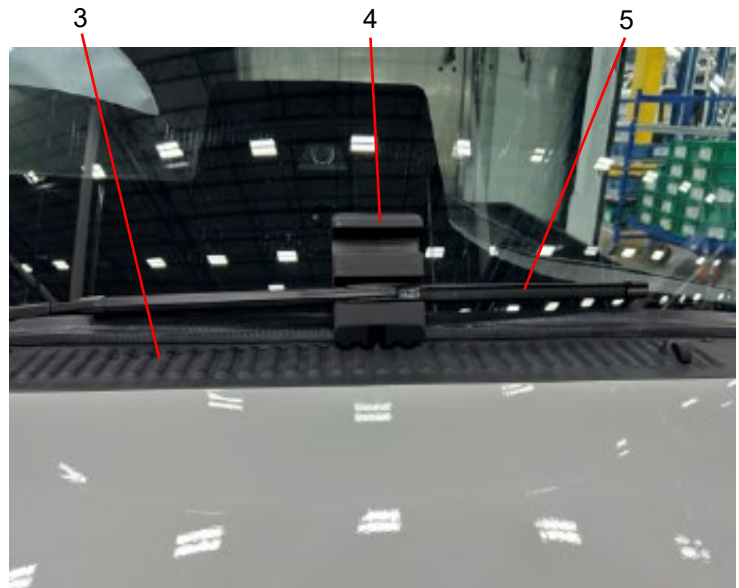
- 18) Position fixture FT-0059 (Item 4) in the center of the upper cowl (Item 3).
- 19) Loosely position the right-hand wiper arm (Item 2) over the wiper motor stud (Item 1) and place the right-hand wiper (Item 5) into the lower slot on fixture FT-0059 (Item 4).

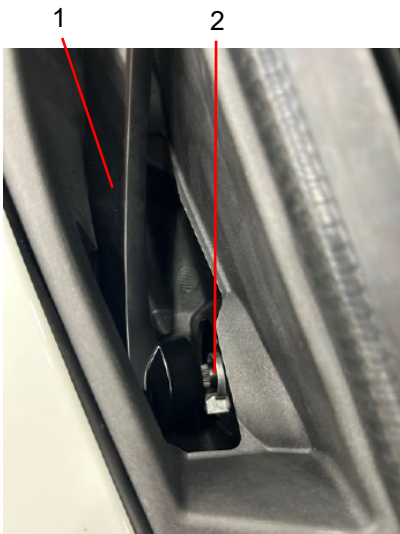
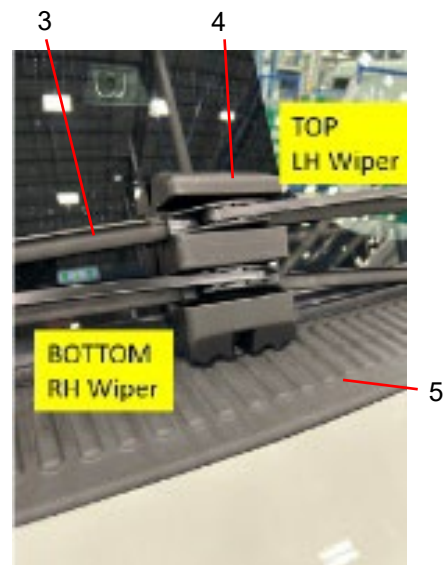
- 20) Ensure that fixture FT-0059 (Item 4) is in the center of the upper cowl (Item 5).
- 21) Loosely position the left-hand wiper arm (Item 1) over the wiper arm motor stud (Item 2) and place the left-hand wiper (Item 3) into the upper slot on fixture FT-0059 (Item 4).

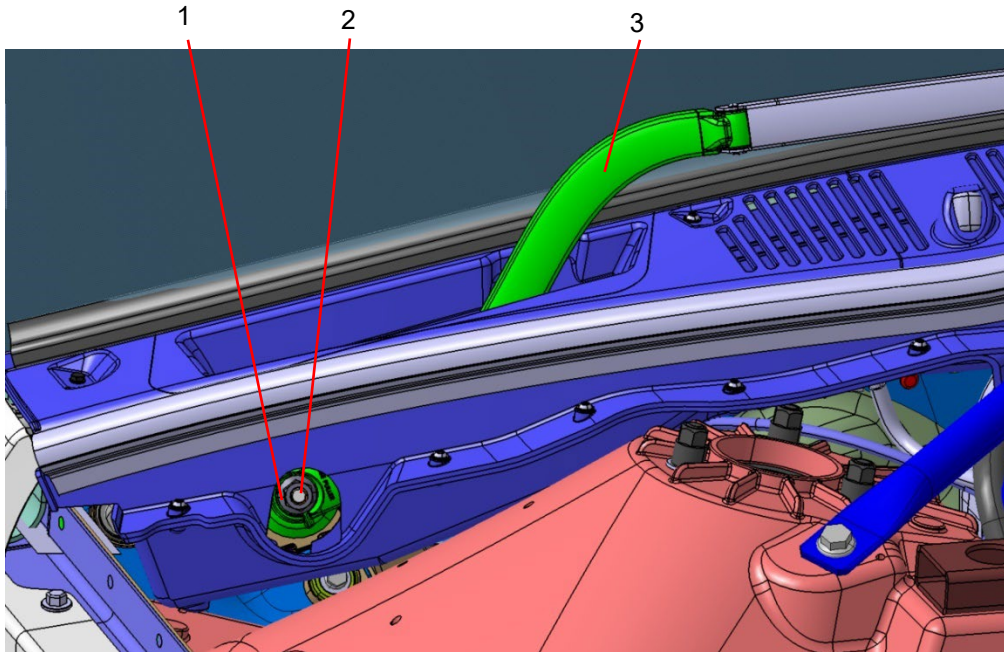
- 22) With both wipers positioned in fixture FT-0059, push the right-hand wiper arm (Item 3) onto the wiper arm motor stud (Item 2) and secure with locknut (Item 1). Tighten locknut to 28 lb-ft (38.0 N·m).

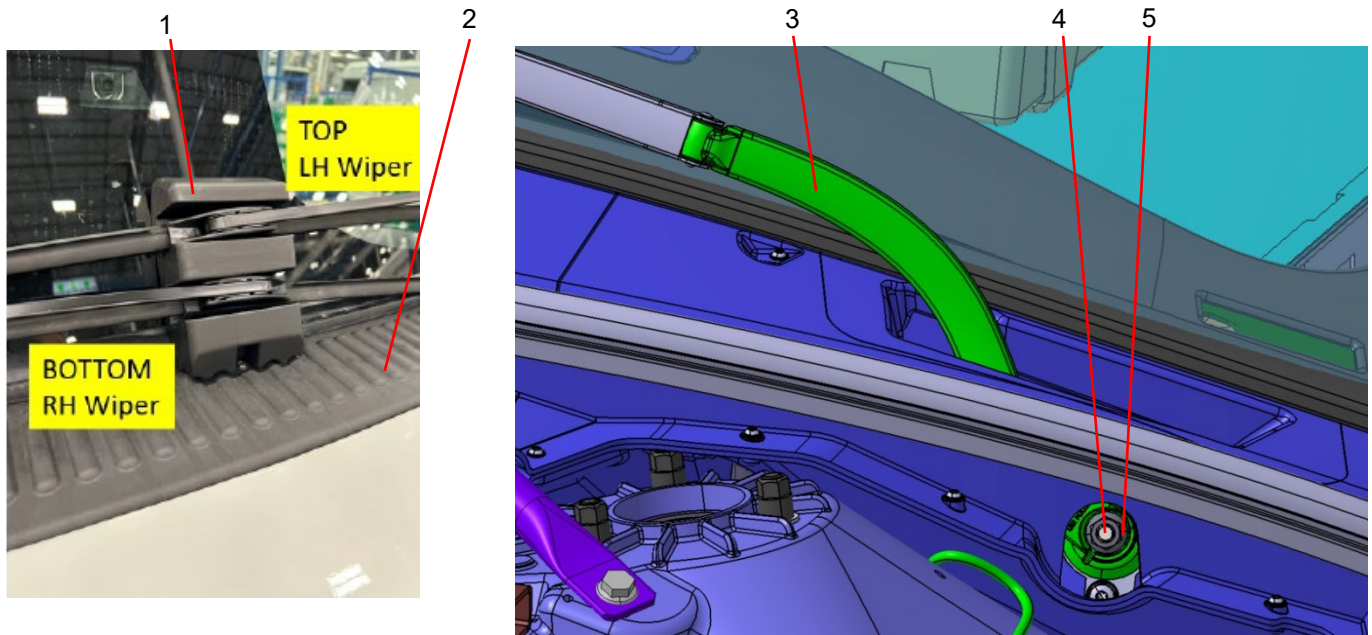
- 23) Push the left-hand wiper arm (Item 3) onto the wiper arm motor stud (Item 4) and with an assistant holding fixture FT-0059 (Item 1) down firmly on the upper cowl (Item 2), secure the left-hand wiper arm (Item 3) onto the wiper motor stud (Item 4) with the locknut (Item 5). Tighten locknut to 28 lb-ft (38.0 N·m).

NOTE: As the locknuts are tightened clockwise to obtain the torque, an assistant will be required to hold down the left-hand wiper and ensure that the fixture remains in contact with the upper cowl while torquing.

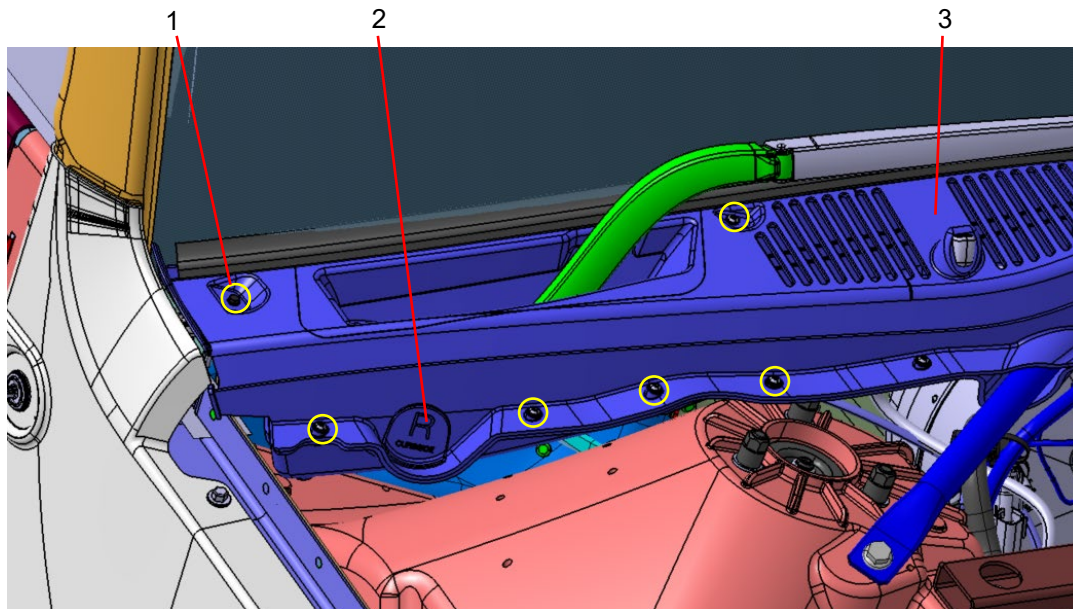
- 24) Secure the right side of the upper cowl (Item 3) with six screws (Item 1). Tighten screws to 18 lb-in (2.03 N·m).
- 25) Install the upper cowl right hand wiper arm access plug (Item 2) into upper cowl (Item 3).

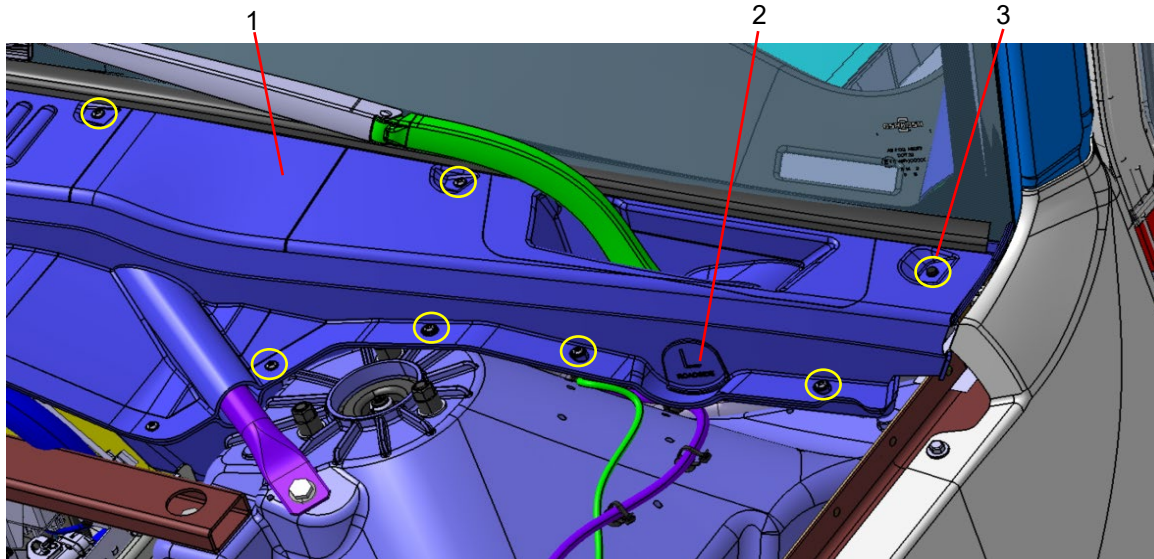
- 26) Secure the left side of the upper cowl (Item 1) with seven screws (Item 3). Tighten screws to 18 lb-in (2.03 N·m).
- 27) Install the upper cowl left hand wiper arm access plug (Item 2) into the upper cowl (Item 1).
- 28) Close and latch the hood.
