Safety Recall: 2024 ZDX Passenger-Side Front Stabilizer Bracket Bolt Inspection

Year	Model	Trim Level	VIN Range
2024	ZDX	ALL	Check iN VIN Status for eligibility.

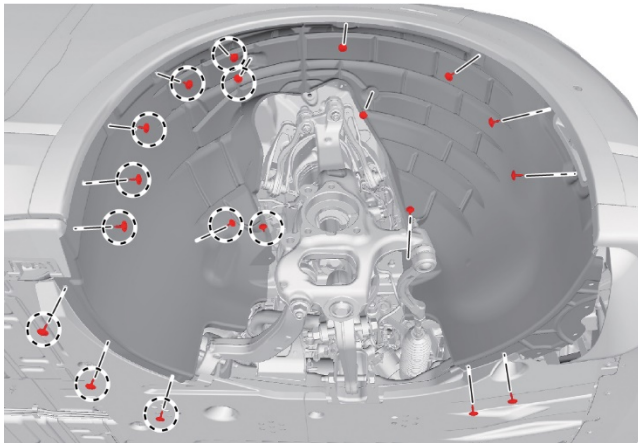
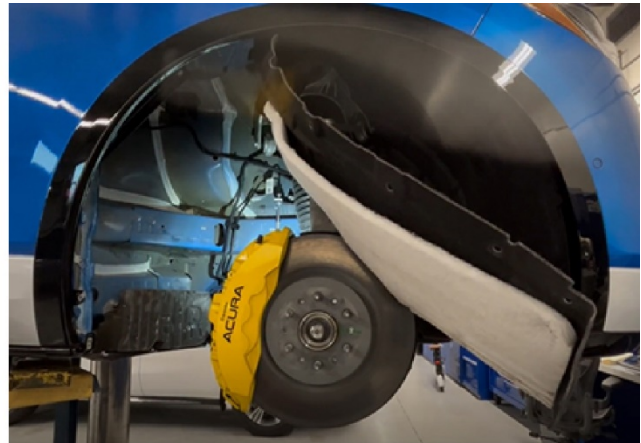
1. Remove the front right tire and wheel assembly.
 - [Tire and Wheel Removal and Installation](#)
2. Remove the mounting bolts (circled) for the rear half of the wheelhouse liner, then move the rear half of the wheelhouse liner to allow access to the front stabilizer bar mounting bolts.

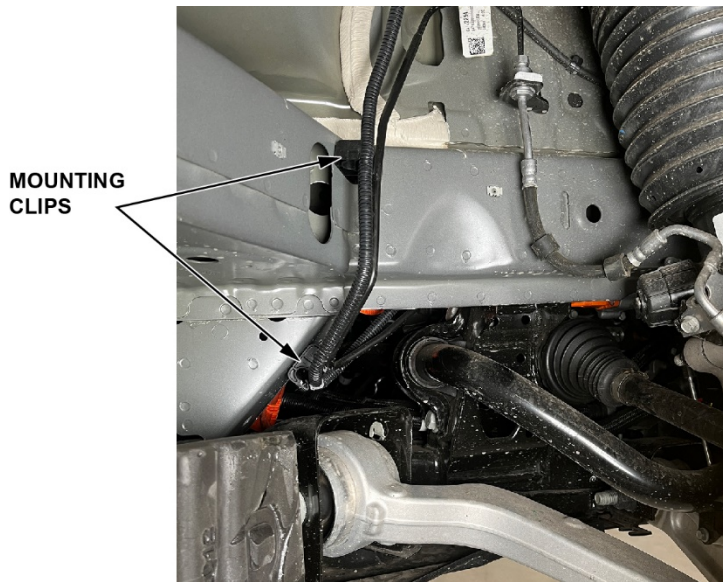
3. Release the harness and brake line from the two mounting clips.

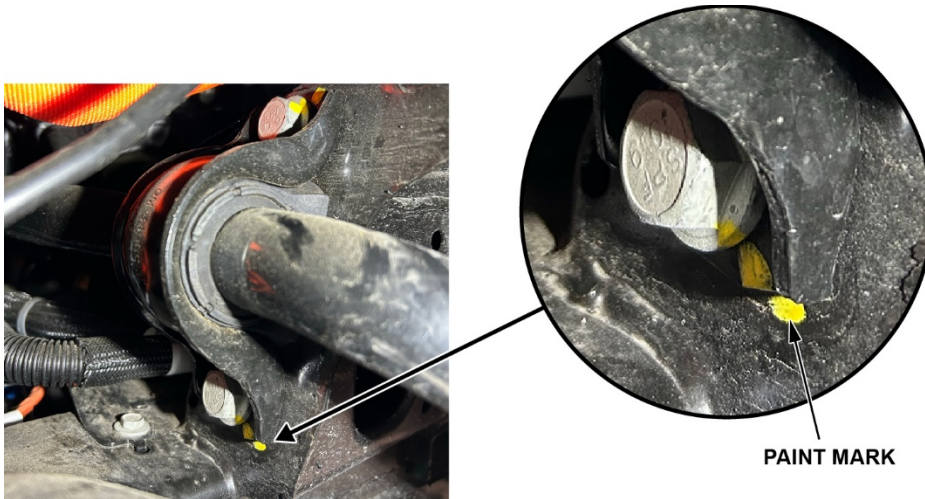
4. Make a reference mark on both bolts and the stabilizer bar bracket with a paint pen.
NOTE: If any bolts are missing, refer to the appropriate Required Action in Step 5.

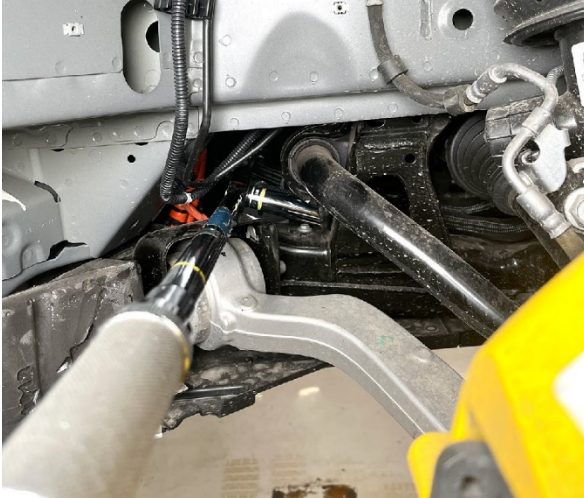
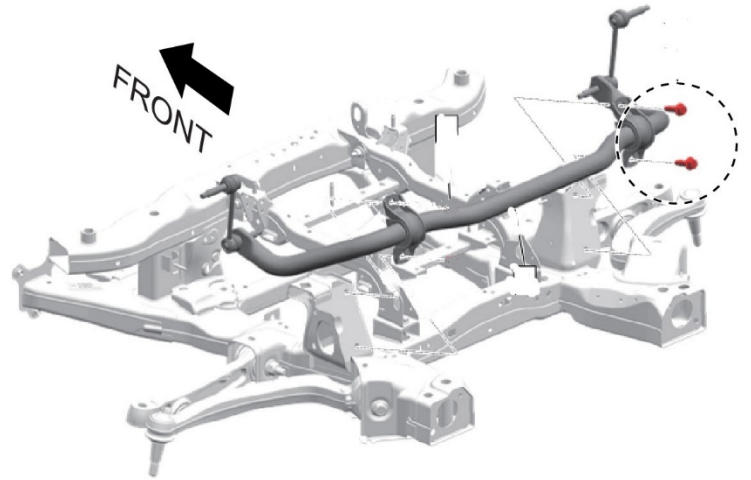
5. Torque both right-side front stabilizer bar bracket bolts to **10 N·m (7 lb-ft)**, then check the paint marks to see if the bolts have moved:

Bolt Status	Required Action
Neither of the two bolts have moved.	Torque the two passenger-side front stabilizer bar bracket bolts to 100 N·m (74 lb-ft) .
One bolt moved, or is missing.	Replace the loose or missing bolt with a new bolt, then torque the two passenger-side front stabilizer bar bracket bolts to 100 N·m (74 lb-ft) .
Both bolts have moved.	Replace both bolts with new bolts, then torque the two passenger-side front stabilizer bar bracket bolts to 100 N·m (74 lb-ft) .
Both bolts are missing.	Inspect the EV battery cable, the drive motor battery charger inlet hose, the drive motor power distribution control module hose, and the stabilizer bar for any damage. Replace any damaged components. Replace both bolts with new bolts, then torque the two passenger-side front stabilizer bar bracket bolts to 100 N·m (74 lb-ft) .

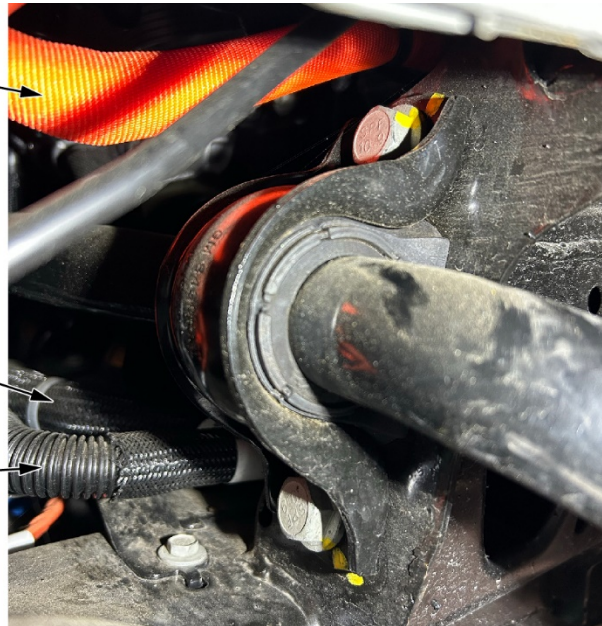
During assembly, the passenger-side front stabilizer bar bracket bolts may have been improperly fastened. If the bracket bolt(s) loosens and separates from the vehicle frame, the stabilizer bar and/or bracket can damage the high voltage cables and/or EV battery coolant lines.

EV BATTERY CABLE

DRIVE MOTOR BATTERY CHARGER INLET HOSE

DRIVE MOTOR POWER DISTRIBUTION CONTROL MODULE HOSE

Inspect the passenger side front stabilizer bolts, inspect for damage if bolts are missing, replace any damaged parts, replace missing bolts, tighten bolts to proper torque specification.
