## Customer Legal Recall

**MAS004687**  
(CLR 25-04)

### Customer Legal Recall # 784 – U.S. MY24 GranTurismo– Homologation label Replacement

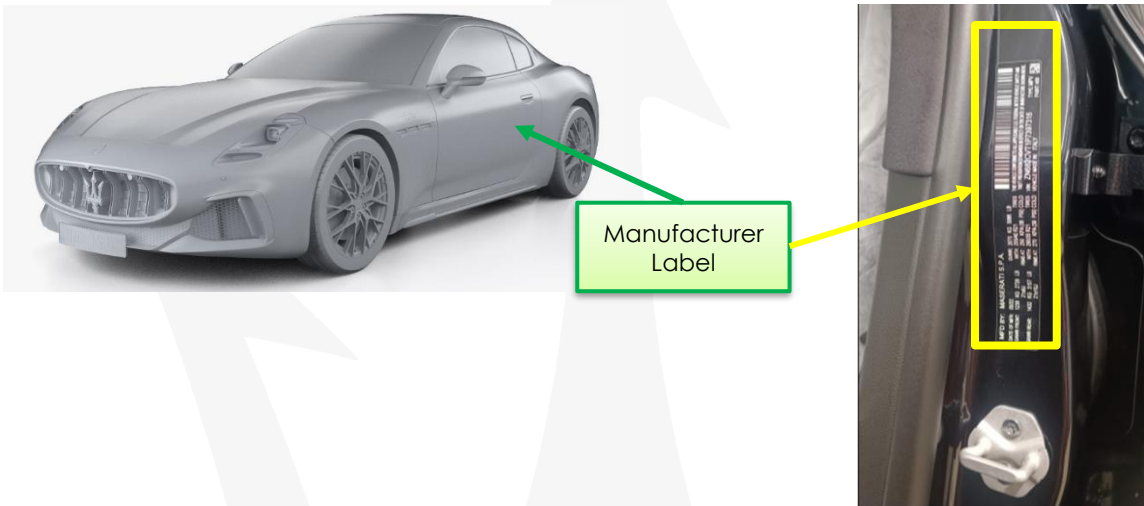
**US Market Version – PN 670218898**

- **Manufacturer Label** - positioned on the B-pillar on the driver's side.

DATE OF MFR: XX/XX	GVWR: XXXX KG XXXX LB	THIS VEHICLE CONFORMS TO ALL APPLICABLE U.S. FEDERAL MOTOR VEHICLE SAFETY AND THEFT PREVENTION STANDARDS IN EFFECT ON THE DATE OF MANUFACTURE SHOWN ABOVE.	
GAWR FRONT: XXXX KG XXXX LB 20x8.5	WITH: PXXX / XXRXX	TIRES	VIN: ZARXXXXXXXXX00000
GAWR REAR: XXXX KG XXXX LB 20x8.5	RIMS AT: XXX KPA (XX PSI) COLD	TIRES	VEHICLE MADE IN: ITALY
	WITH: PXXX / XXRXX	TIRES	TYPE: MPV
	RIMS AT: XXX KPA (XX PSI) COLD	TIRES	PAINT: XXX

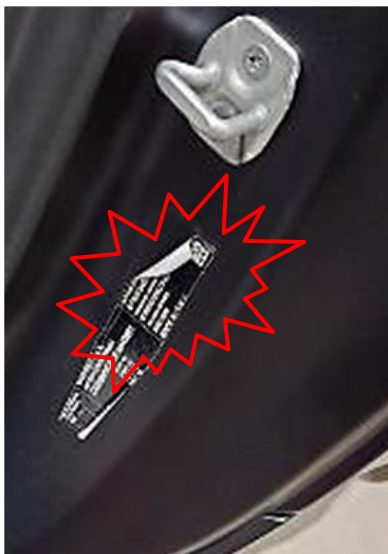
Figure 1: NA Market version

- **Tire pressure plate** - For the **USA**, the "Tire Pressure Information" labels installed inside the B-pillar must also be checked and possibly replaced.

1. Identify the labels to be checked by checking the exact location in the appropriate section "Location of the Labels to be checked".
2. Check that the entire label does not have any lifting zones. The verification must be carried out both visually and with a light tactile test of the edges to be sure that there are no lifting triggers.

3. If the labels checked do **not show signs of lifting** or detaching, No further action is needed.
4. If, on the other hand, there is even a **minimal lifting area**, it is necessary to proceed with the complete **removal and replacement of the damaged label**. To do this, follow the instructions in this bulletin to replace.

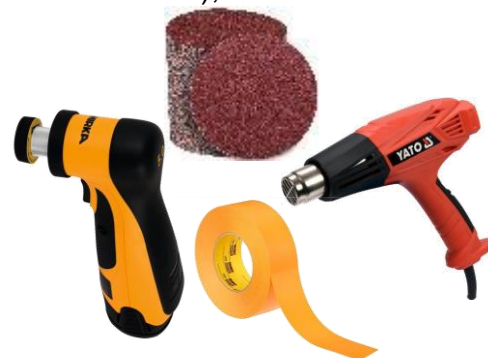
1. Apply masking around the label to be replaced using a **3M 2525** type body tape or similar, taking care to leave a **1 mm offset** around the existing label.

**IMPORTANT:** the tape must be applied by first laying out the two long sides (**A**) and then the two shorter sides, in **a single solution** (there must be no cuts and/or joints of tape on the same side).

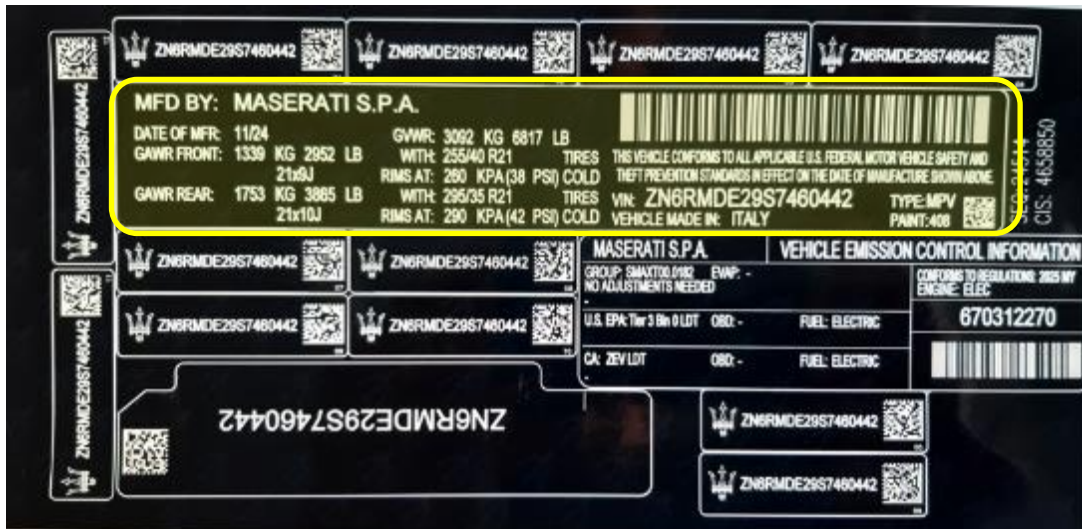
Figure 4: Example of a label sheet

**ATTENTION:** carefully check that the VIN shown on the old label is the same as the new one and take only the necessary label from the label sheet (The "manufacturer label" is shown in the example photo below).

10. Place the new label on the **reworked and cleaned area**, making sure that the **direction of the application** is the same as the one removed, i.e. with **the writing facing the outside of the car.**
11. Make sure that the label adheres well to the surface using a Teflon spatula to remove any bubbles that may have been created.
12. Be very careful, remove the masking taping, and clean the entire area of glue residues using a cloth soaked in **isopropyl alcohol** or equivalent solution.

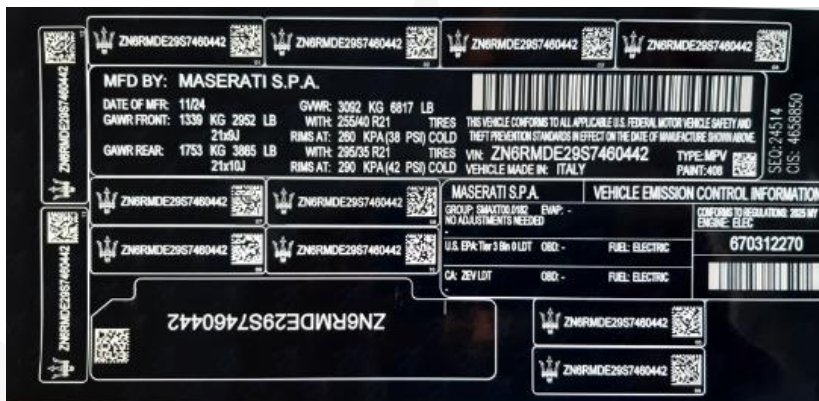
Figure 5: Example of a label sheet

**Note:** A single sheet will be delivered on which all the car labels will be present. Select the necessary labels, as indicated in the bulletin, and destroy the remaining part.

**It is also necessary to order the "Tire Pressure Info" labels.**
