Recall Campaign Bulletin

Mercedes-Benz

CAMPAIGN NO.	2025040012
CAMPAIGN DESC.	25P9192004
NHTSA ID	25V253
SUBJECT	Check Seat Belt Tensioner Cover
MODEL(S)	C-Class (206 platform)
MODEL YEAR(S)	2022 – 2025
CAMPAIGN POPULATION	46

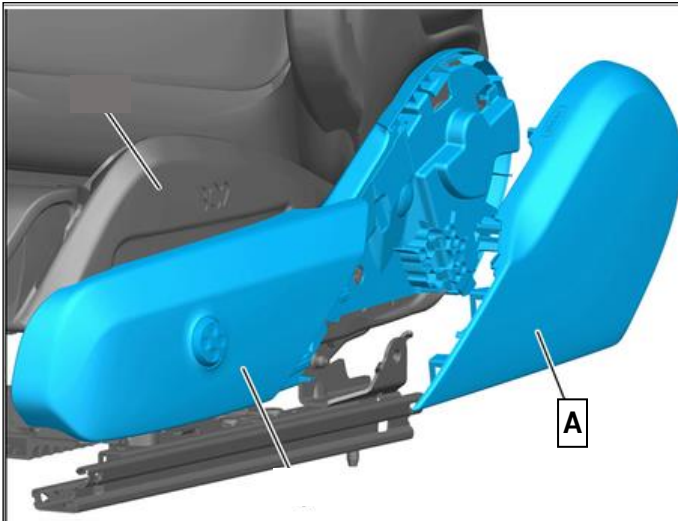
Figure 1

1. Remove the outer seat trim from the driver seat (**Figure 1, A**).

NOTE: Only the trim (**Figure 1, A**) needs to be removed!
